ARDSLEY

FLOOD RISK MANAGEMENT PROJECT

*FLOODWALLS, INTERIOR DRAINAGE SYSTEM AND FLOOD DAMAGE
REDUCTION CHANNEL*

2010 PERIODIC INSPECTION REPORT No.1

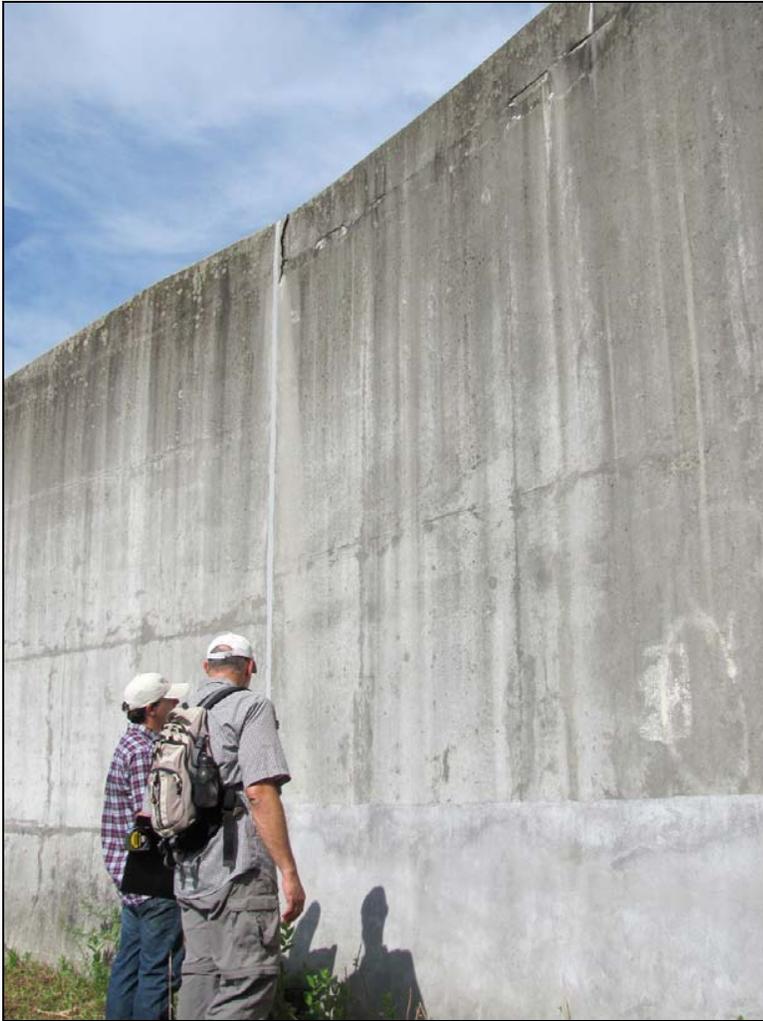
Inspect ID: NAR1_2010_a_0011 **Title:** USACE_CENAN_NAR1_2010_a_0011_1.jpg **Caption:** Significant cracks and spalling on top of floodwall.

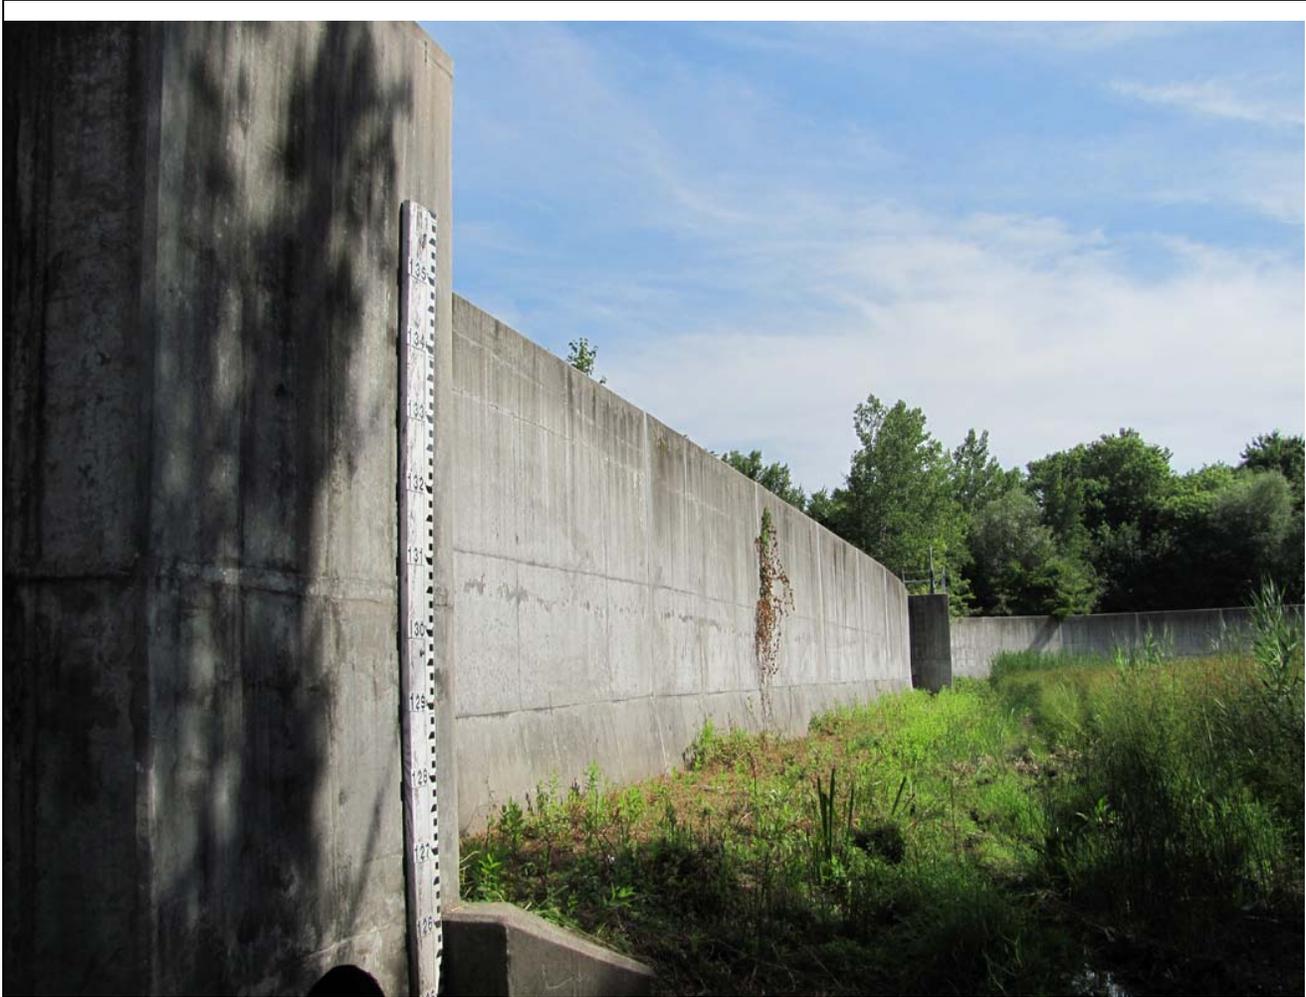
Inspect ID: NAR1_2010_a_0016 **Title:** USACE_CENAN_NAR1_2010_a_0016_1.jpg **Caption:** Vine growing on protected side of floodwall. Also note cracking and spalling.

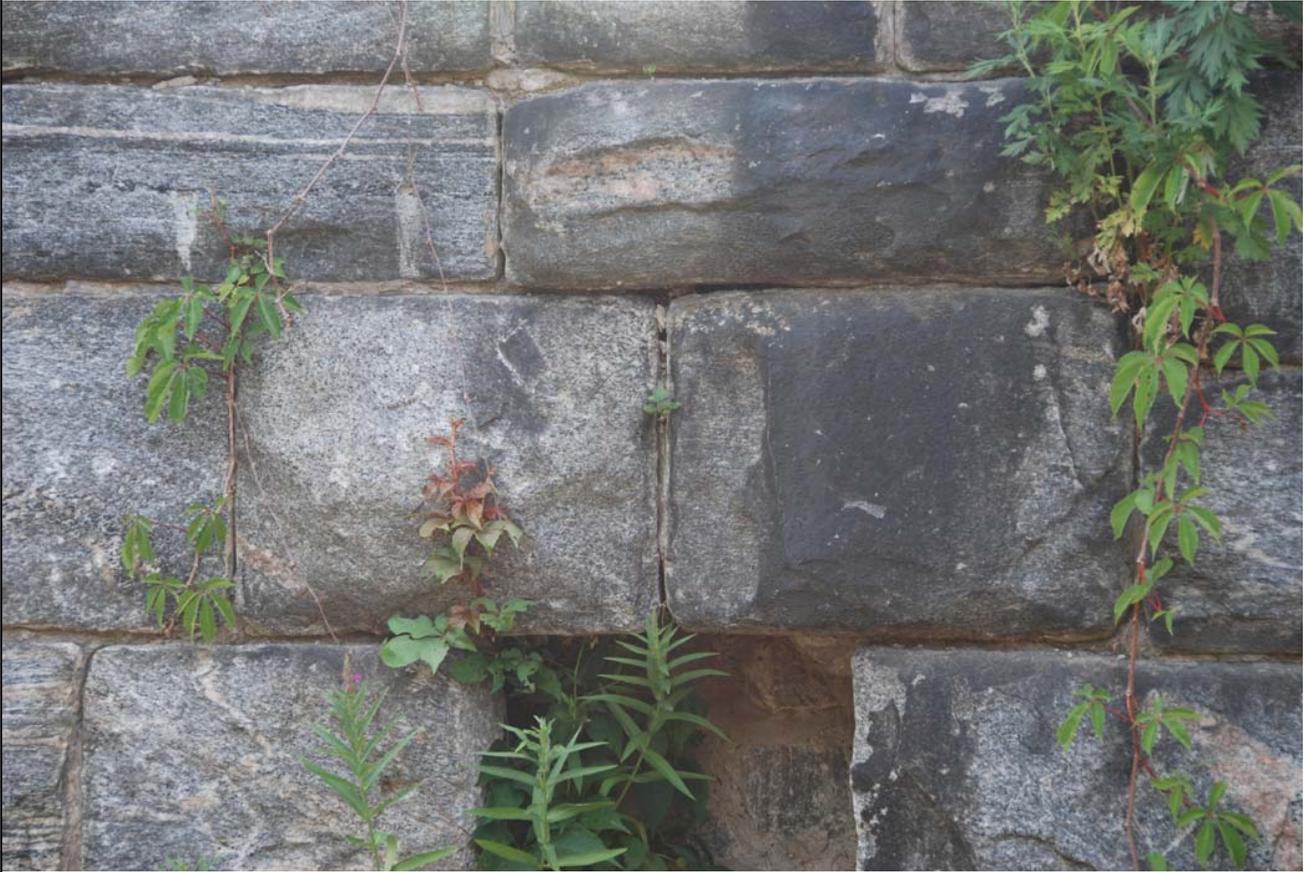
Inspect ID: NAR1_2010_a_0003 **Title:** USACE_CENAN_NAR1_2010_a_0003_1.jpg **Caption:** The headwall adjacent to the NYCDEP blow off tunnel at Saw Mill River Road is visibly deteriorated. Vegetation is visible and a few stones have already fallen out.

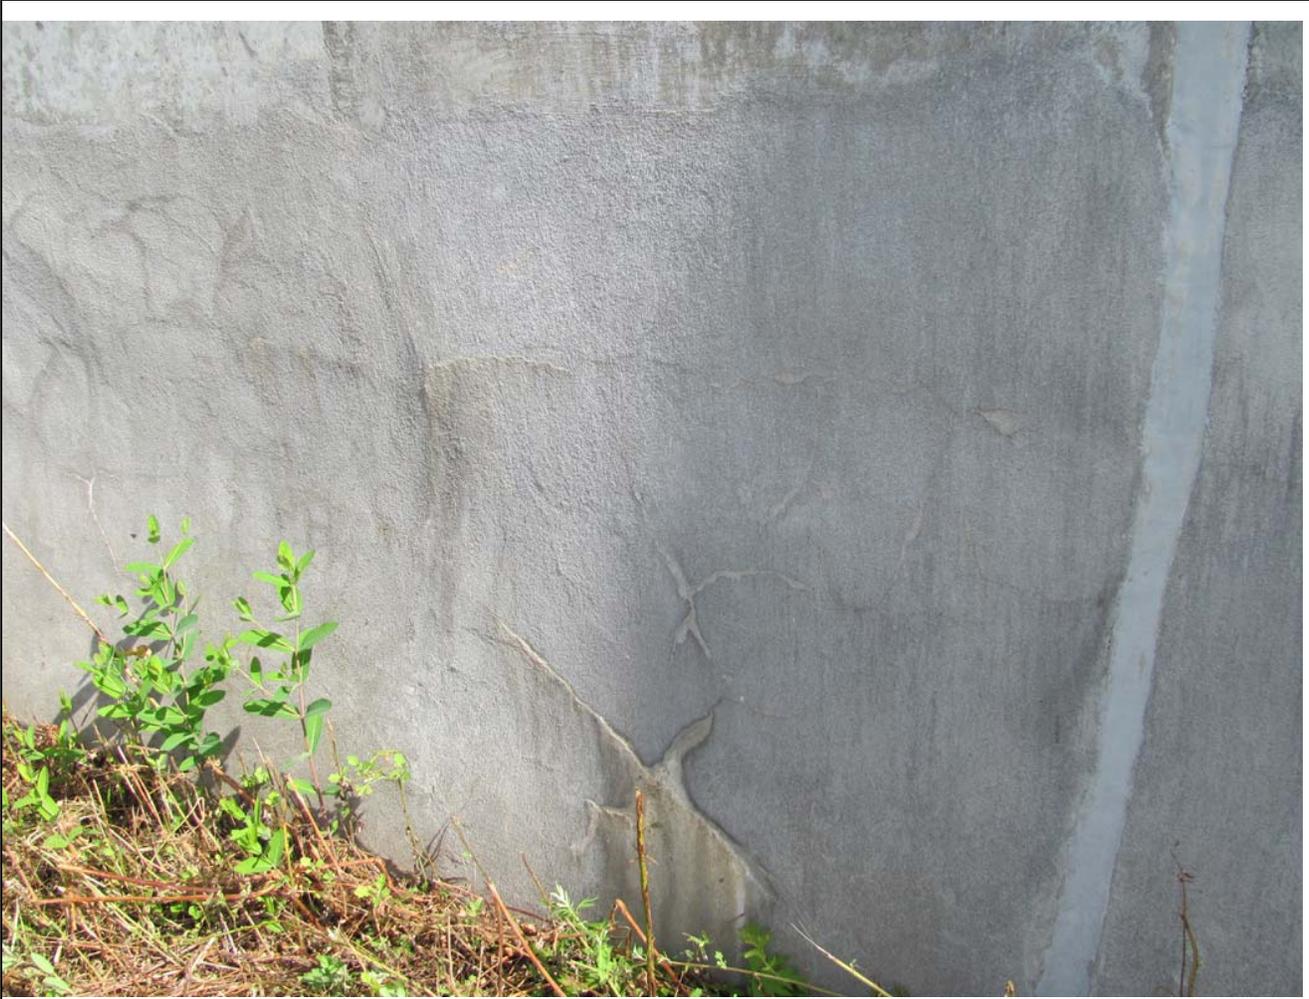
Inspect ID: NAR1_2010_a_0010 **Title:** USACE_CENAN_NAR1_2010_a_0010_1.jpg **Caption:** Concrete spalling on recently repaired areas on the protected side of the floodwall. Damage is mainly on the curved portion of the floodwall.

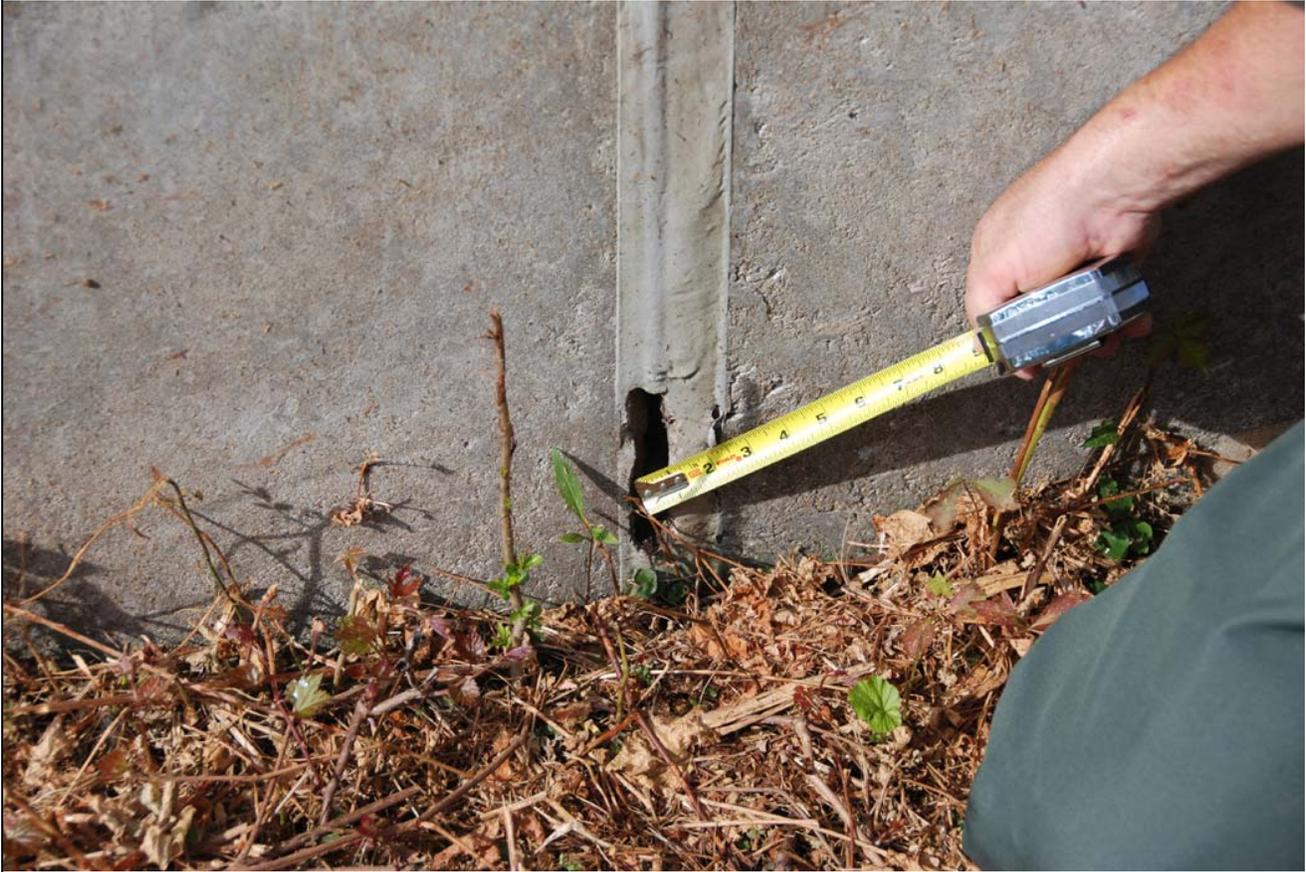
Inspect ID: NAR1_2010_a_0055 **Title:** USACE_CENAN_NAR1_2010_a_0055_1.jpg **Caption:** Missing caulking in monolith joint at base of flood wall on exposed side.

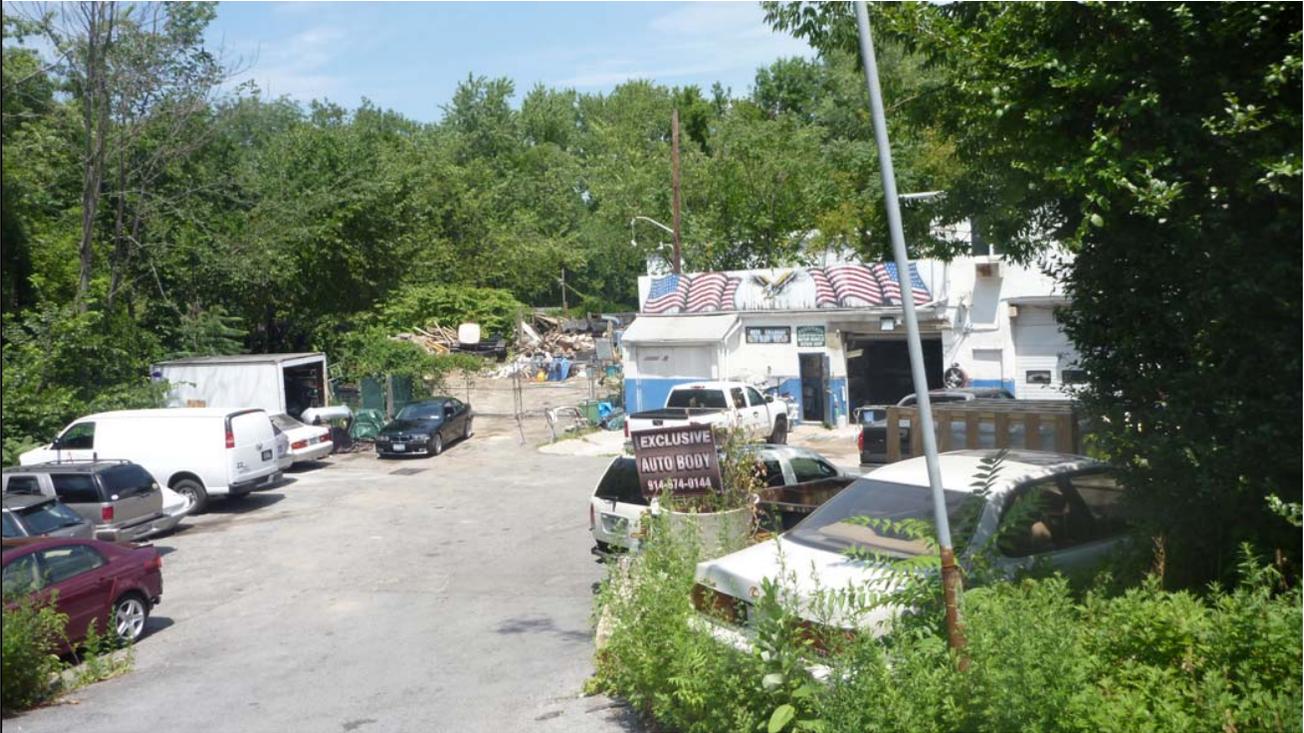
Inspect ID: NAR1_2010_a_0058 **Title:** USACE_CENAN_NAR1_2010_a_0058_1.jpg **Caption:** Building #4: Closure structure and stop logs are unavailable or missing and owner reports having up to 6 ft. of water in the garage.

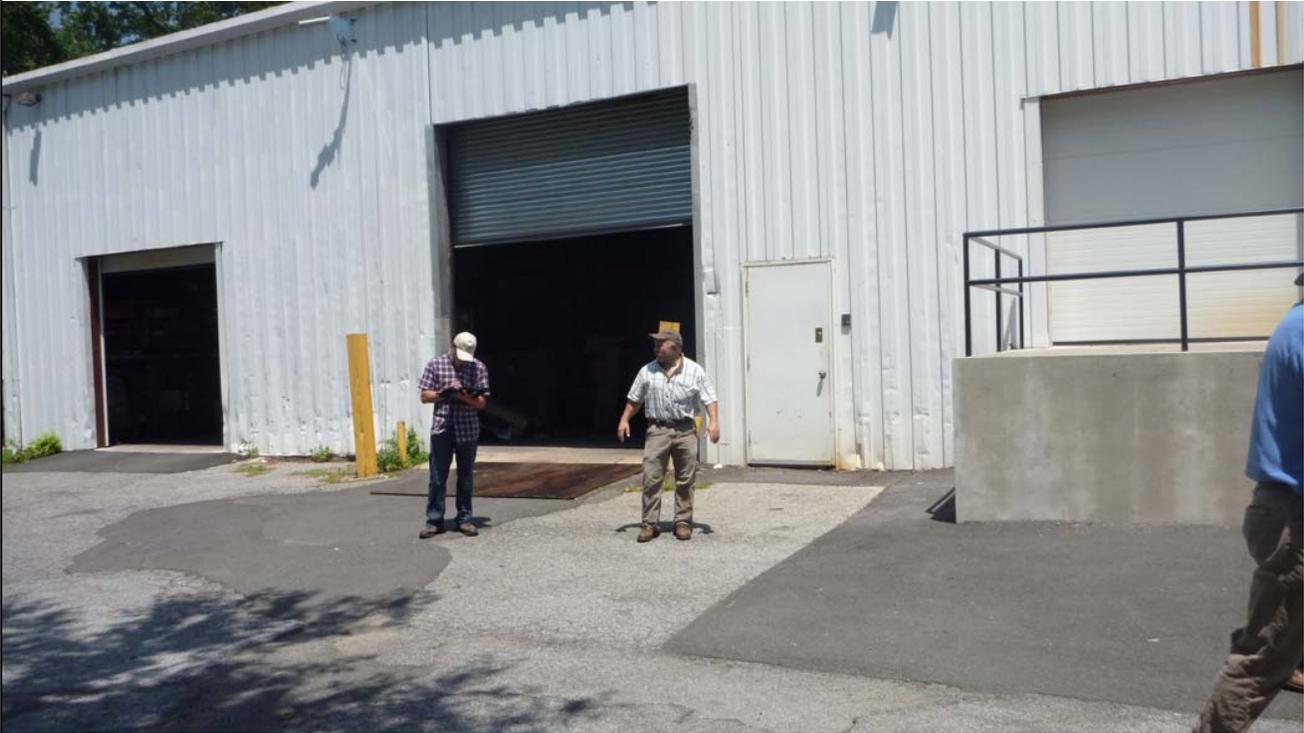
Inspect ID: NAR1_2010_a_0059 **Title:** USACE_CENAN_NAR1_2010_a_0059_1.jpg **Caption:** Building #3, stop log closure structure was not constructed. This deletion is noted on the As-built plans.

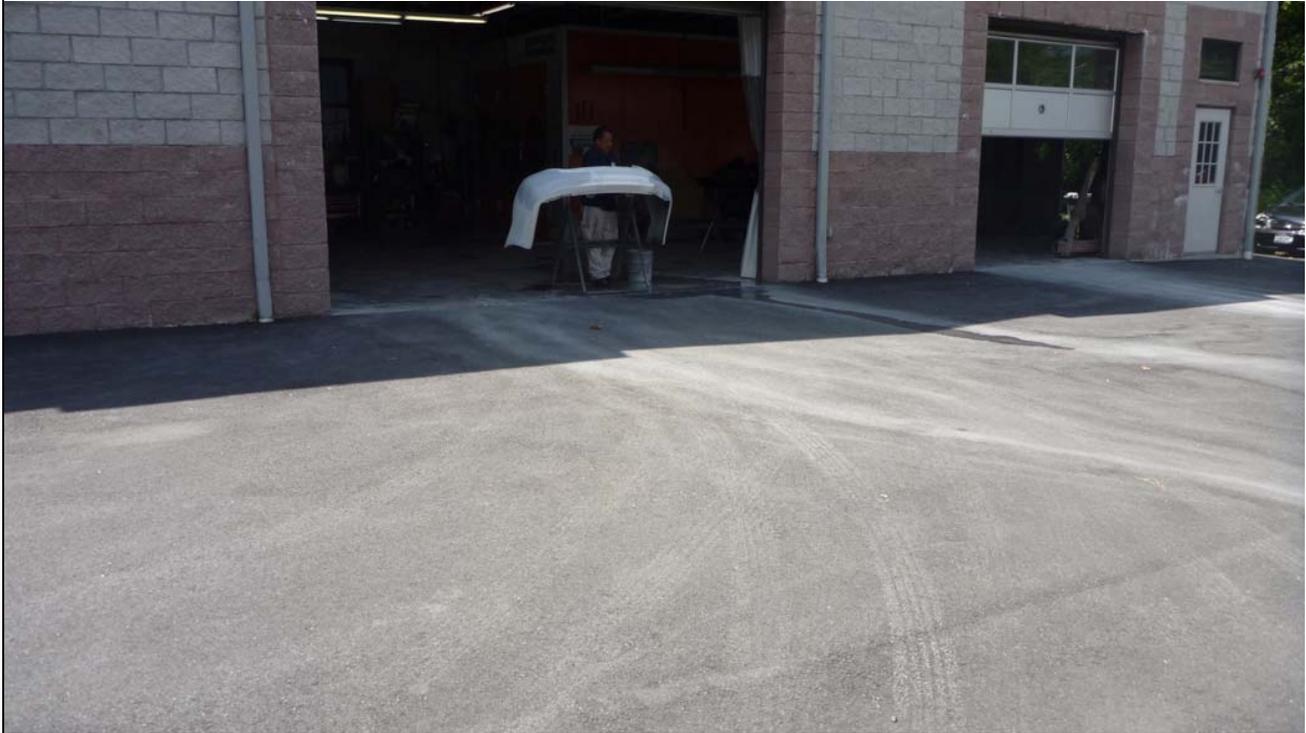
Inspect ID: NAR1_2010_a_0061 **Title:** USACE_CENAN_NAR1_2010_a_0061_1.jpg **Caption:** Addition to Building #2. No flood proofing was installed or remains. This is noted on the As-built plans.

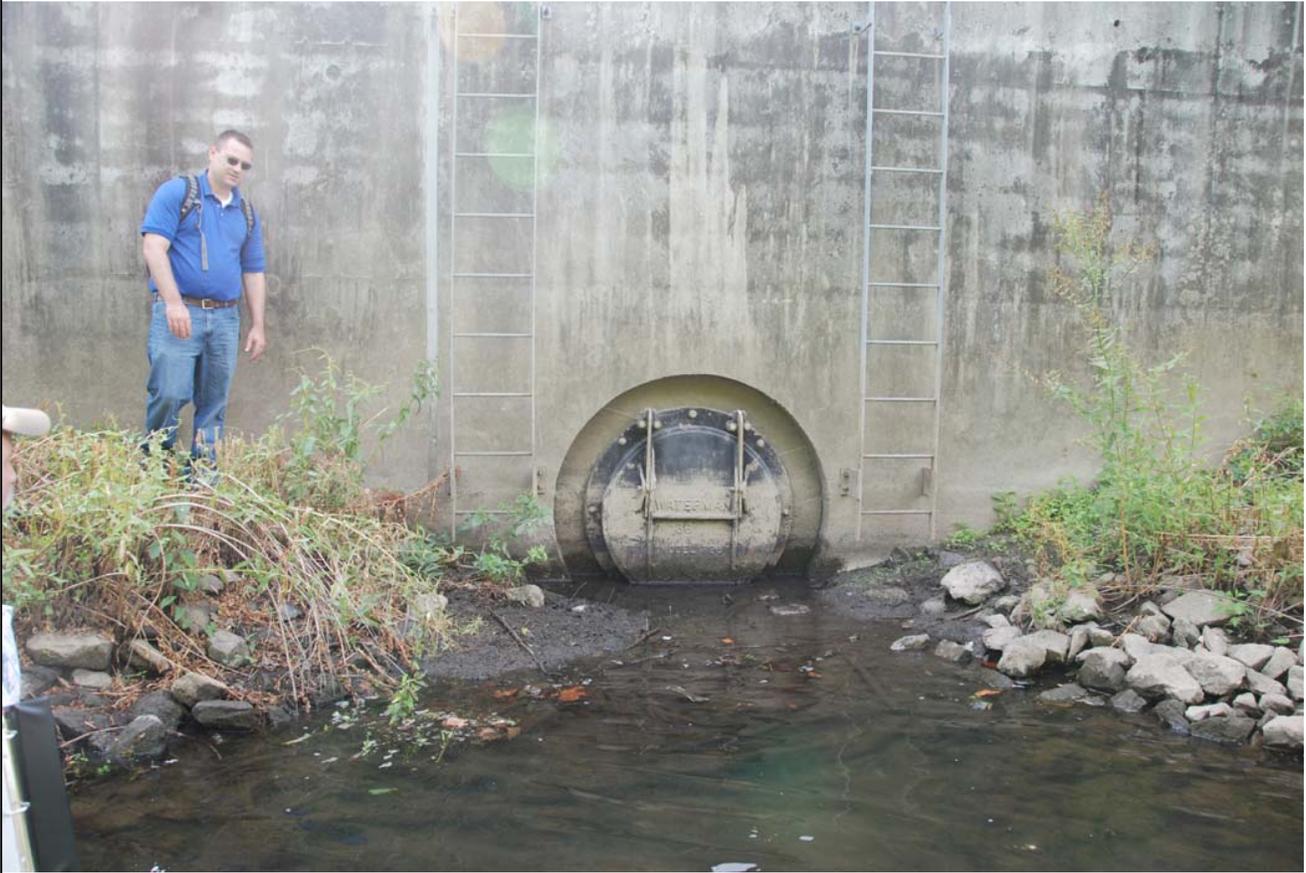
Inspect ID: NAR1_2010_a_0014 **Title:** USACE_CENAN_NAR1_2010_a_0014_1.jpg **Caption:** Drainage structure (DS) #4 outlet is a 36" wide flap gate in good condition. Sediments are building up in the discharge channel.

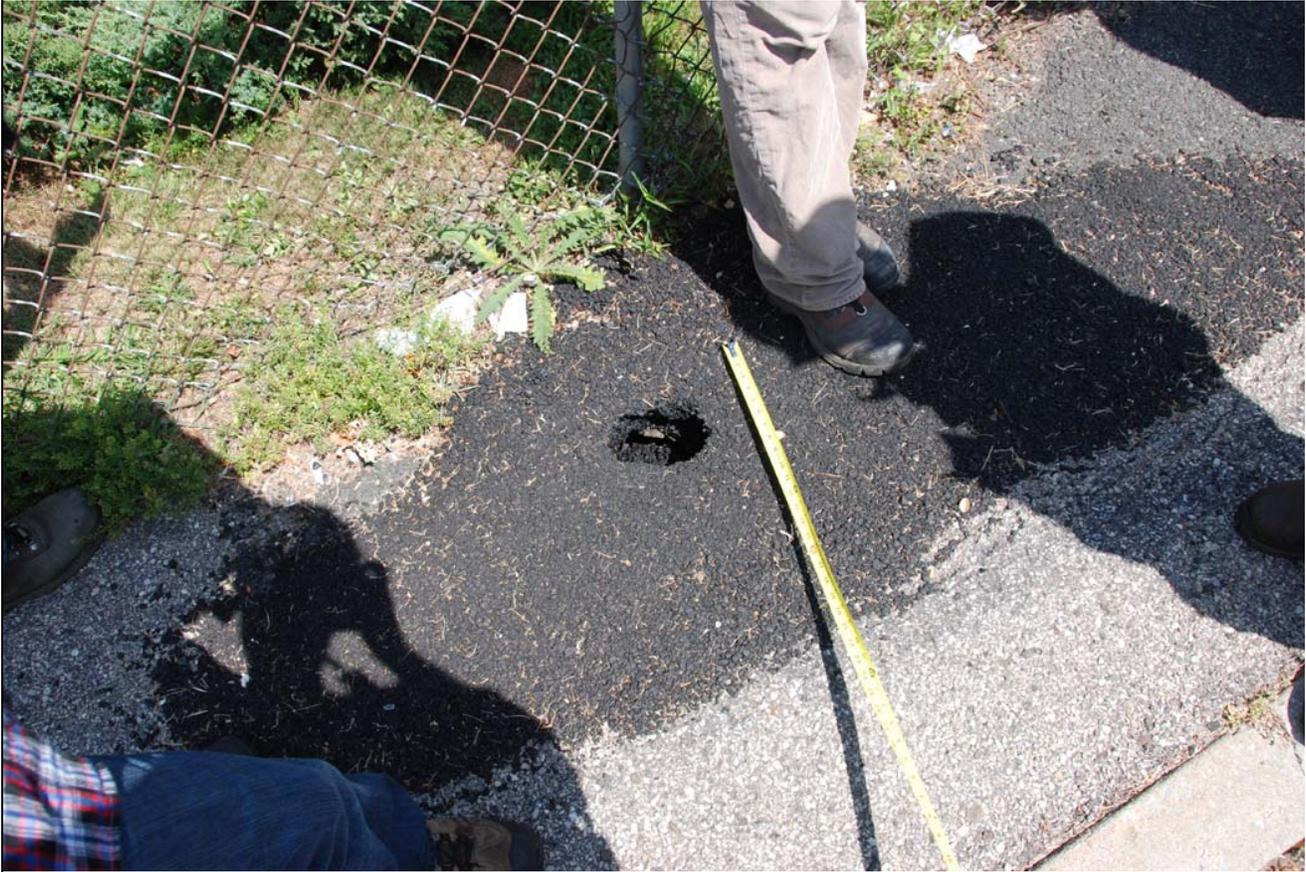
Inspect ID: NAR1_2010_a_0052 **Title:** USACE_CENAN_NAR1_2010_a_0052_1.jpg **Caption:** Sink hole in recently repaired asphalt on sidewalk above 30 inch drainage pipe.

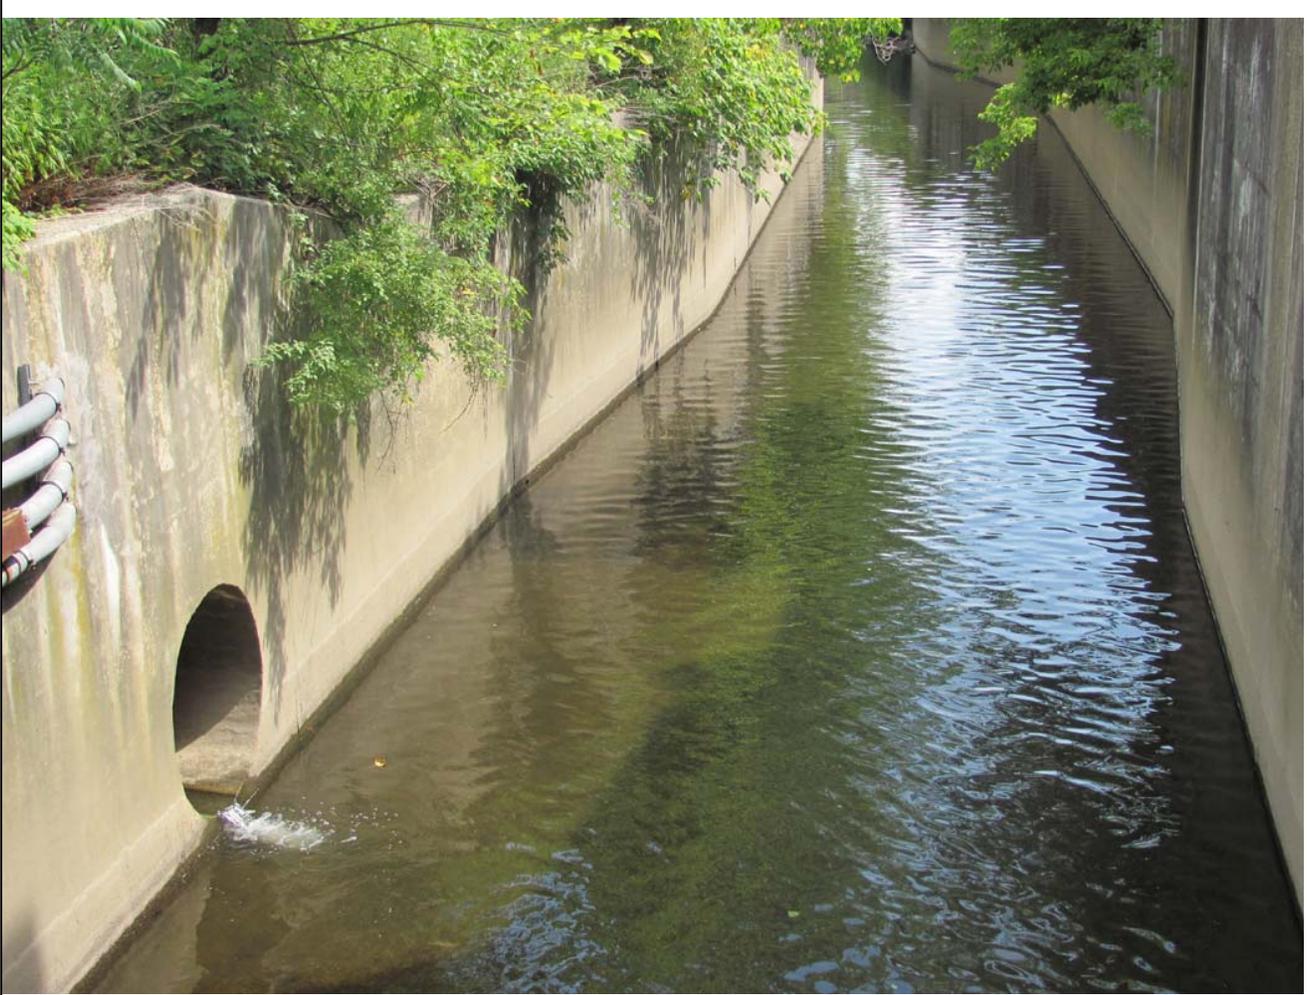
Inspect ID: NAR1_2010_a_0023 **Title:** USACE_CENAN_NAR1_2010_a_0023_1.jpg **Caption:** Vegetation encroaching on both sides of channel.

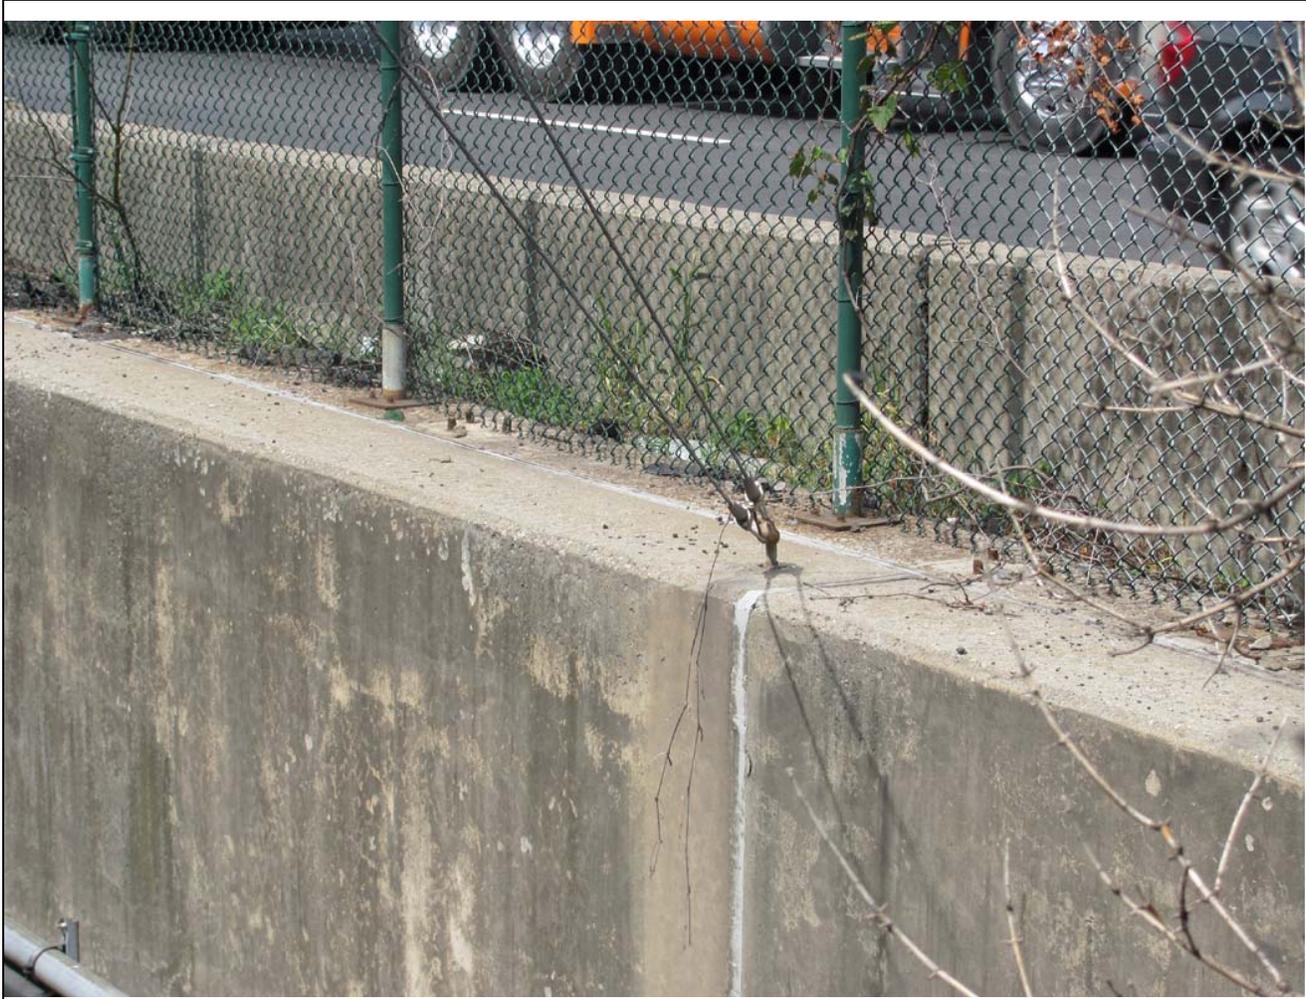
Inspect ID: NAR1_2010_a_0024 **Title:** USACE_CENAN_NAR1_2010_a_0024_1.jpg **Caption:** Guy wire encroaching over channel. NYS Thruway in background.

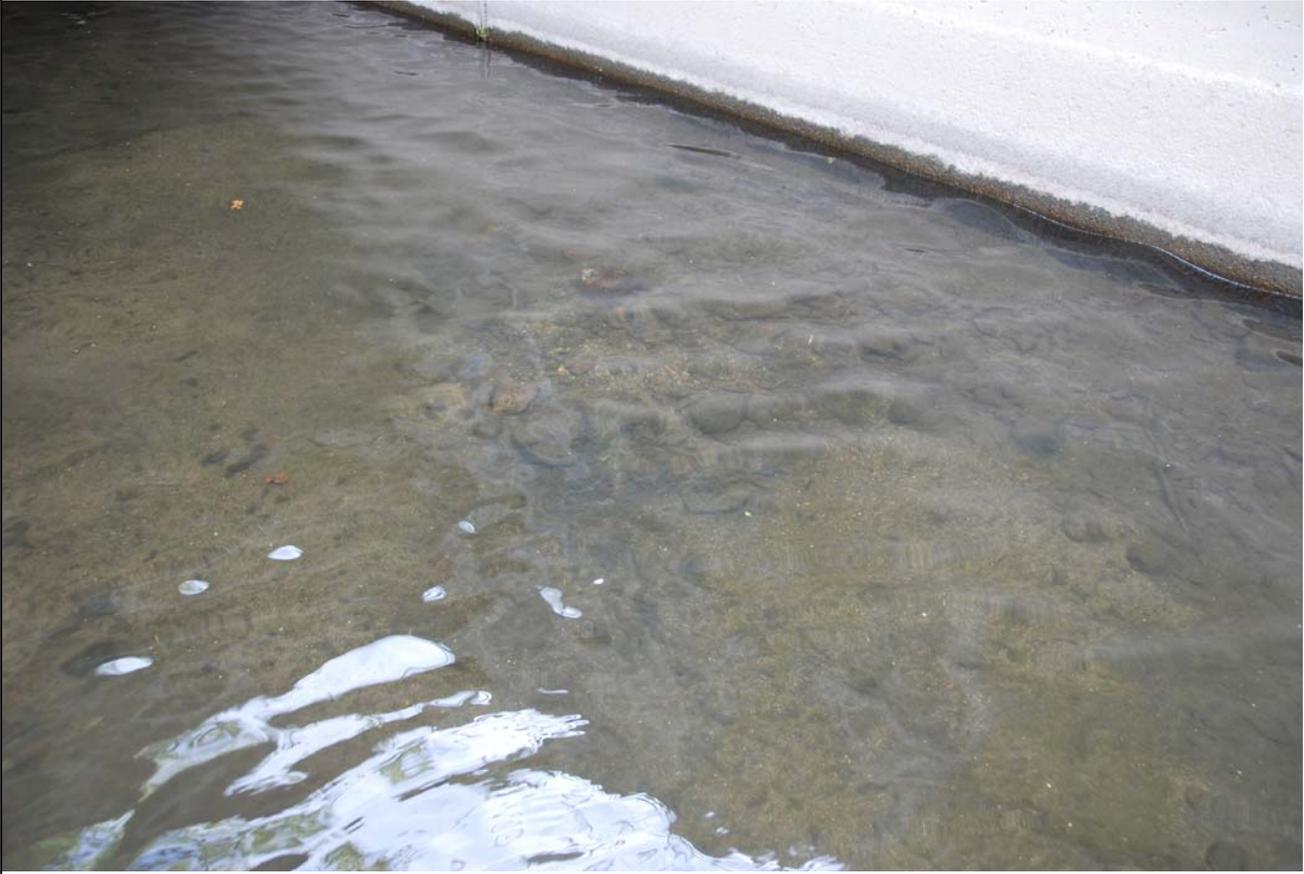
Inspect ID: NAR1_2010_a_0025 **Title:** USACE_CENAN_NAR1_2010_a_0025_1.jpg **Caption:** Sedimentation and rocks in concrete channel.

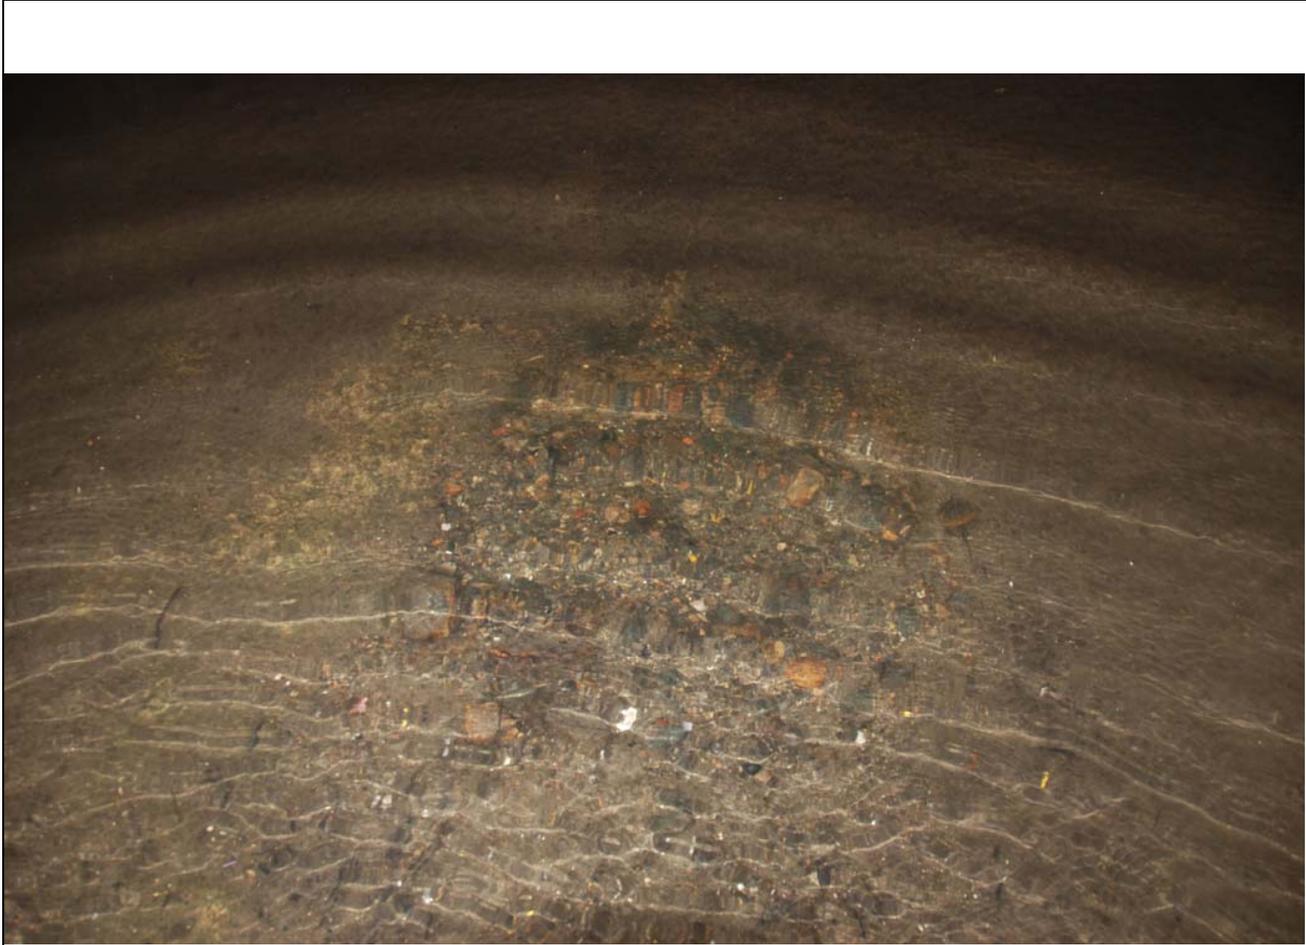
Inspect ID: NAR1_2010_a_0026 **Title:** USACE_CENAN_NAR1_2010_a_0026_1.jpg **Caption:** Scour hole in bottom of the concrete channel.

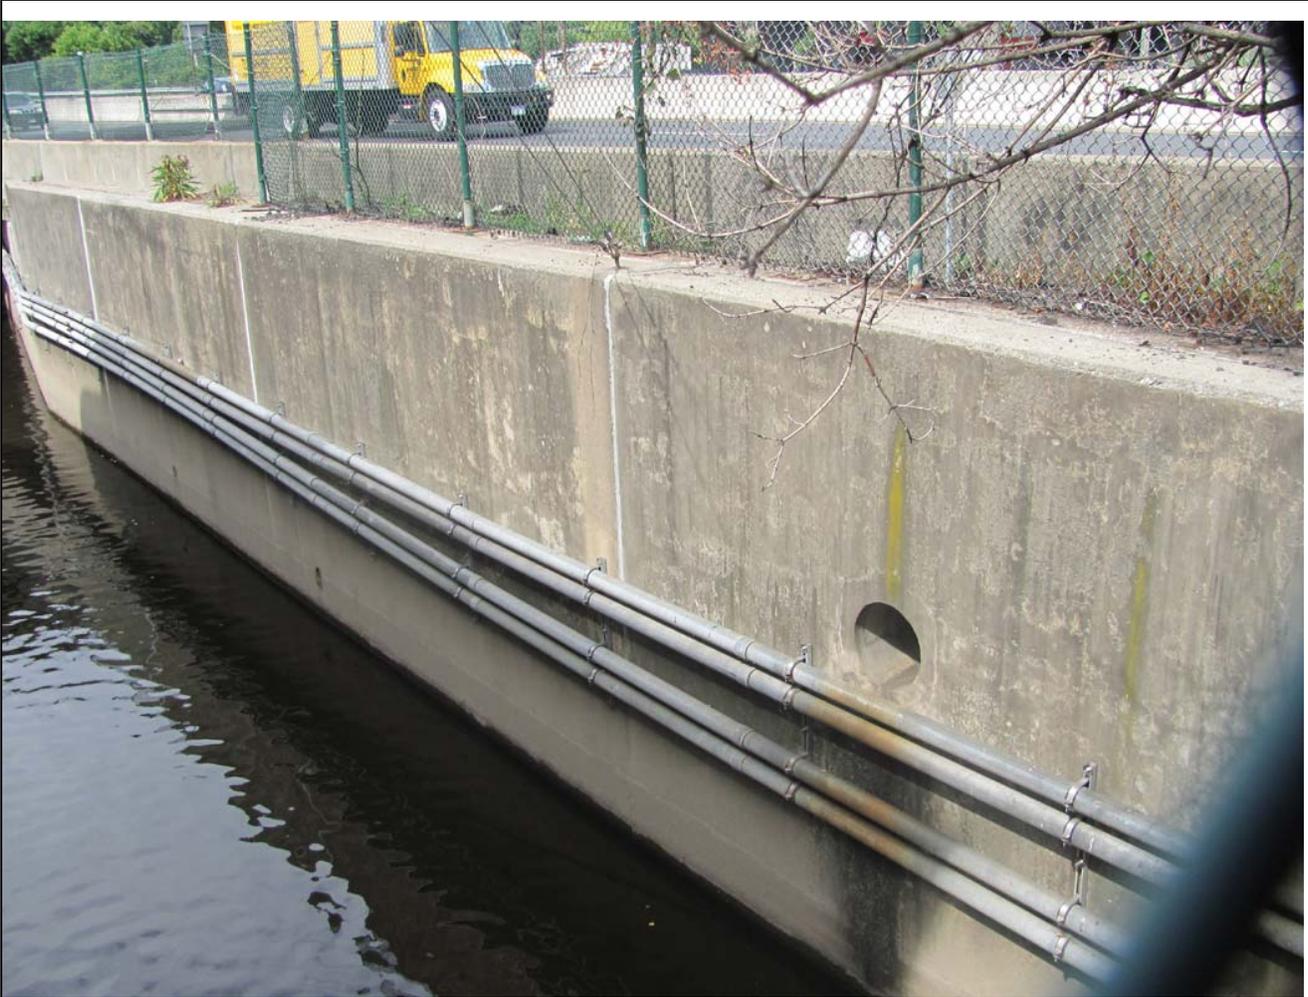
Inspect ID: NAR1_2010_a_0028 **Title:** USACE_CENAN_NAR1_2010_a_0028_1.jpg **Caption:** Metal conduits (pipes) on right side of concrete channel not on as-built plans.

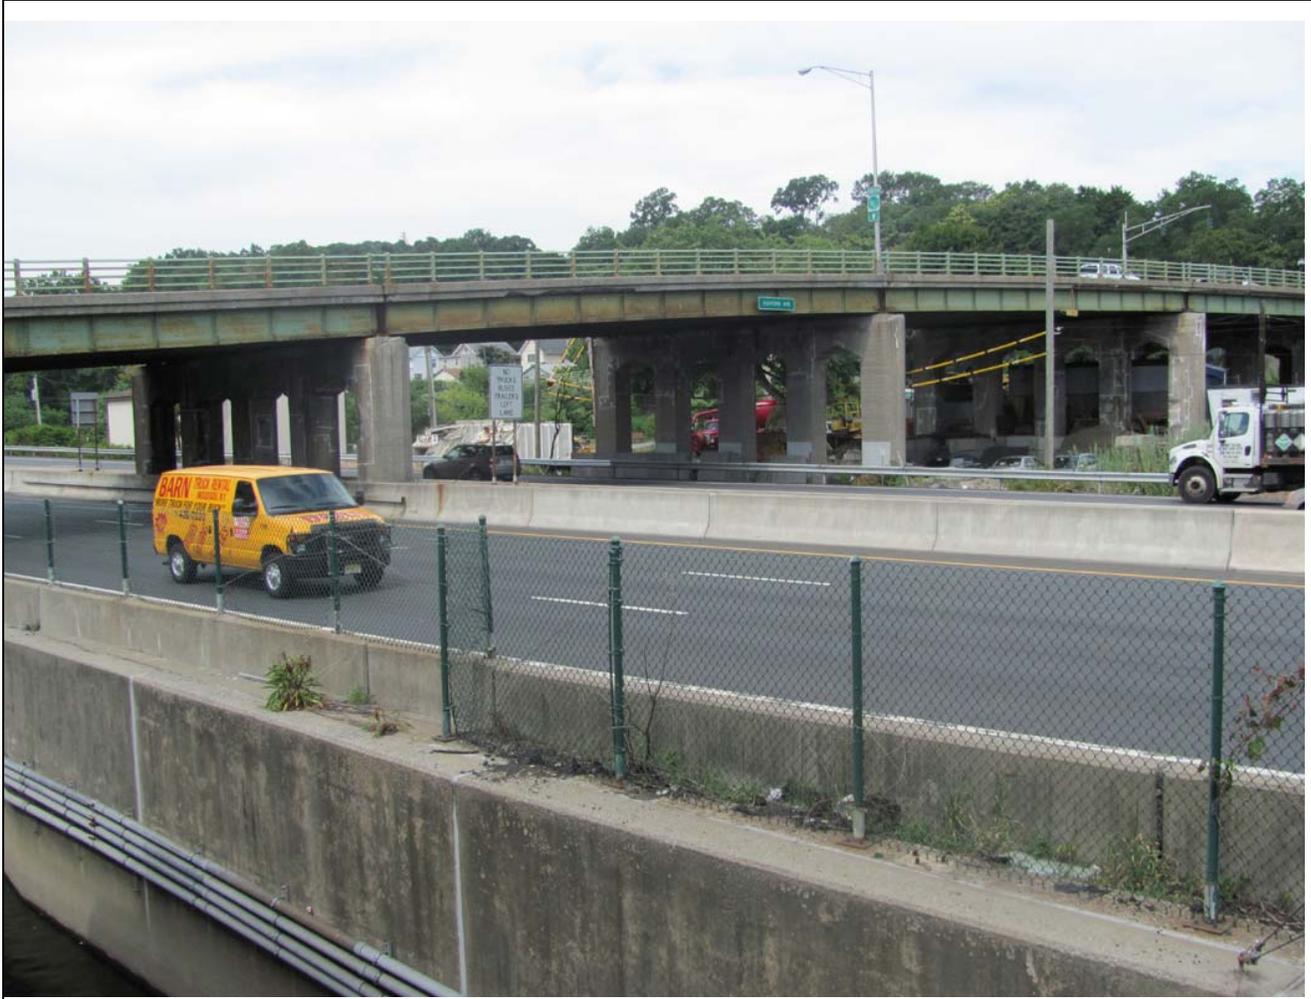
Inspect ID: NAR1_2010_a_0029 **Title:** USACE_CENAN_NAR1_2010_a_0029_1.jpg **Caption:** Chain-link fence between concrete channel and NYS Thruway not on as-built plans.

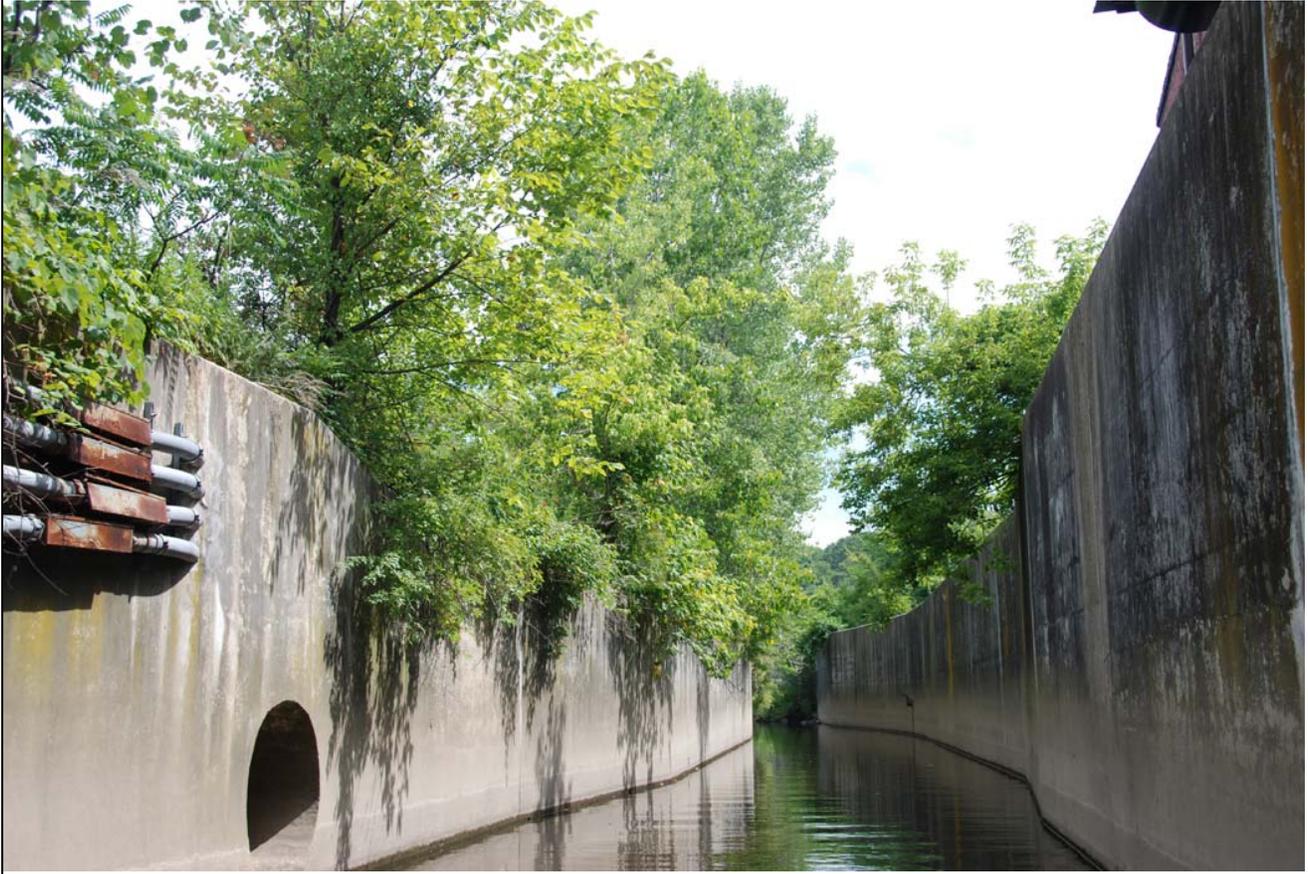
Inspect ID: NAR1_2010_a_0029 **Title:** USACE_CENAN_NAR1_2010_a_0029_2.jpg **Caption:** Trees encroaching and overhanging on western bank (right bank; photo left) of channel wall need to be taken down.

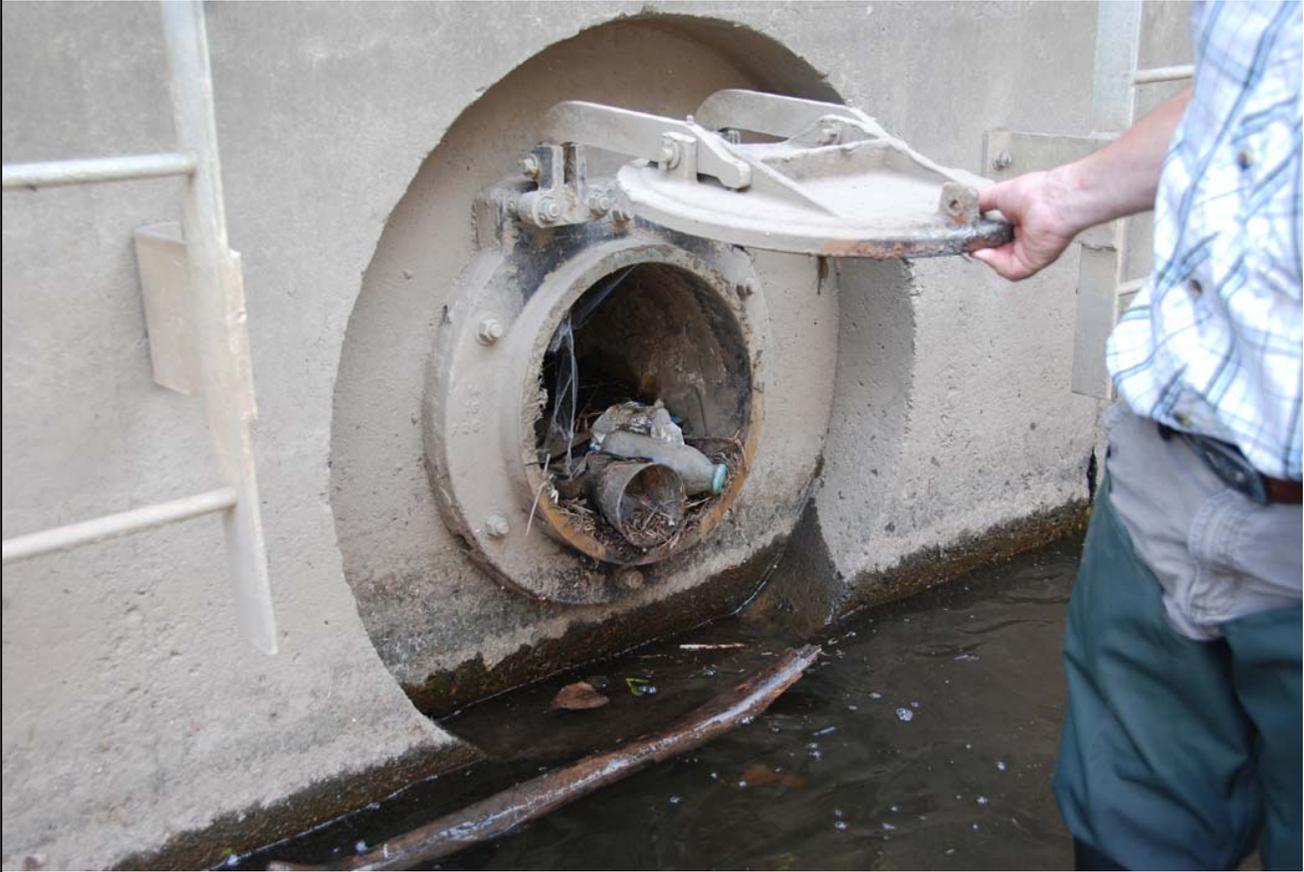
Inspect ID: NAR1_2010_a_0030 **Title:** USACE_CENAN_NAR1_2010_a_0030_1.jpg **Caption:** DS #1 outlet pipe full of debris.

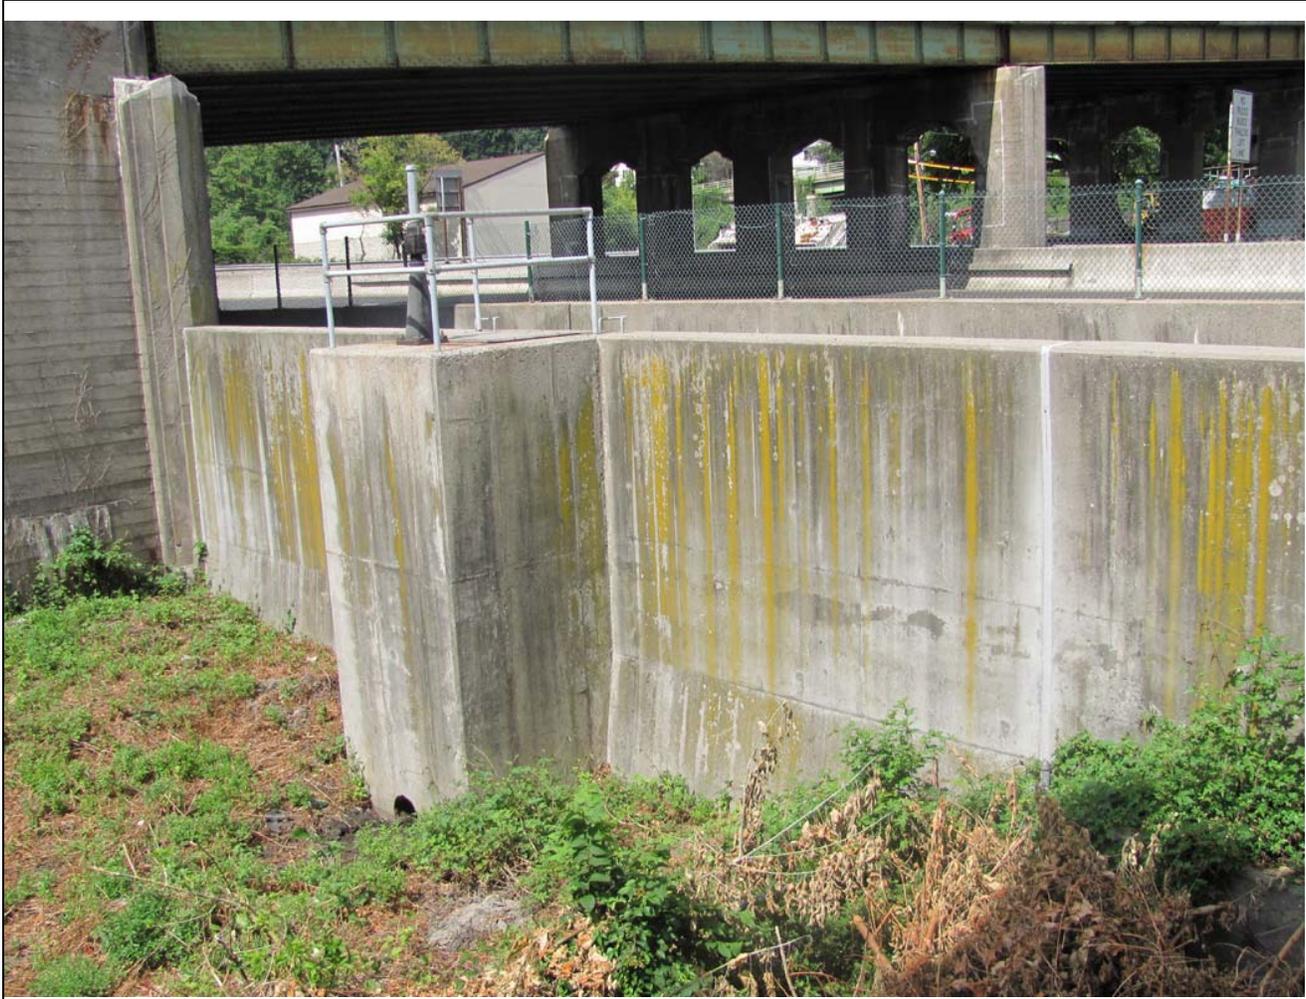
Inspect ID: NAR1_2010_a_0030 **Title:** USACE_CENAN_NAR1_2010_a_0030_2.jpg **Caption:** Loose handrail on top of DS#1.
