ARDSLEY

FLOOD RISK MANAGEMENT PROJECT

*FLOODWALLS, INTERIOR DRAINAGE SYSTEM AND FLOOD DAMAGE
REDUCTION CHANNEL*

2010 PERIODIC INSPECTION REPORT No.1

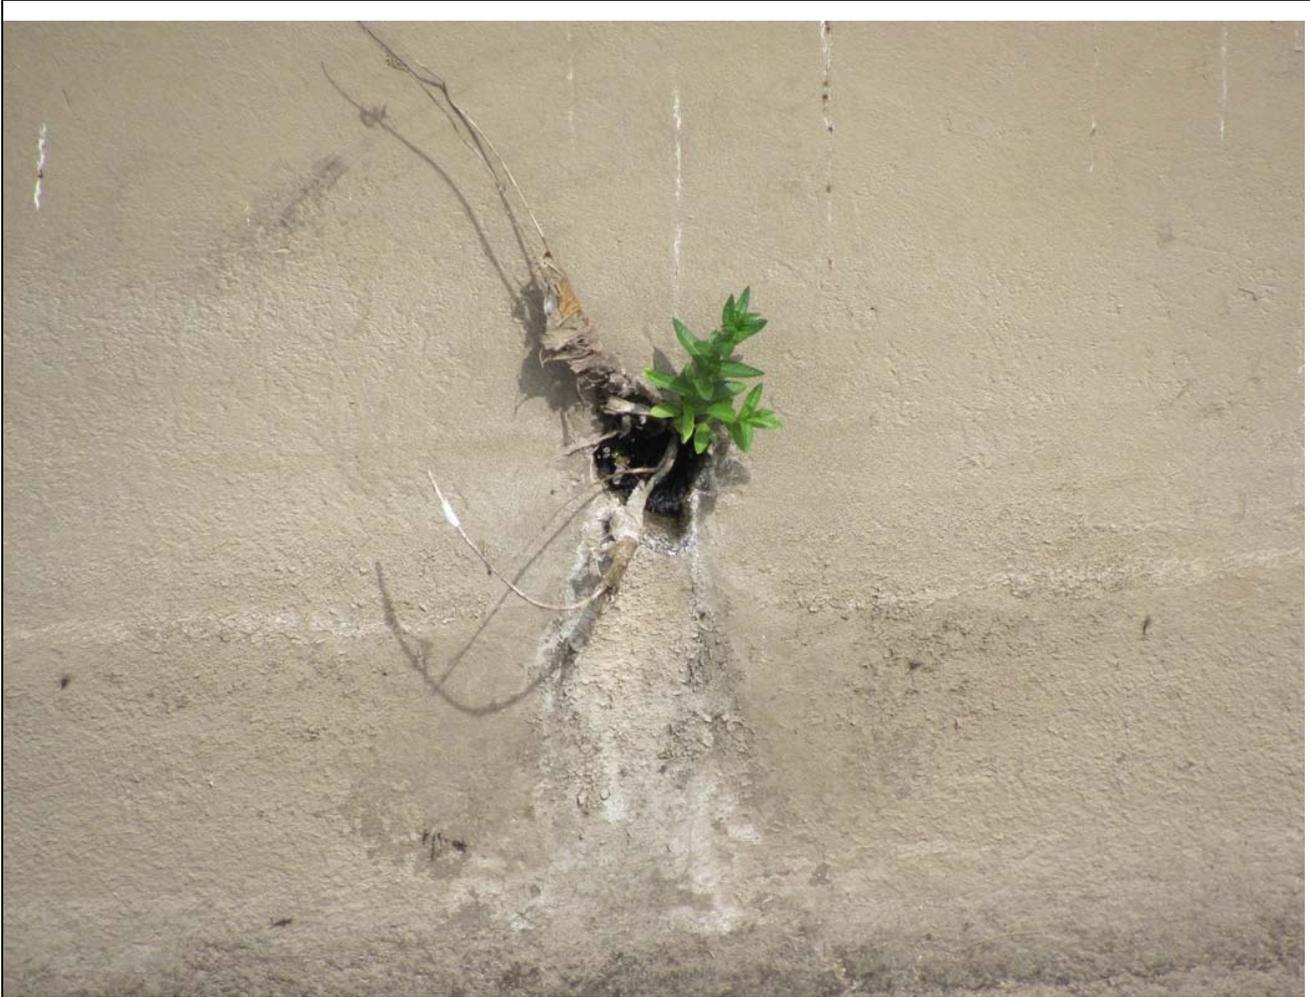
Inspect ID: NAR1_2010_a_0031 **Title:** USACE_CENAN_NAR1_2010_a_0031_1.jpg **Caption:** Weep hole has vegetation growing out of it.

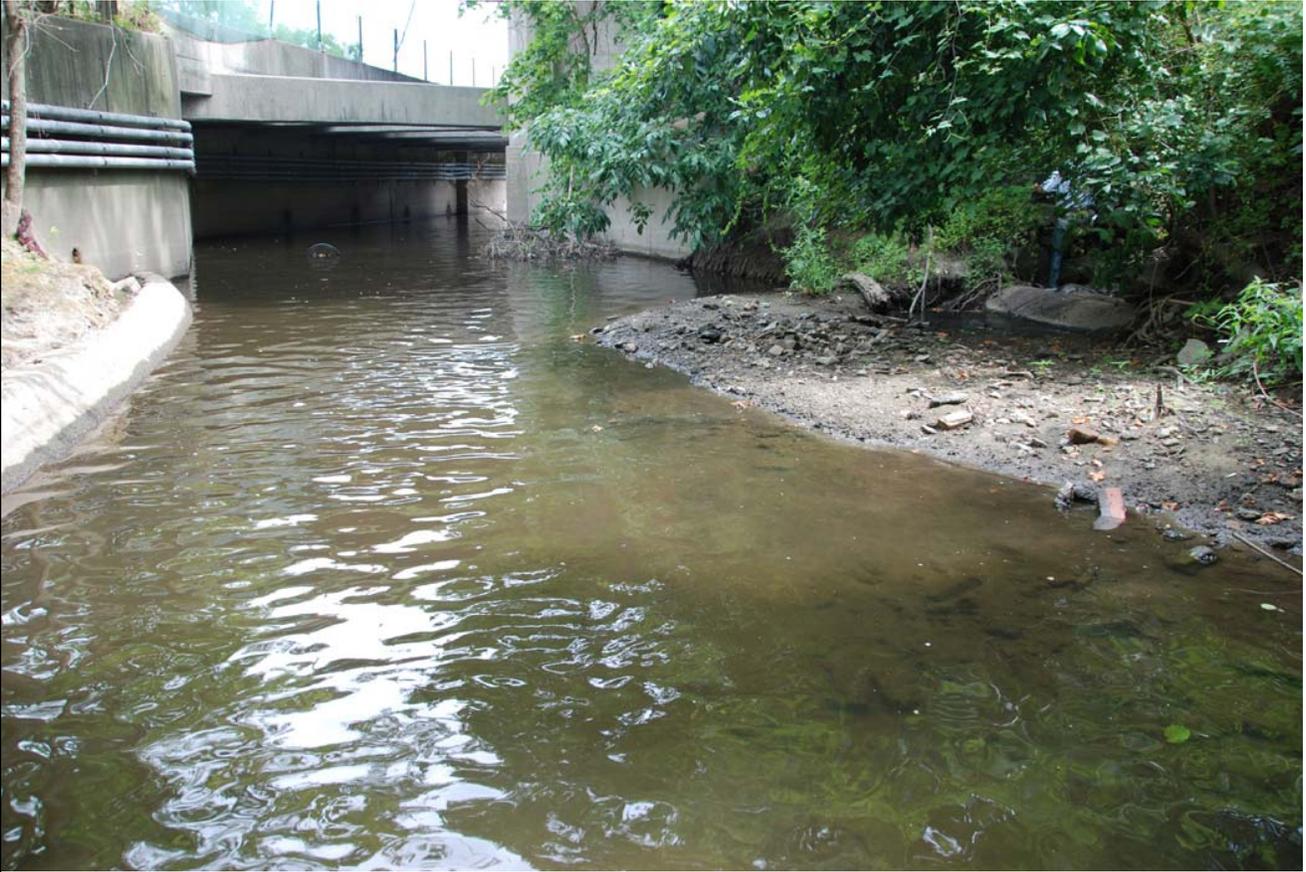
Inspect ID: NAR1_2010_a_0032 **Title:** USACE_CENAN_NAR1_2010_a_0032_1.jpg **Caption:** Shoaling along left bank of the earthen channel that is just downstream of the project. Approximately half the channel is obstructed by this debris.

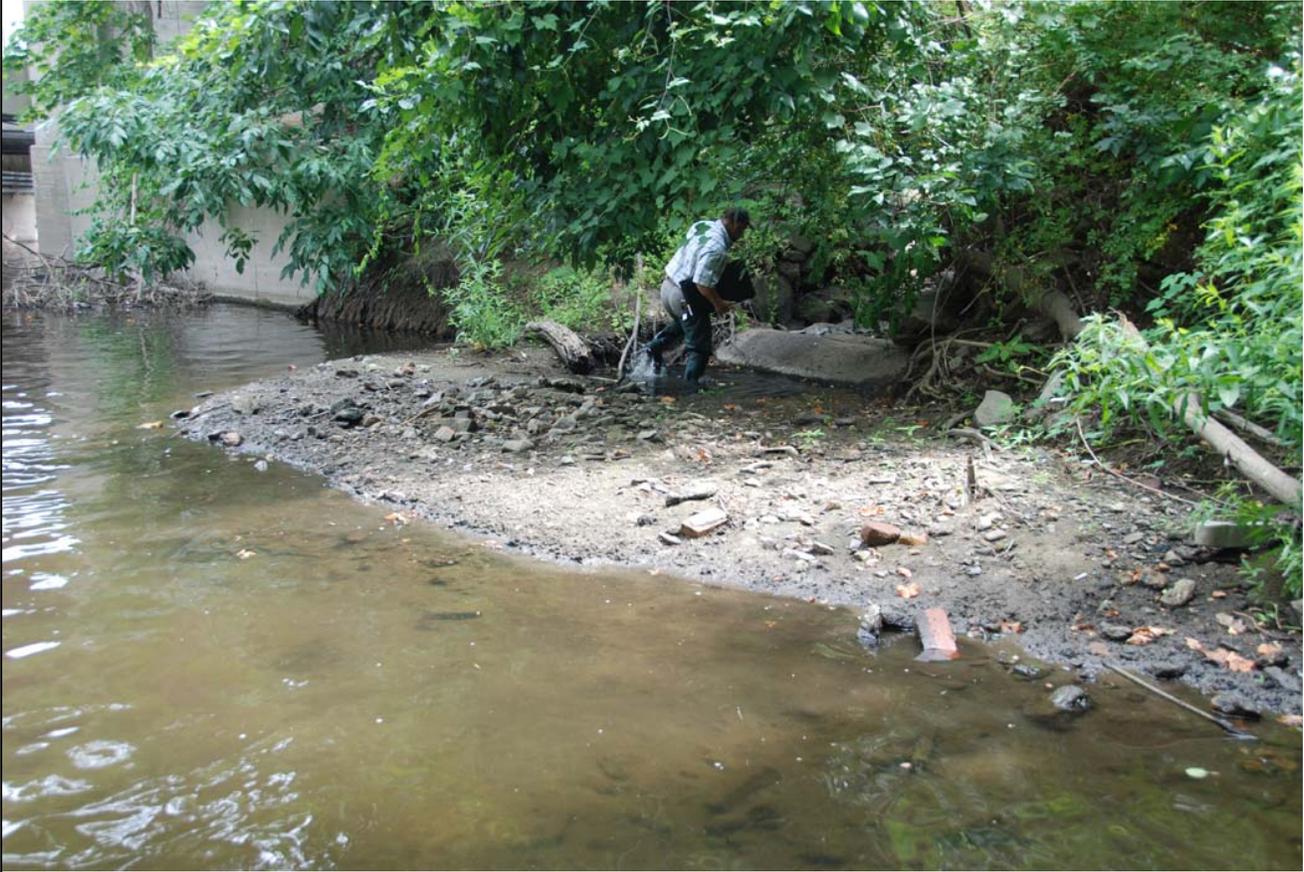
Inspect ID: NAR1_2010_a_0033 **Title:** USACE_CENAN_NAR1_2010_a_0033_1.jpg **Caption:** Large trees along left bank downstream of concrete channel.

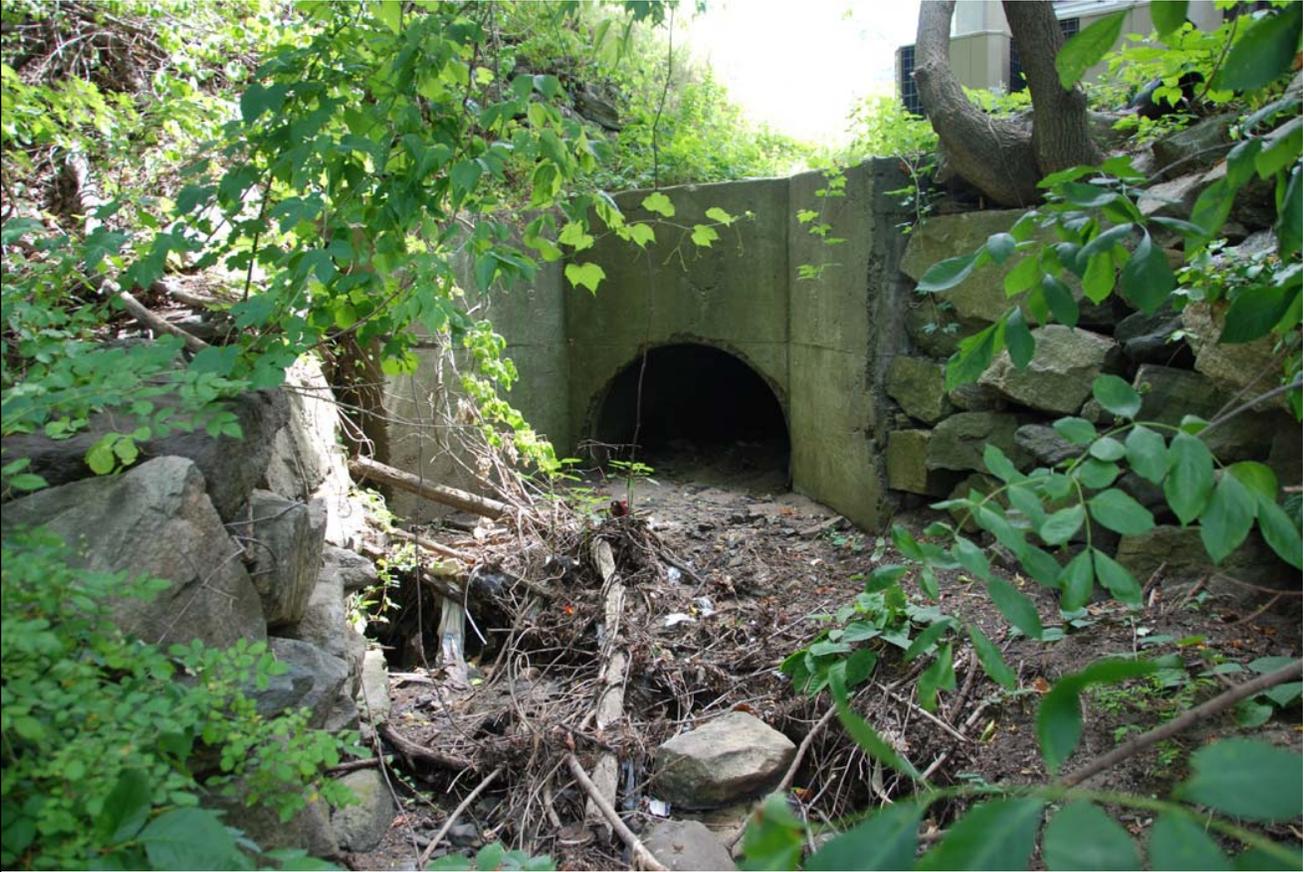
Inspect ID: NAR1_2010_a_0036 **Title:** USACE_CENAN_NAR1_2010_a_0036_1.jpg **Caption:** Debris at headwall of 60 in. culvert on the south side of Ashford Ave. (located south of the USACE project). Note that this pipe replaced a ditch that was shown on the approved plans.

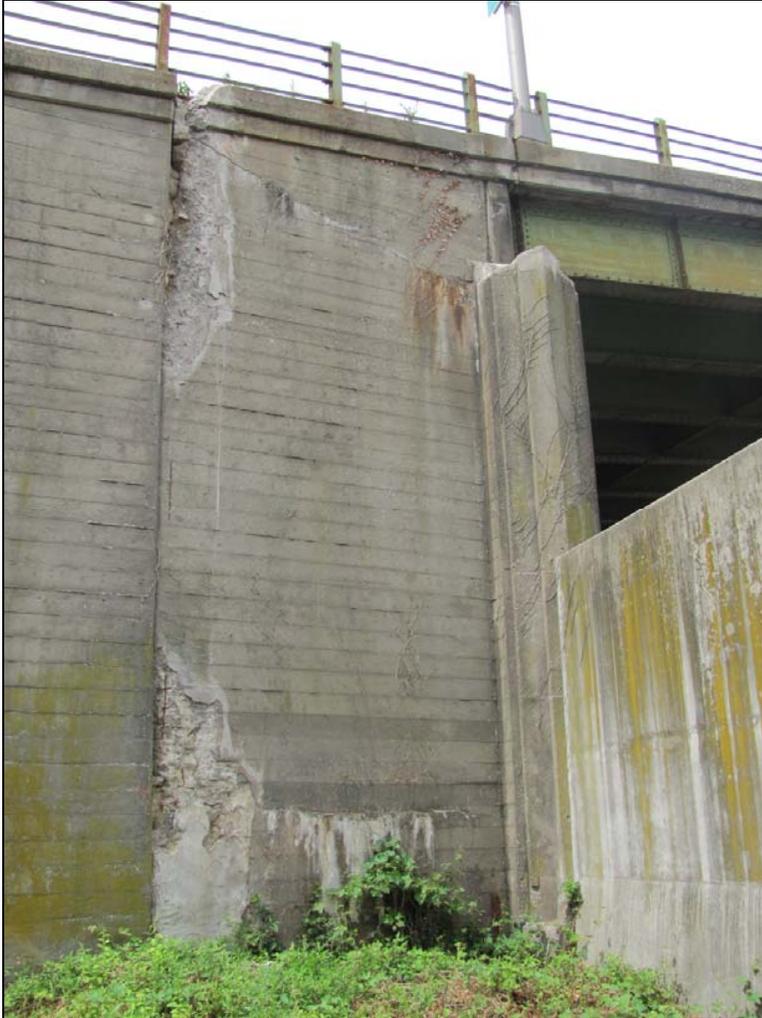
Inspect ID: NAR1_2010_a_0037 **Title:** USACE_CENAN_NAR1_2010_a_0037_1.jpg **Caption:** Deterioration of concrete at Ashford Avenue bridge.

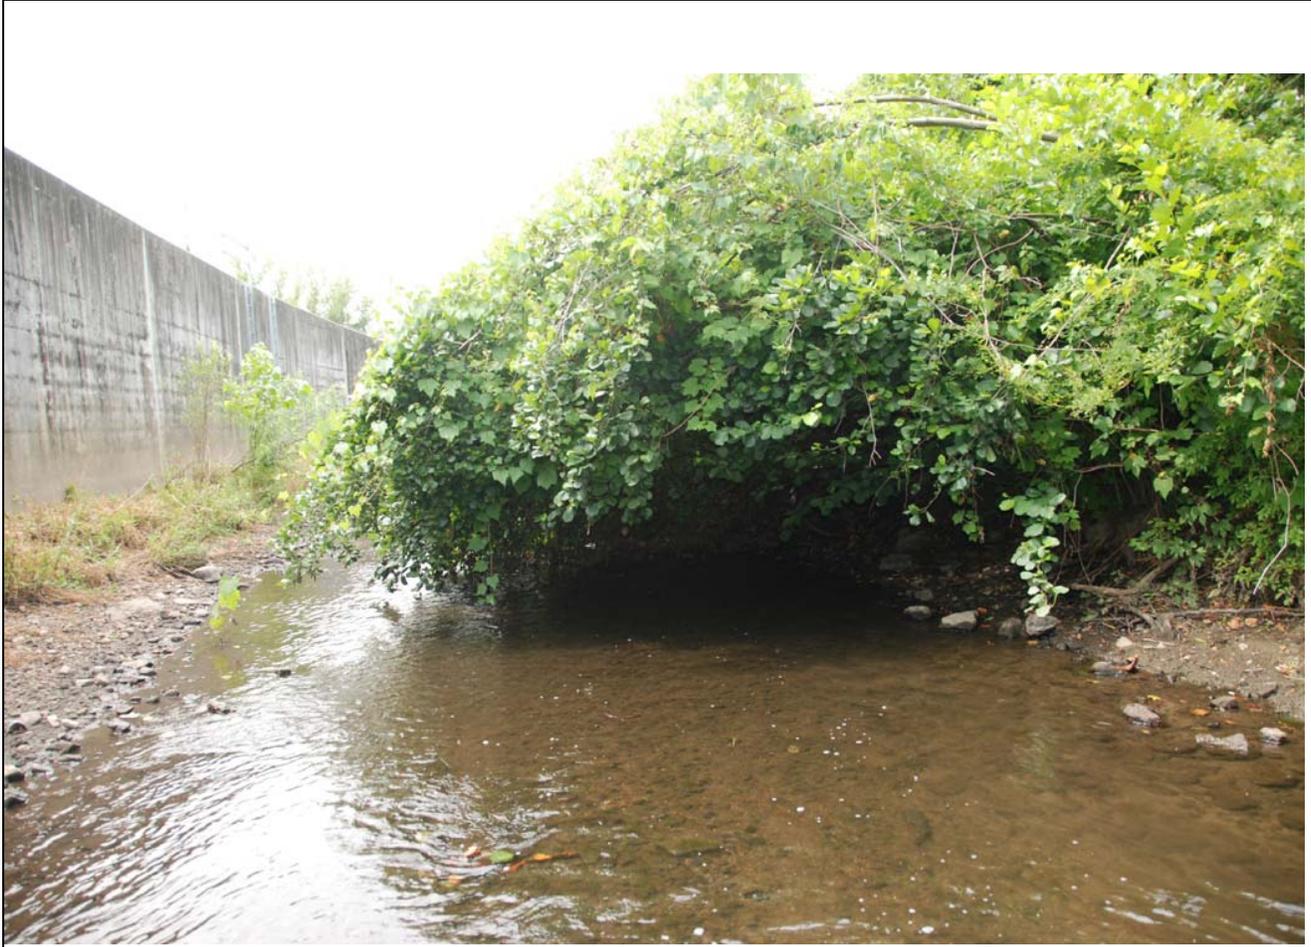
Inspect ID: NAR1_2010_a_0039 **Title:** USACE_CENAN_NAR1_2010_a_0039_1.jpg **Caption:** Vegetation along right bank growing into channel that could impede flow.

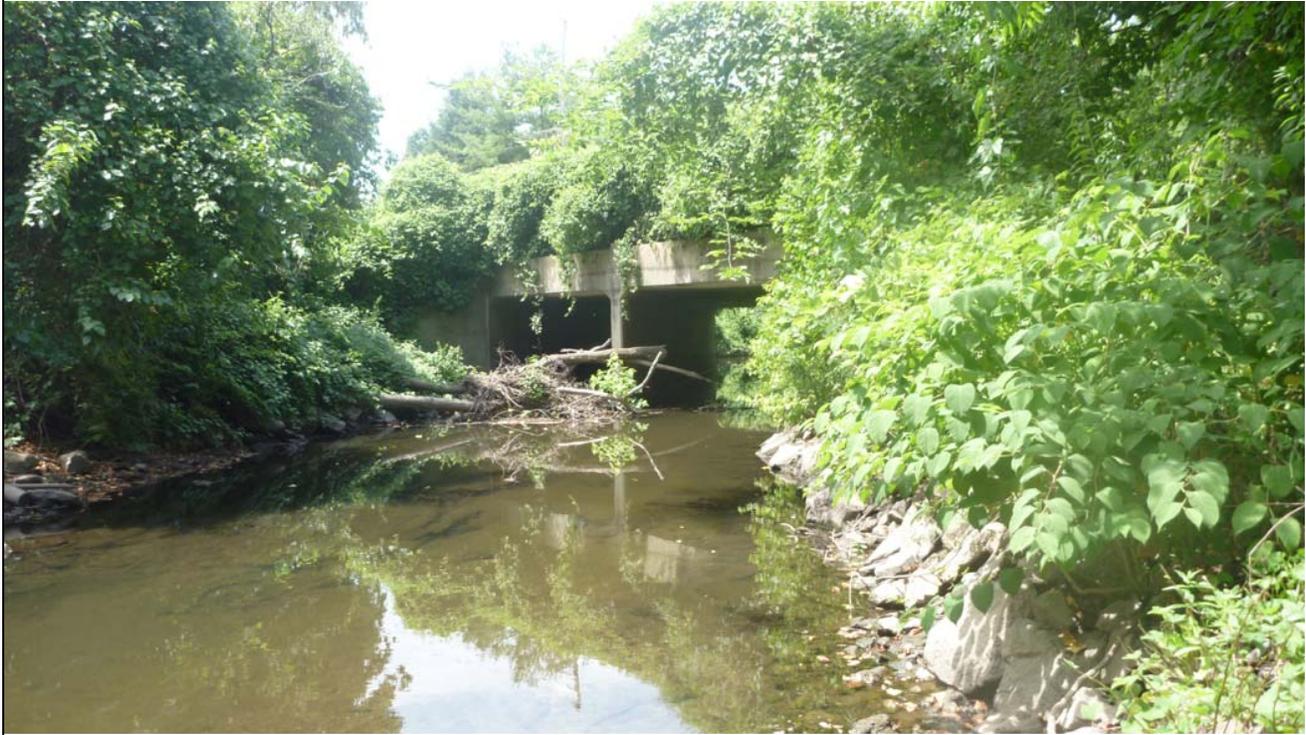
Inspect ID: NAR1_2010_a_0056 **Title:** USACE_CENAN_NAR1_2010_a_0056_1.jpg **Caption:** Large tree has fallen and is partially blocking flow of relocated channel immediately downstream of Elm Street.

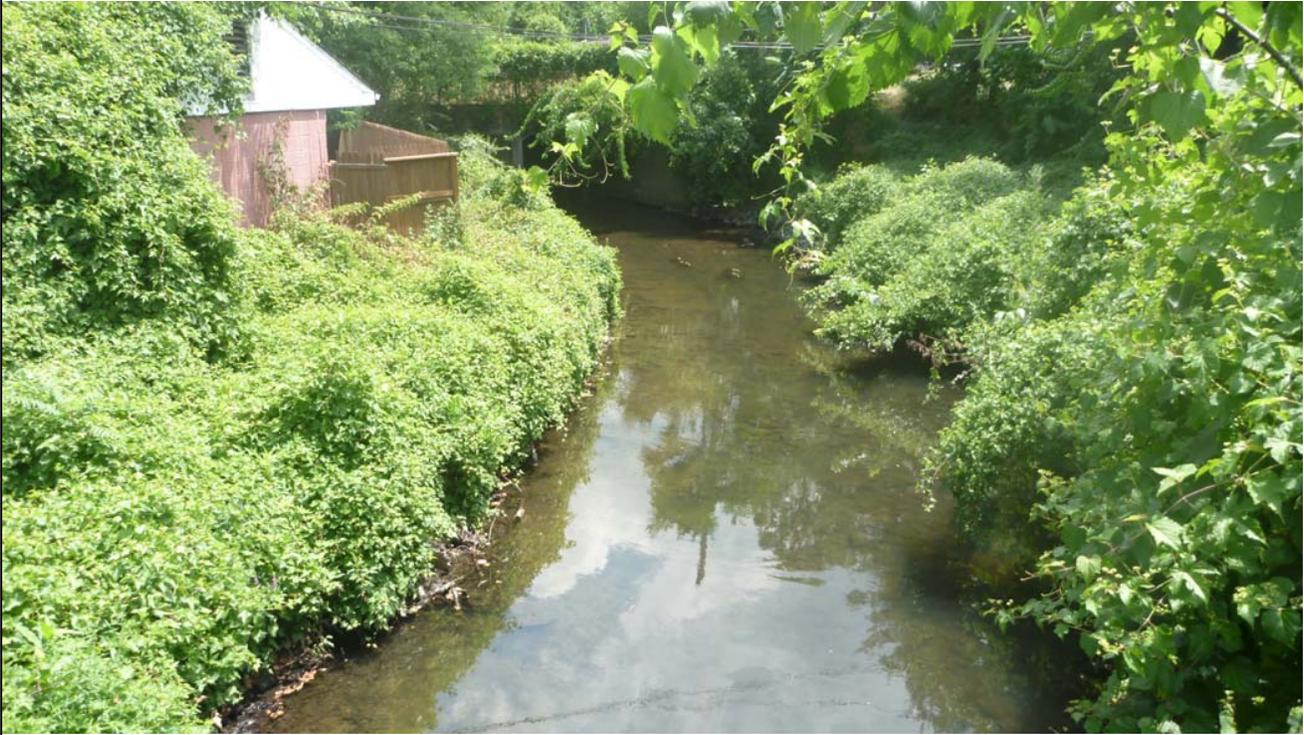
Inspect ID: NAR1_2010_a_0057 **Title:** USACE_CENAN_NAR1_2010_a_0057_1.jpg **Caption:** Vegetation growth through riprap-protected slopes and encroaching in flood reduction channel.

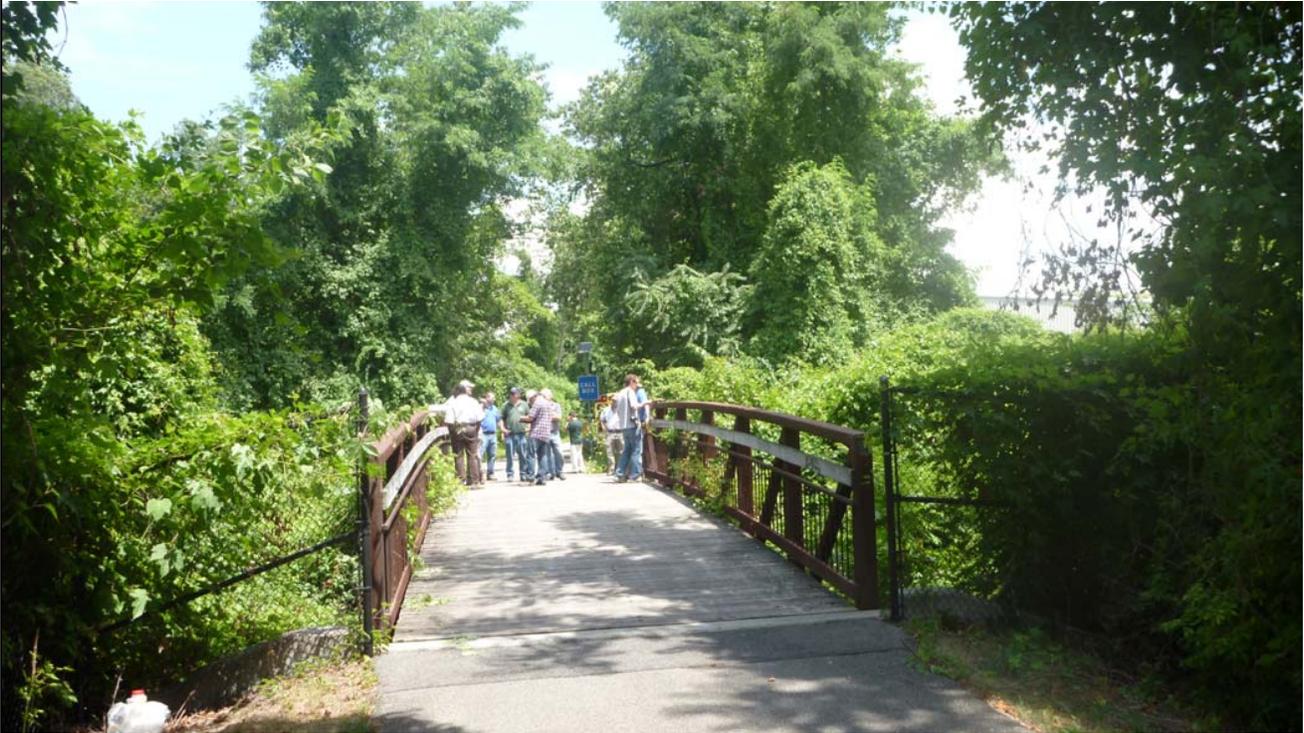
Inspect ID: NAR1_2010_a_0057 **Title:** USACE_CENAN_NAR1_2010_a_0057_2.jpg **Caption:** Pedestrian bridge that replaced RR bridge from the old Putnam RR line. Pedestrian bridge is not on the as-built plans.

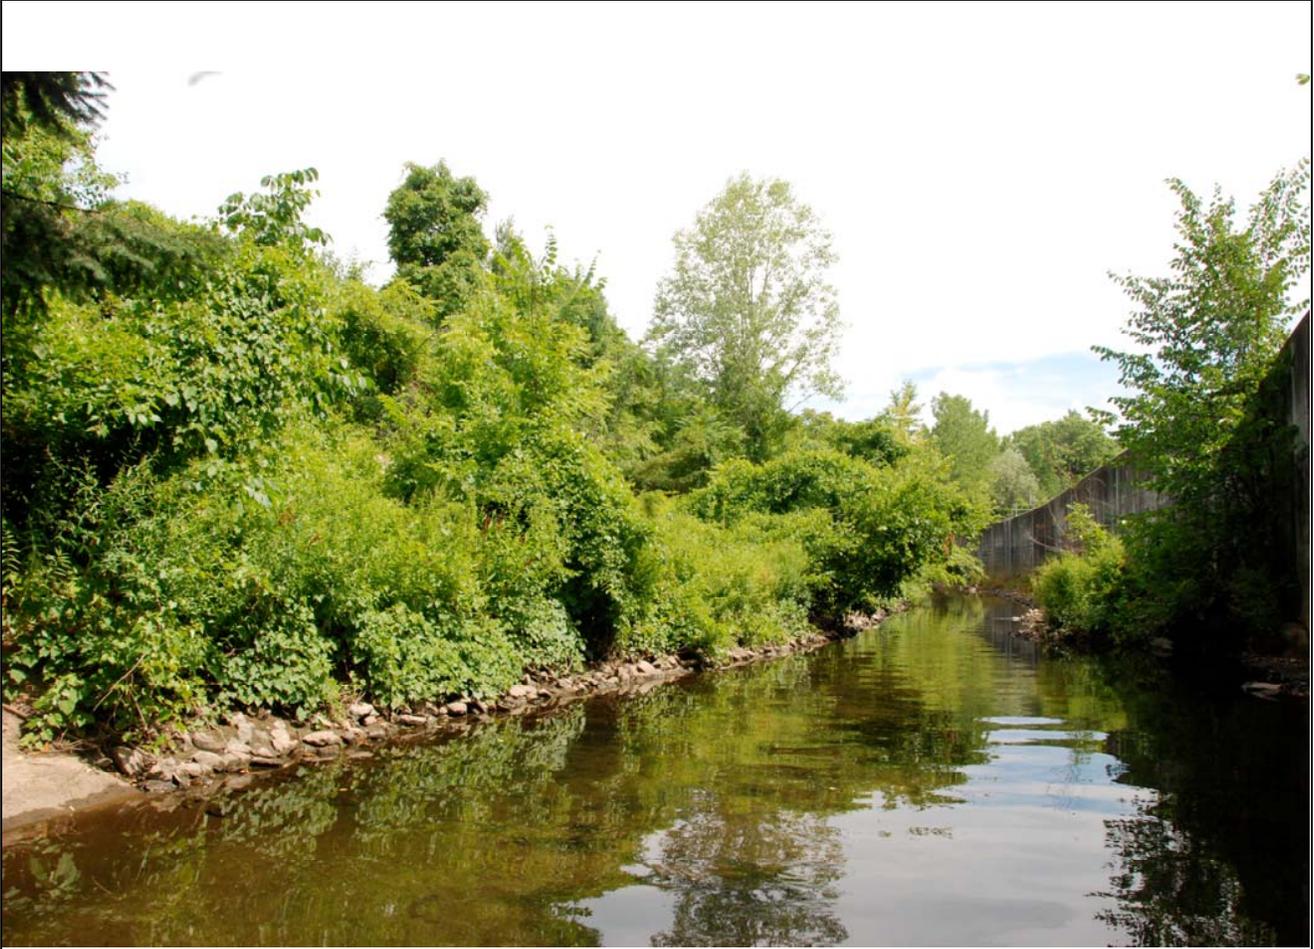
Inspect ID: NAR1_2010_a_0070 **Title:** USACE_CENAN_NAR1_2010_a_0070_1.jpg **Caption:** Photo looking upstream. Vegetation growing through riprap revetment along right bank (photo left).

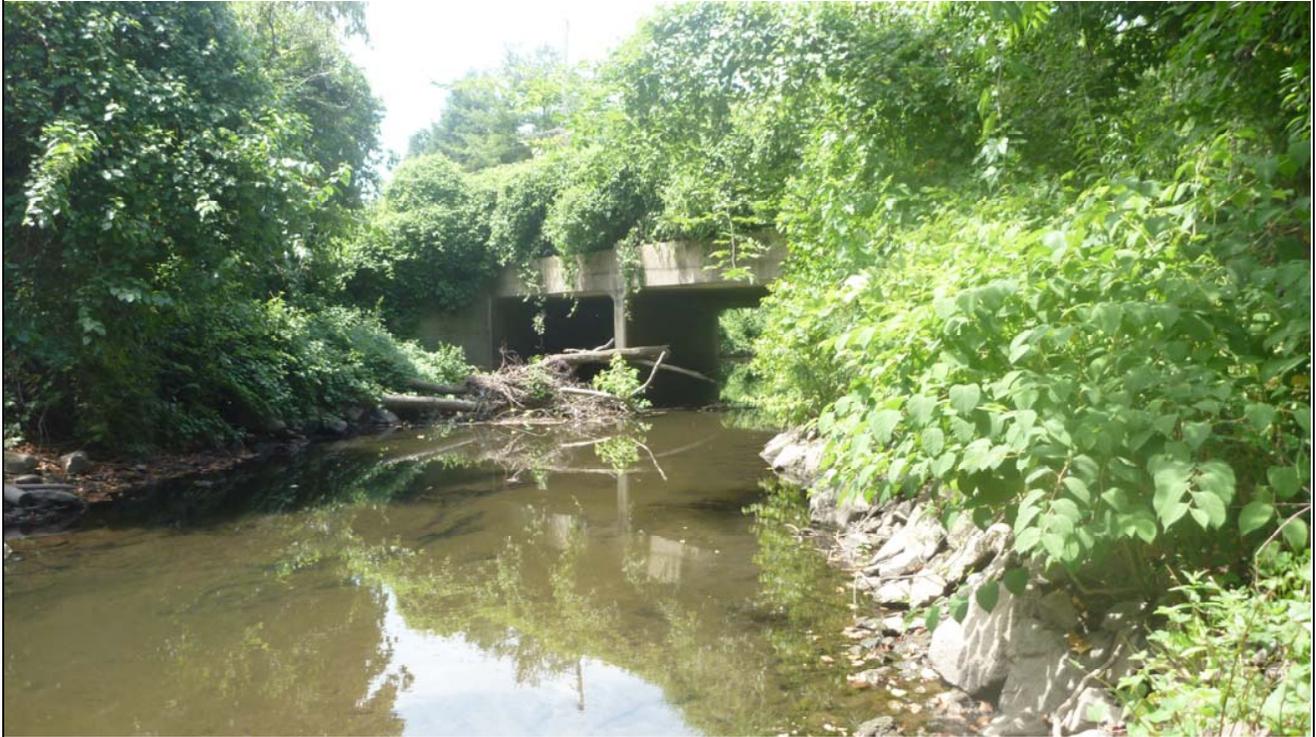
Inspect ID: NAR1_2010_a_0071 **Title:** USACE_CENAN_NAR1_2010_a_0071_1.jpg **Caption:** Heavy vegetation growth through riprap-protected slope (photo right).
