Flood Damage Reduction Segment / System Inspection Report

Name of Segment / System: Ardsley Flood Control Project

Date Report Prepared: 7/17/2019

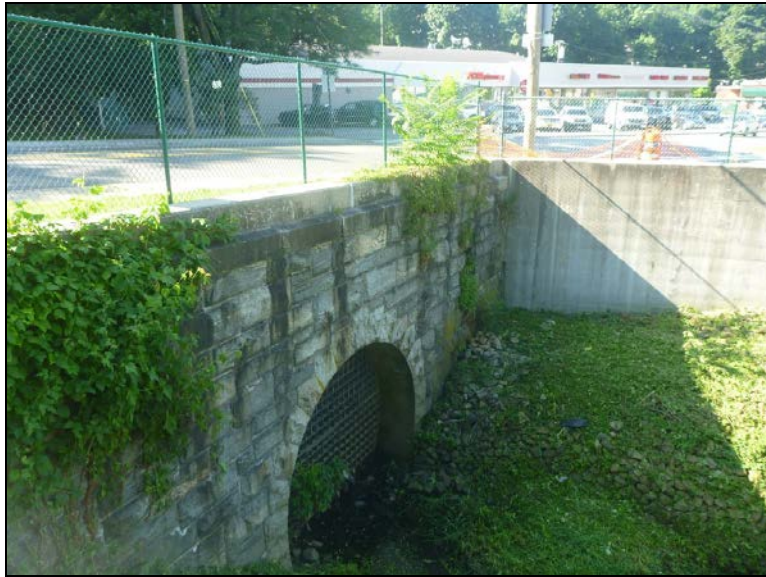
Inspect ID: NAR1_2019_a_0007 **Title:** USACE_CENAN_NAR1_2019_a_0007_1.jpg
Rated Item: 1. Unwanted Vegetation Growth **Caption:** Rating: Minimally Acceptable;
Remarks: Vegetation growth in joints of masonry facade of monolith 59/60. According to NYSDEC, the masonry structure belongs to New York City DEP.; Action: Clean and repoint masonry.; Station_1: 4+45B

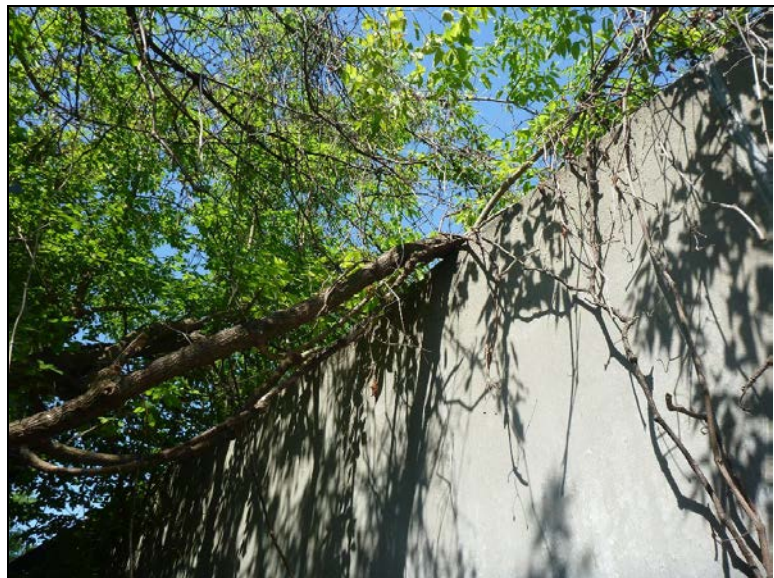
<p>Inspect ID: NAR1_2019_a_0054 Title: USACE_CENAN_NAR1_2019_a_0054_1.jpg Rated Item: 1. Unwanted Vegetation Growth Caption: Rating: Minimally Acceptable; Remarks: Vegetation on top of floodwall at monolith 12.; Action: Remove vegetation in accordance with USACE guidelines.; Station_1: 2+50U</p>

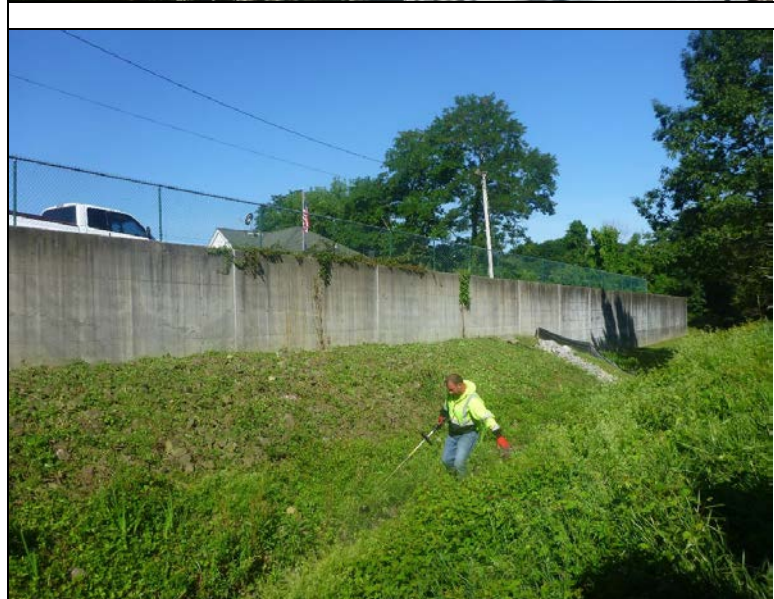
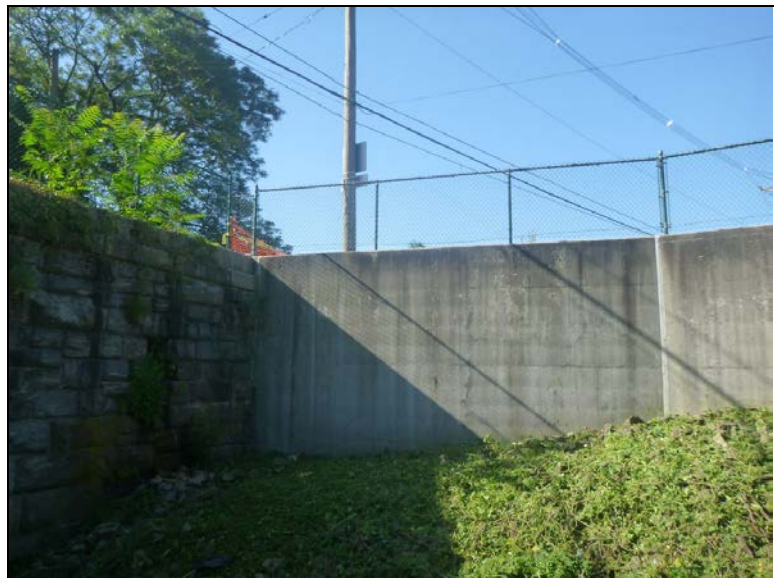
<p>Inspect ID: NAR1_2019_a_0004 Title: USACE_CENAN_NAR1_2019_a_0004_1.jpg Rated Item: 2. Encroachments Caption: Rating: Minimally Acceptable; Remarks: Fence on top of floodwall running from monolith 47-60 not in the original plans.; Action: Seek authorization from USACE for the encroachment to remain.; Station_1: 2+20B; Station_2: 4+45B</p>

<p>Inspect ID: NAR1_2019_a_0004 Title: USACE_CENAN_NAR1_2019_a_0004_2.jpg Rated Item: 2. Encroachments Caption: Rating: Minimally Acceptable; Remarks: Fence on top of floodwall running from monolith 47-60 not in the original plans.; Action: Seek authorization from USACE for the encroachment to remain.; Station_1: 2+20B; Station_2: 4+45B</p>

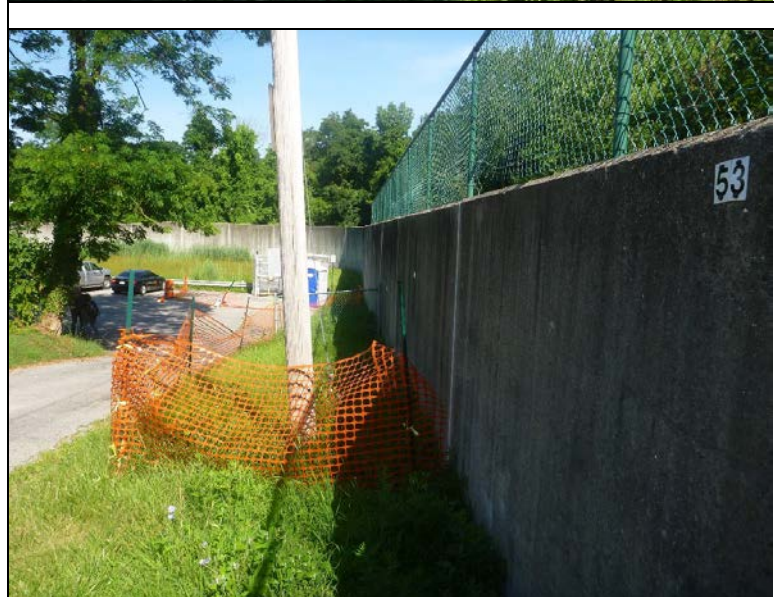
<p>Inspect ID: NAR1_2019_a_0018 Title: USACE_CENAN_NAR1_2019_a_0018_1.jpg Rated Item: 2. Encroachments Caption: Rating: Minimally Acceptable; Remarks: Utility pole and guy wire within 4 ft of floodwall on protected side. NYSDEC indicated that there are plans to move the pole and wire across the drive during a future upgrade.; Action: Proceed with the plan to move the pole during the next upgrade.; Station_1: 3+30B</p>

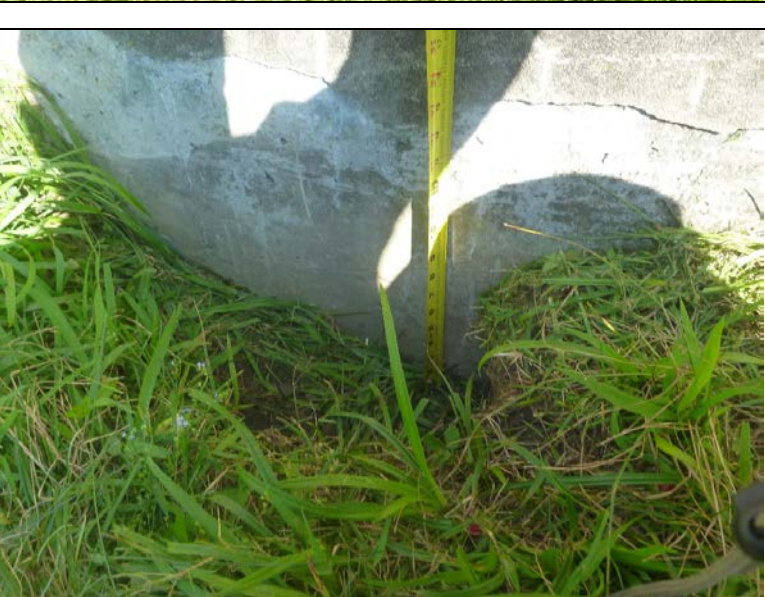
<p>Inspect ID: NAR1_2019_a_0031 Title: USACE_CENAN_NAR1_2019_a_0031_1.jpg Rated Item: 2. Encroachments Caption: Rating: Minimally Acceptable; Remarks: Animal burrow at the base of the protected side of monolith 41. 1 ft deep. 2 ft wide.; Action: Fill the burrow and establish a program to control animal activity near the floodwall.; Station_1: 8+00 U</p>

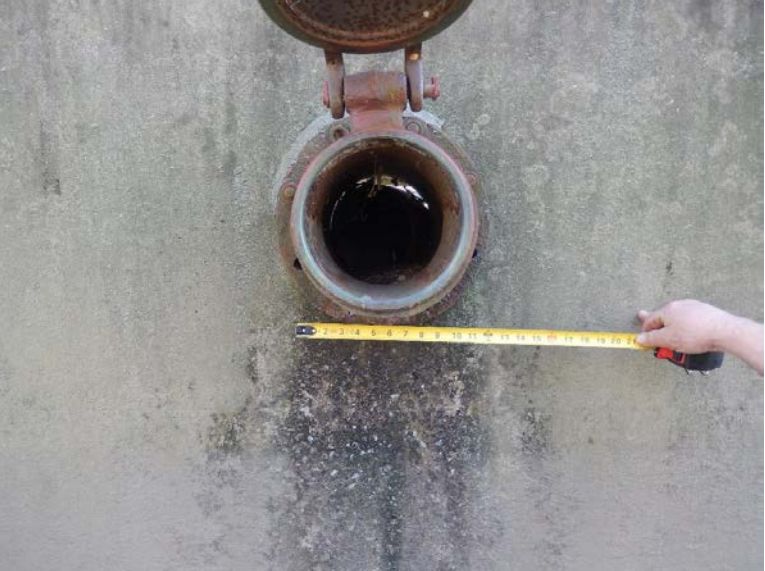
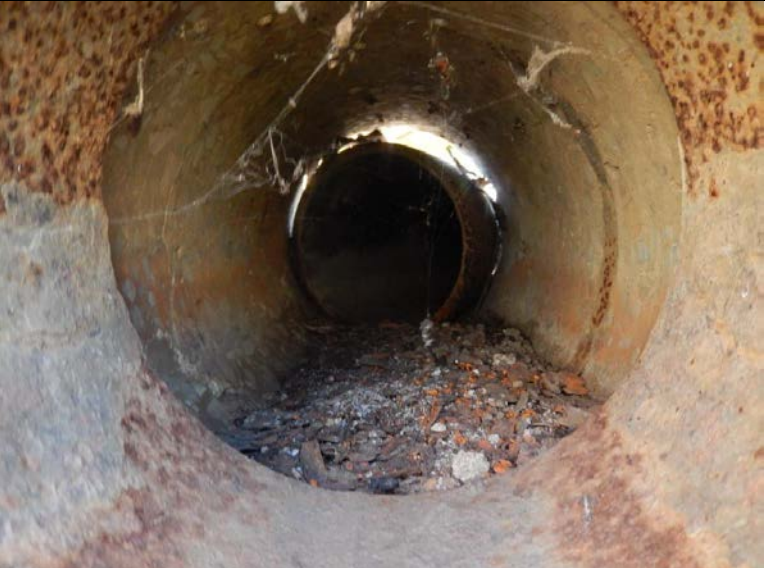
<p>Inspect ID: NAR1_2019_a_0052 Title: USACE_CENAN_NAR1_2019_a_0052_1.jpg Rated Item: 2. Encroachments Caption: Rating: Minimally Acceptable; Remarks: Unauthorized flap gate in monolith 18 is connected to 8" IDP noted in observation #50. Flap gate found in open position in 2016.; Action: Maintian flap gate. Investigate easement agreement and dispose of encroachment accordingly.; Station_1: 3+75U; Photo taken prior to the 2019 inspection.</p>

<p>Inspect ID: NAR1_2019_a_0052 Title: USACE_CENAN_NAR1_2019_a_0052_2.jpg Rated Item: 2. Encroachments Caption: Rating: Minimally Acceptable; Remarks: Unauthorized flap gate in monolith 18 is connected to 8" IDP noted in observation #50. Flap gate found in open position in 2016.; Action: Maintian flap gate. Investigate easement agreement and dispose of encroachment accordingly.; Station_1: 3+75U; Photo taken prior to the 2019 inspection.</p>

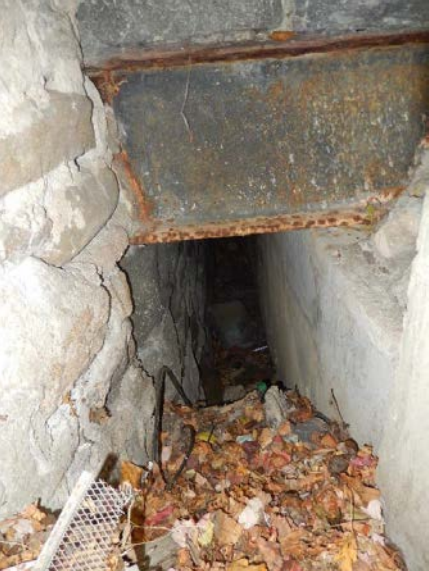
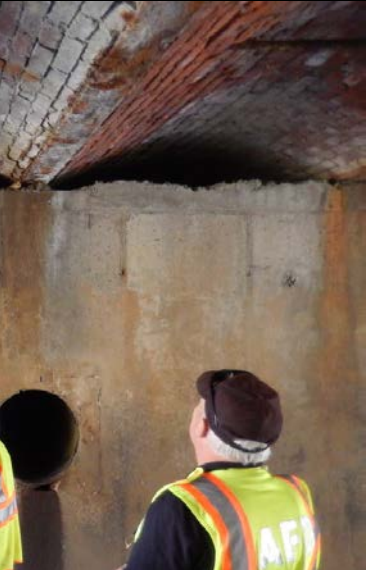
<p>Inspect ID: NAR1_2019_a_0060 Title: USACE_CENAN_NAR1_2019_a_0060_4.jpg Rated Item: 2. Encroachments Caption: Rating: Minimally Acceptable; Remarks: Gaps between arched deck of old Ashford Ave Bridge and top of floodwall need to be sealed. Common fill that is shown on section STA 2+18U between concrete channel and old bridge abutment is missing.; Action: Investigate missing concrete and fill and replace in accordance with the project plans.; Station_1: 1+80U; Photo taken prior to the 2019 inspection.</p>

<p>Inspect ID: NAR1_2019_a_0060 Title: USACE_CENAN_NAR1_2019_a_0060_5.jpg Rated Item: 2. Encroachments Caption: Rating: Minimally Acceptable; Remarks: Gaps between arched deck of old Ashford Ave Bridge and top of floodwall need to be sealed. Common fill that is shown on section STA 2+18U between concrete channel and old bridge abutment is missing.; Action: Investigate missing concrete and fill and replace in accordance with the project plans.; Station_1: 1+80U; Photo taken prior to the 2019 inspection.</p>

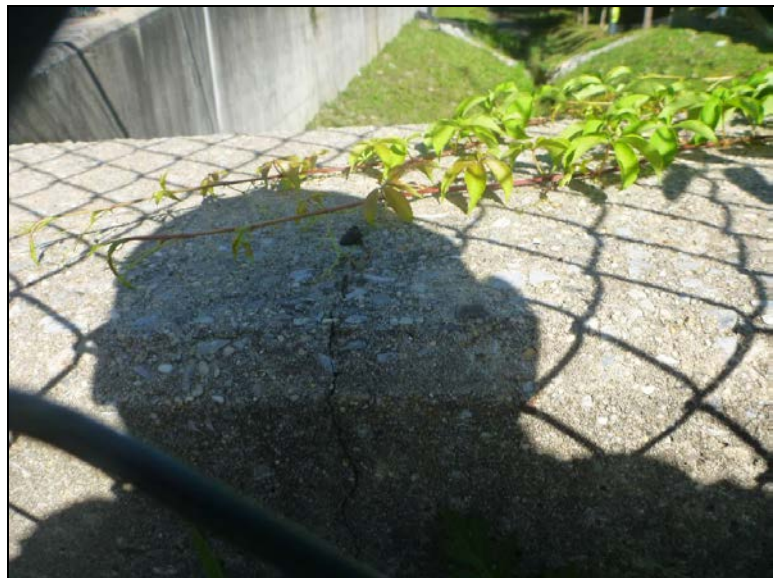
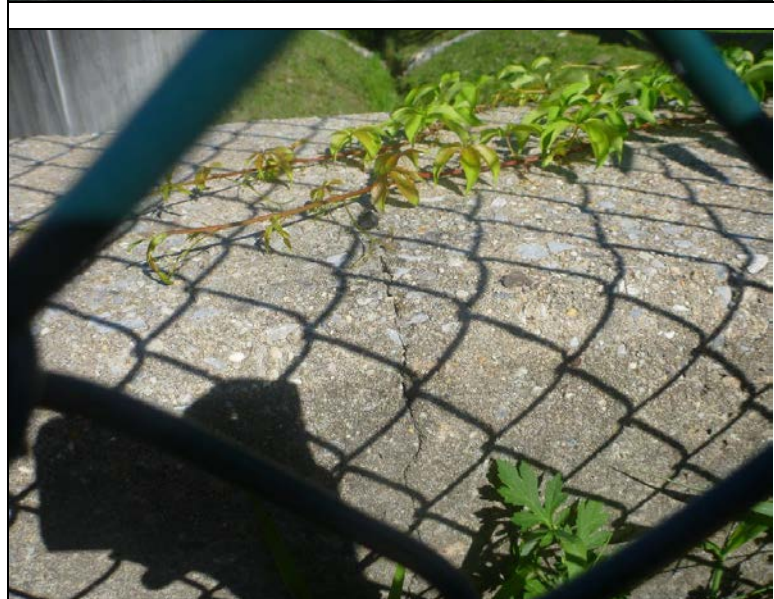
<p>Inspect ID: NAR1_2019_a_0010 Title: USACE_CENAN_NAR1_2019_a_0010_1.jpg Rated Item: 4. Concrete Surfaces Caption: Rating: Minimally Acceptable; Remarks: Hairline crack at the top of monolith 59, associated with missing stone facade.; Action: Monitor to ensure that crack does not widen and repair concrete as necessary.; Station_1: 4+45B</p>

<p>Inspect ID: NAR1_2019_a_0010 Title: USACE_CENAN_NAR1_2019_a_0010_2.jpg Rated Item: 4. Concrete Surfaces Caption: Rating: Minimally Acceptable; Remarks: Hairline crack at the top of monolith 59, associated with missing stone facade.; Action: Monitor to ensure that crack does not widen and repair concrete as necessary.; Station_1: 4+45B</p>

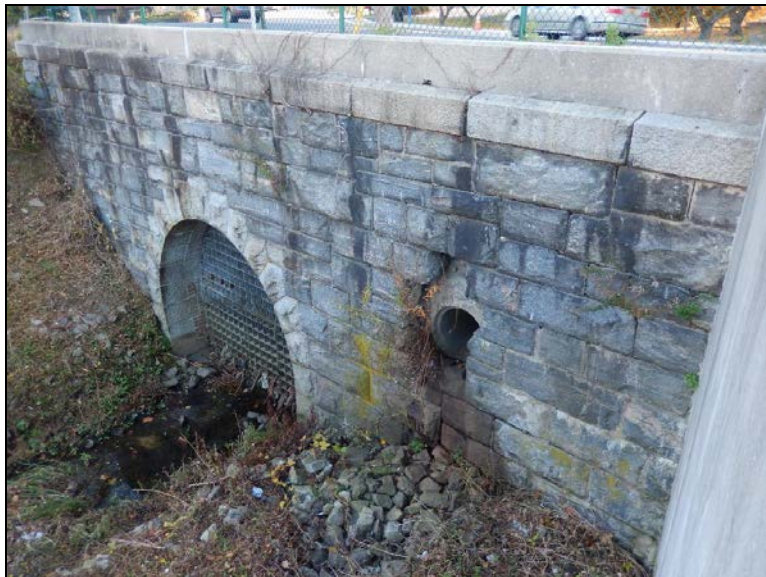
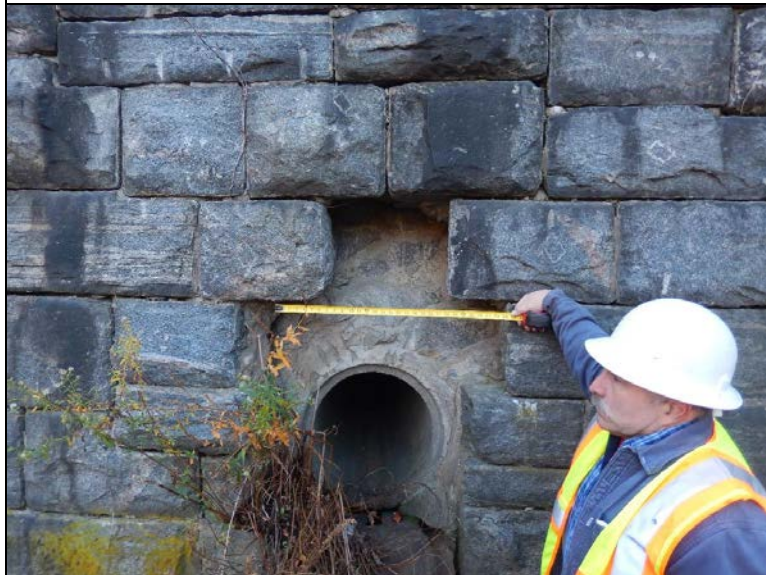
Inspect ID: NAR1_2019_a_0011 **Title:** USACE_CENAN_NAR1_2019_a_0011_1.jpg
Rated Item: 4. Concrete Surfaces **Caption:** Rating: Minimally Acceptable; Remarks: The headwall adjacent to the NYCDEP blow off tunnel (monolith 59) is visibly deteriorated. Stones are missing above drainage outlet pipe.; Action: The public sponsor must determine which municipal entity is responsible for the headwall and have the damage repaired.; Station_1: 4+45B; Photo taken prior to the 2019 inspection.

Inspect ID: NAR1_2019_a_0011 **Title:** USACE_CENAN_NAR1_2019_a_0011_2.jpg
Rated Item: 4. Concrete Surfaces **Caption:** Rating: Minimally Acceptable; Remarks: The headwall adjacent to the NYCDEP blow off tunnel (monolith 59) is visibly deteriorated. Stones are missing above drainage outlet pipe.; Action: The public sponsor must determine which municipal entity is responsible for the headwall and have the damage repaired.; Station_1: 4+45B; Photo taken prior to the 2019 inspection.

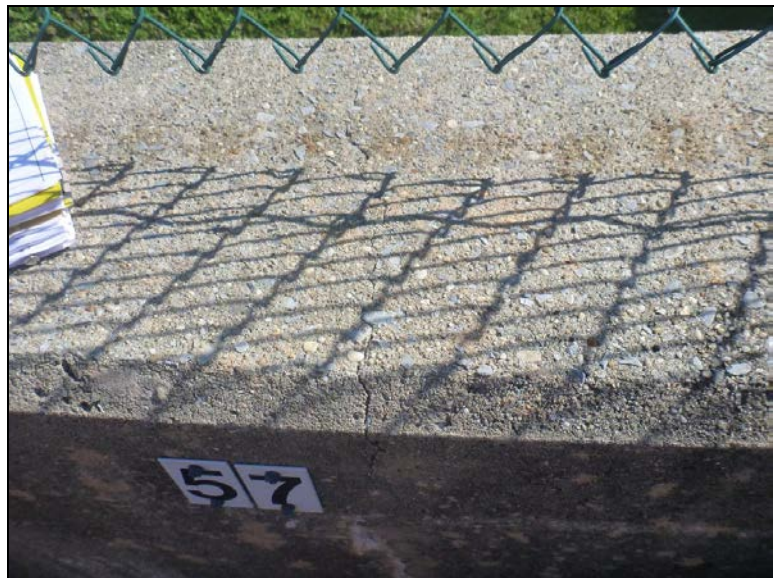
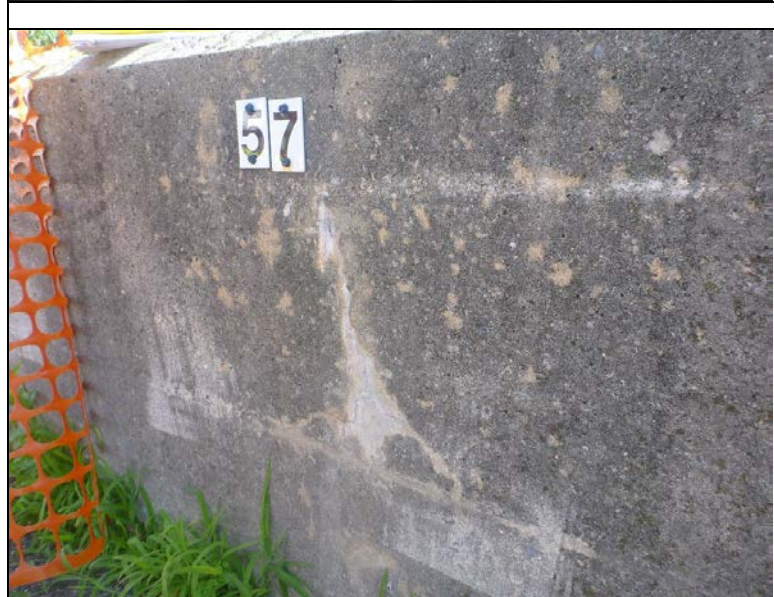
<p>Inspect ID: NAR1_2019_a_0015 Title: USACE_CENAN_NAR1_2019_a_0015_1.jpg Rated Item: 4. Concrete Surfaces Caption: Rating: Minimally Acceptable; Remarks: Minor cracking and efflorescence at the top of monolith 57.; Action: Monitor cracking and efflorescence to ensure they do not worsen. Repair concrete in accordance with USACE guidelines as necessary.; Station_1: 4+05B</p>

<p>Inspect ID: NAR1_2019_a_0015 Title: USACE_CENAN_NAR1_2019_a_0015_2.jpg Rated Item: 4. Concrete Surfaces Caption: Rating: Minimally Acceptable; Remarks: Minor cracking and efflorescence at the top of monolith 57.; Action: Monitor cracking and efflorescence to ensure they do not worsen. Repair concrete in accordance with USACE guidelines as necessary.; Station_1: 4+05B</p>

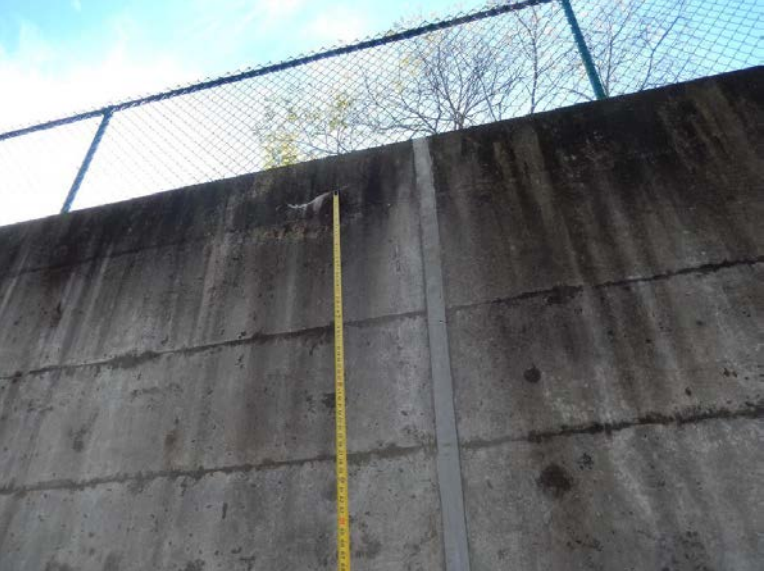
<p>Inspect ID: NAR1_2019_a_0023 Title: USACE_CENAN_NAR1_2019_a_0023_1.jpg Rated Item: 4. Concrete Surfaces Caption: Rating: Minimally Acceptable; Remarks: Spall with efflorescence at top of monolith 51 on the unprotected side. Could not access in 2019.; Action: Repair concrete surface in accordance with USACE Guidelines.; Station_1: 2+80B; Photo taken prior to the 2019 inspection.</p>

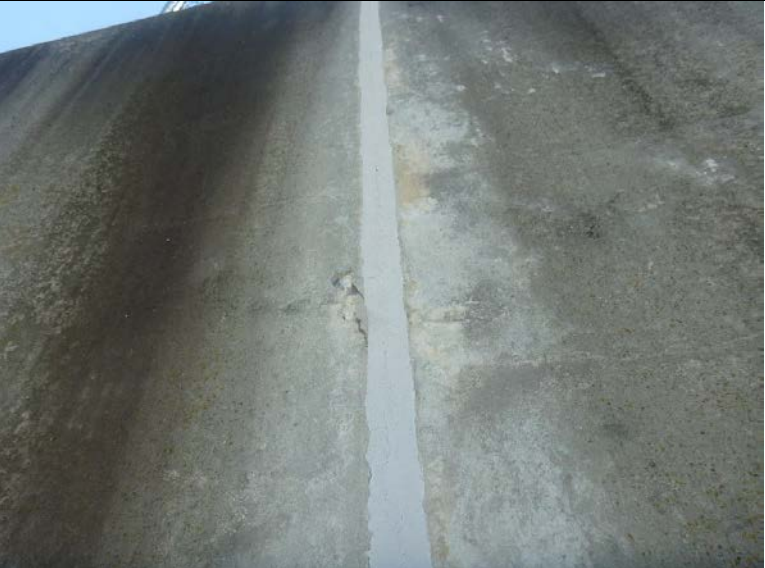
<p>Inspect ID: NAR1_2019_a_0026 Title: USACE_CENAN_NAR1_2019_a_0026_1.jpg Rated Item: 4. Concrete Surfaces Caption: Rating: Minimally Acceptable; Remarks: Minor spalling on the protected side of monolith 47 near joint.; Action: Repair concrete surface in accordance with USACE Guidelines.; Station_1: 2+20B</p>

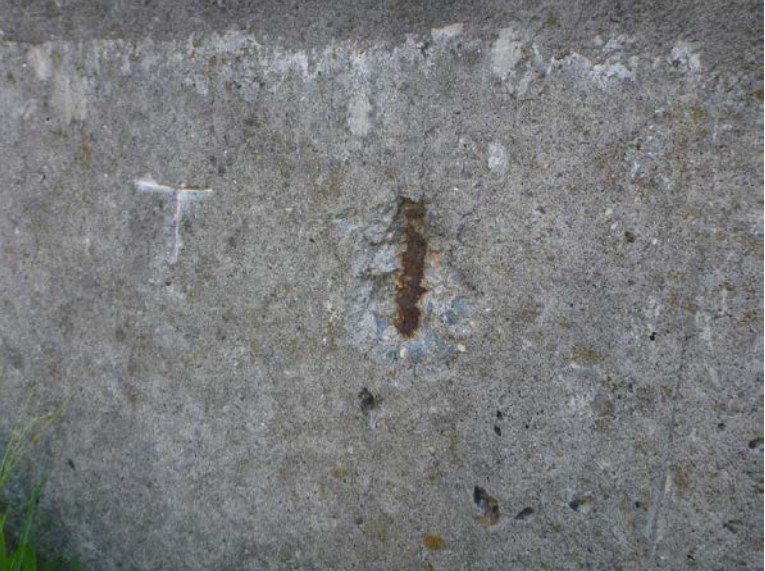
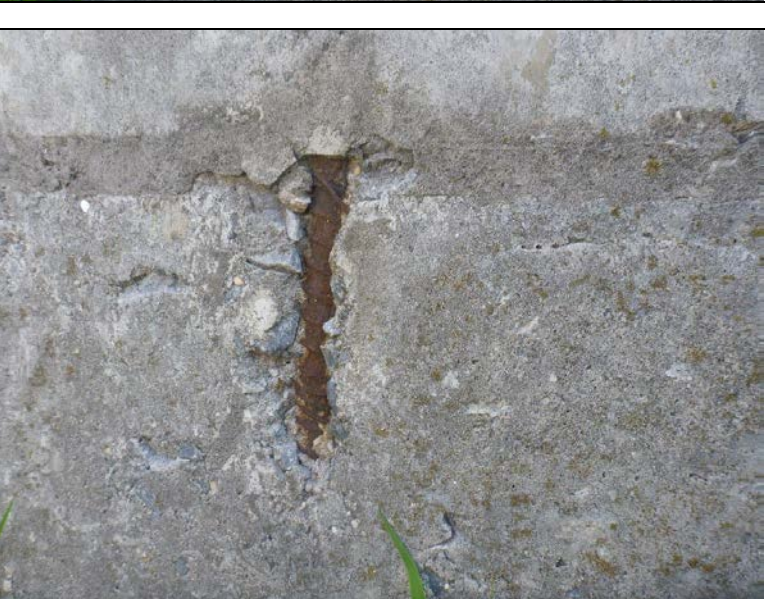
<p>Inspect ID: NAR1_2019_a_0027 Title: USACE_CENAN_NAR1_2019_a_0027_1.jpg Rated Item: 4. Concrete Surfaces Caption: Rating: Minimally Acceptable; Remarks: Exposed rebar near base of monolith 47.; Action: Repair concrete surface in accordance with USACE guidelines.; Station_1: 2+15B</p>

<p>Inspect ID: NAR1_2019_a_0027 Title: USACE_CENAN_NAR1_2019_a_0027_2.jpg Rated Item: 4. Concrete Surfaces Caption: Rating: Minimally Acceptable; Remarks: Exposed rebar near base of monolith 47.; Action: Repair concrete surface in accordance with USACE guidelines.; Station_1: 2+15B</p>

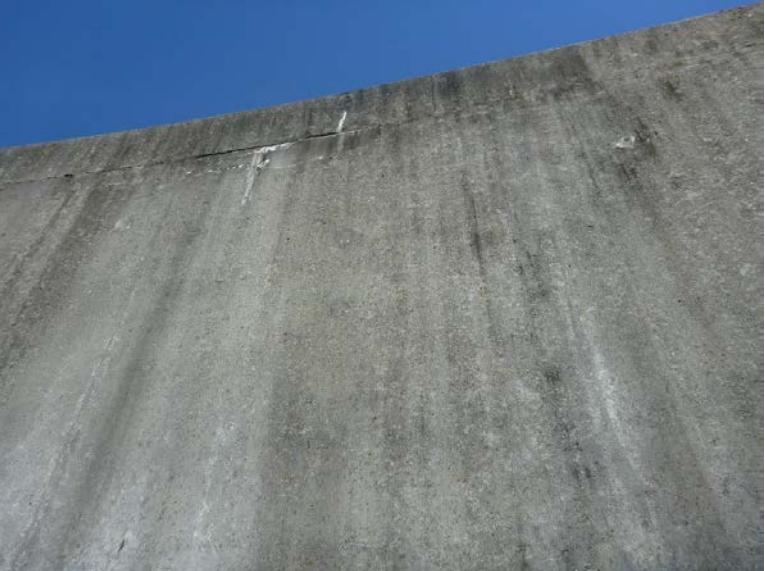
<p>Inspect ID: NAR1_2019_a_0032 Title: USACE_CENAN_NAR1_2019_a_0032_3.jpg Rated Item: 4. Concrete Surfaces Caption: Rating: Minimally Acceptable; Remarks: Apparent construction joint has opened along the top of the protected side of monoliths 39 and 40.; Action: Fill the crack and repair concrete surface in accordance with USACE guidelines.; Station_1: 7+80U</p>

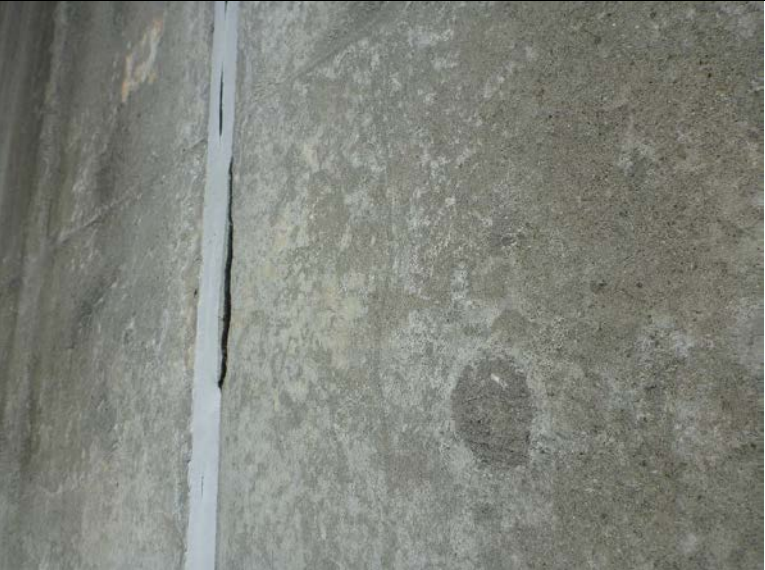
Rated Item	Rating	Rating Guidelines		Location/Remarks/Recommendations
				<p>NAR1_2019_a_0037: Station_1 5+90U: Small spall on protected side of monolith 30 at joint with monolith 29.: Repair concrete surface in accordance with USACE Guidelines. (M)</p> <p>NAR1_2019_a_0039: Station_1 5+65U: Small spall on the protected side of monolith 28 at the joint with monolith 29.: Repair concrete surface in accordance with USACE guidelines. (M)</p> <p>NAR1_2019_a_0049: Station_1 4+70U: Minor spall with exposed rebar on the protected side of monolith 24 near the joint with monolith 23.: NA (M)</p> <p>NAR1_2019_a_0051: Station_1 3+85U: Spalling on the unprotected side of flood wall near joint between monoliths 21 and 20. Could not access in 2019.: Repair concrete surface in accordance with USACE Guidelines. (M)</p> <p>NAR1_2019_a_0066: Station_1 0+85U: Spalling at joint between monoliths 5 and 4. Could not access in 2019.: Repair concrete surface in accordance with USACE Guidelines. (M)</p> <p>NAR1_2019_a_0071: Station_1 1+05U: Spalling at monolith 5 near joint of monolith 6. Could not access in 2019.: Repair concrete surface in accordance with USACE Guidelines. (M)</p>

<p>Inspect ID: NAR1_2019_a_0037 Title: USACE_CENAN_NAR1_2019_a_0037_1.jpg Rated Item: 4. Concrete Surfaces Caption: Rating: Minimally Acceptable; Remarks: Small spall on protected side of monolith 30 at joint with monolith 29.; Action: Repair concrete surface in accordance with USACE Guidelines.; Station_1: 5+90U</p>

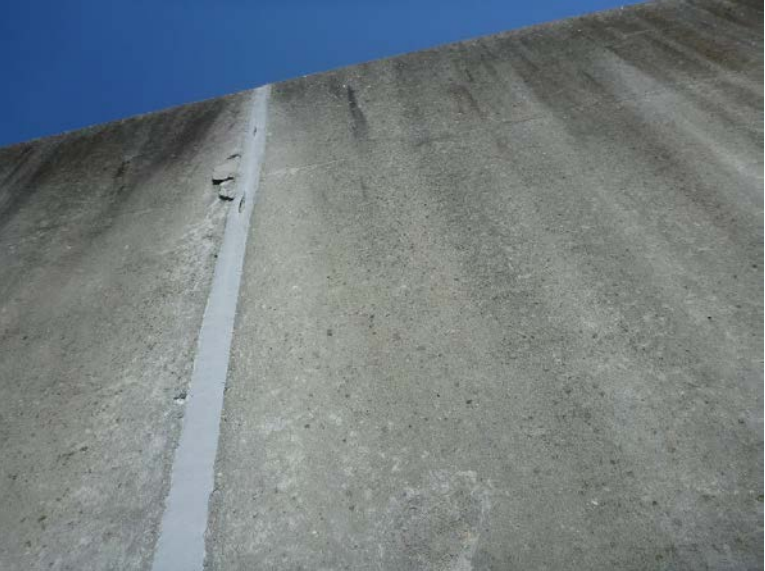
<p>Inspect ID: NAR1_2019_a_0039 Title: USACE_CENAN_NAR1_2019_a_0039_1.jpg Rated Item: 4. Concrete Surfaces Caption: Rating: Minimally Acceptable; Remarks: Small spall on the protected side of monolith 28 at the joint with monolith 29.; Action: Repair concrete surface in accordance with USACE guidelines.; Station_1: 5+65U</p>

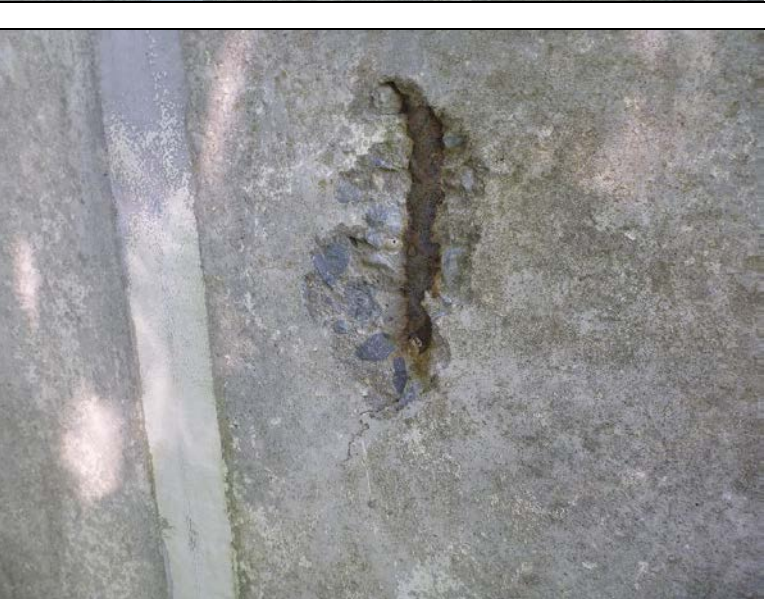
<p>Inspect ID: NAR1_2019_a_0049 Title: USACE_CENAN_NAR1_2019_a_0049_1.jpg Rated Item: 4. Concrete Surfaces Caption: Rating: Minimally Acceptable; Remarks: Minor spall with exposed rebar on the protected side of monolith 24 near the joint with monolith 23.; Action: NA; Station_1: 4+70U</p>

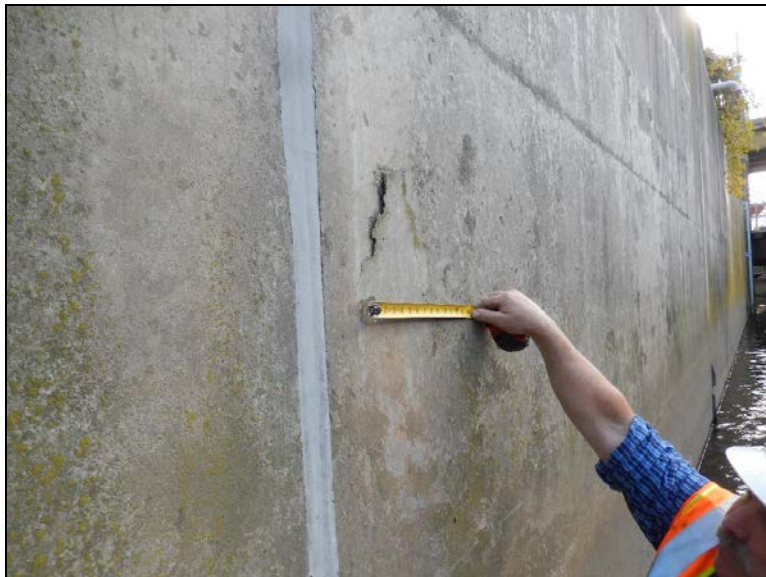
Inspect ID: NAR1_2019_a_0071 **Title:** USACE_CENAN_NAR1_2019_a_0071_1.jpg
Rated Item: 4. Concrete Surfaces **Caption:** Rating: Minimally Acceptable; Remarks: Spalling at monolith 5 near joint of monolith 6. Could not access in 2019.; Action: Repair concrete surface in accordance with USACE Guidelines.; Station_1: 1+05U; Photo taken prior to the 2019 inspection.

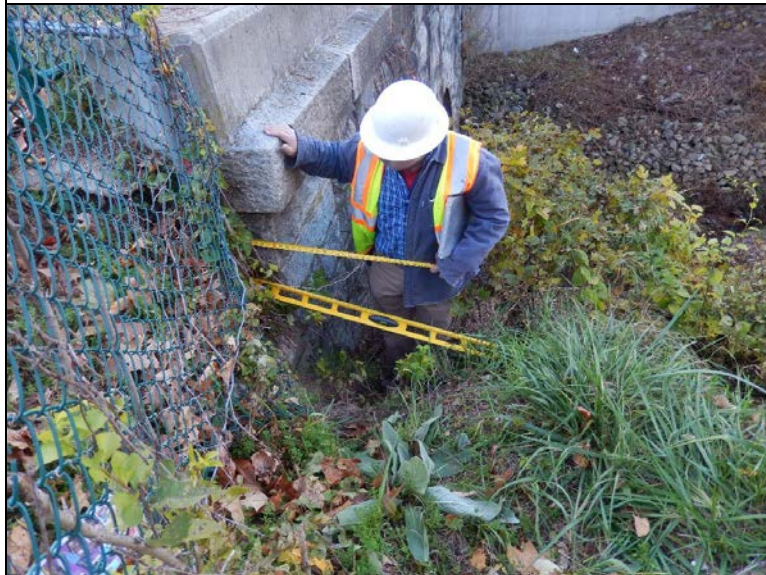
6. Foundation of	M	A	No active erosion, scouring, or bank caving that might endanger the structure's stability.	NAR1_2019_a_0003: Station_1 4+45B: Erosion at headwall

Inspect ID: NAR1_2019_a_0003 **Title:** USACE_CENAN_NAR1_2019_a_0003_2.jpg
Rated Item: 6. Foundation of Concrete Structures **Caption:** Rating: Minimally Acceptable; Remarks: Erosion at headwall on the north side of monolith 60. Vegetation prevented observation in 2019.; Action: Determine source of erosion and repair.; Station_1: 4+45B; Photo taken prior to 2019 inspection.

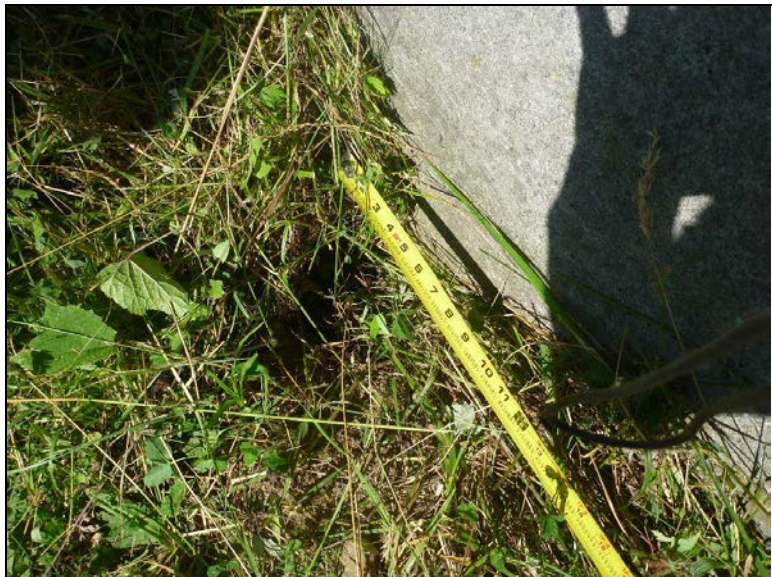
<p>Inspect ID: NAR1_2019_a_0038 Title: USACE_CENAN_NAR1_2019_a_0038_2.jpg Rated Item: 6. Foundation of Concrete Structures Caption: Rating: Minimally Acceptable; Remarks: Animal burrow at base of protected side of monolith 32. 1 ft deep. 1 ft wide.; Action: Fill burrow and establish a program to control animal activity near the floodwall.; Station_1: 6+30U</p>

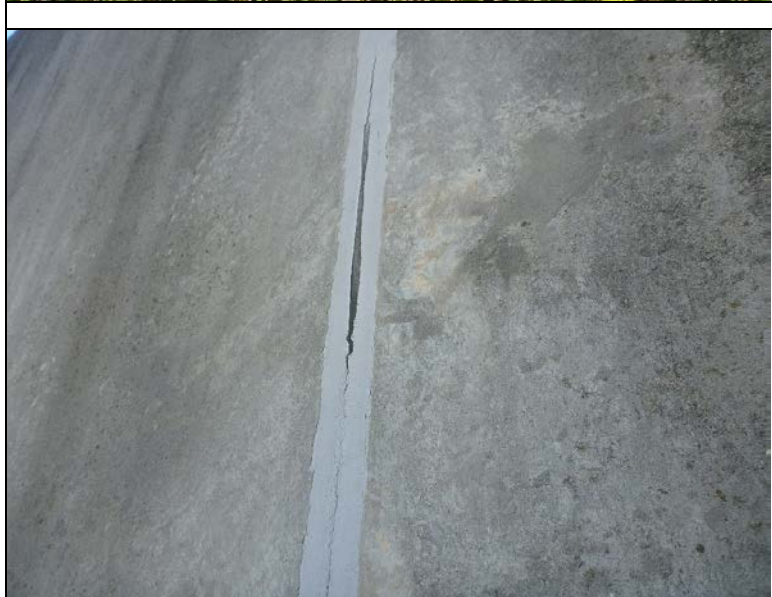
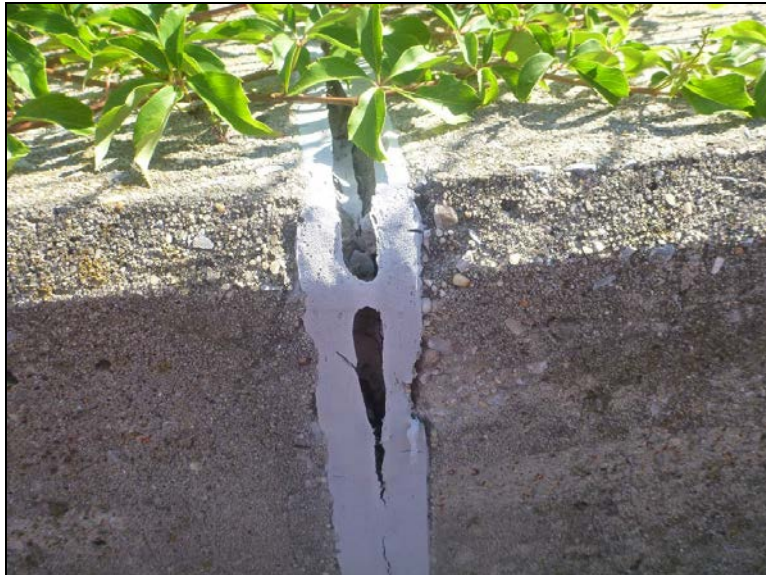
<p>Inspect ID: NAR1_2019_a_0016 Title: USACE_CENAN_NAR1_2019_a_0016_1.jpg Rated Item: 7. Monolith Joints Caption: Rating: Minimally Acceptable; Remarks: The gap sealant has cracked and separated in numerous joints along the entire length of the floodwall.; Action: Explore alternative joint stop material that can withstand the area's unique conditions. Clean joint and apply fresh sealant.; Station_1: 0+00U; Station_2: 4+45B</p>

Inspect ID: NAR1_2019_a_0016 **Title:** USACE_CENAN_NAR1_2019_a_0016_4.jpg
Rated Item: 7. Monolith Joints **Caption:** Rating: Minimally Acceptable; Remarks: The gap sealant has cracked and separated in numerous joints along the entire length of the floodwall.; Action: Explore alternative joint stop material that can withstand the area's unique conditions. Clean joint and apply fresh sealant.; Station_1: 0+00U; Station_2: 4+45B

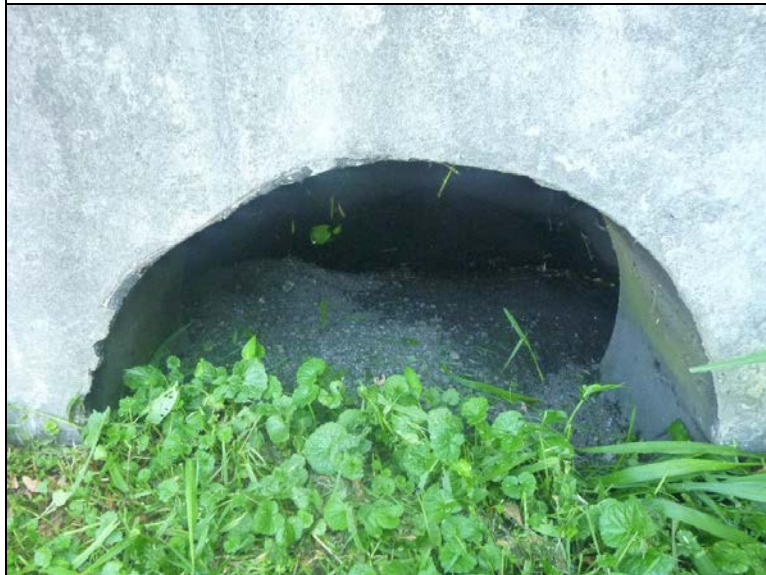
Inspect ID: NAR1_2019_a_0001 **Title:** USACE_CENAN_NAR1_2019_a_0001_1.jpg
Rated Item: 1. Vegetation and Obstructions **Caption:** Rating: Minimally Acceptable; Remarks: Outflow from Junction Chamber # 1 partially blocked with debris and vegetation.; Action: Remove debris and sediment from outlet pipe.; Station_1: 4+45B

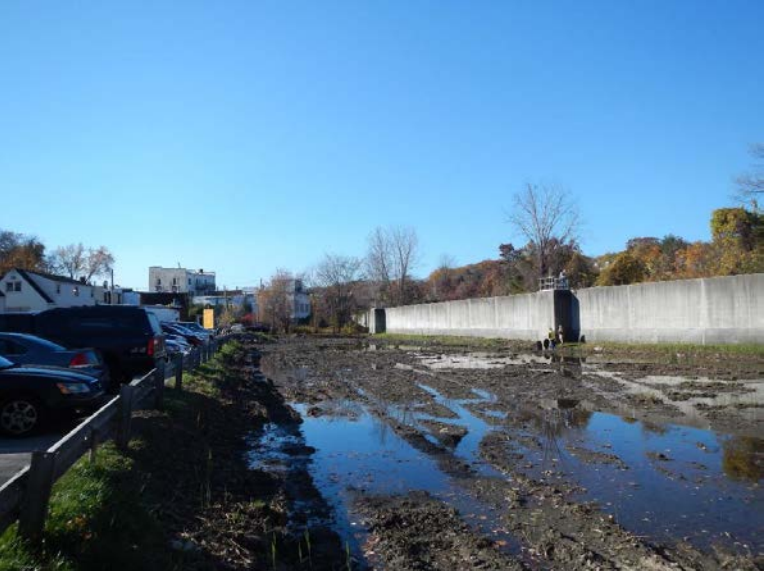
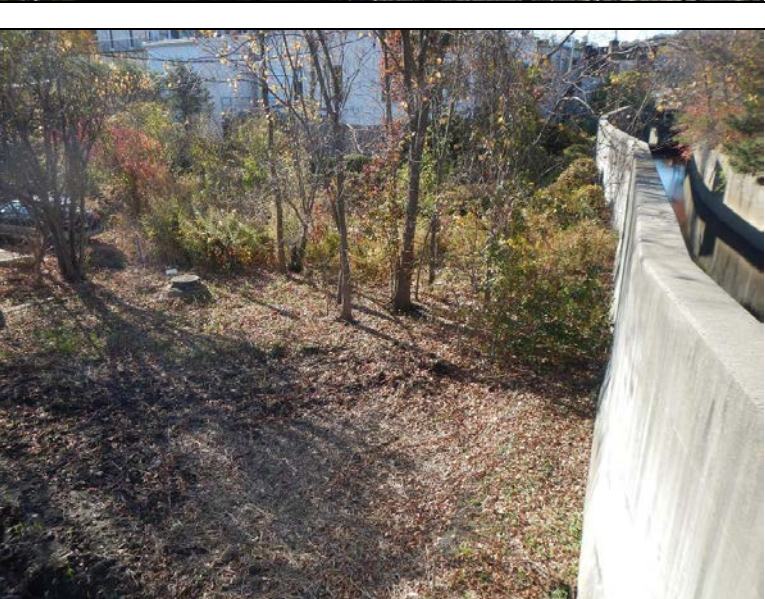
<p>Inspect ID: NAR1_2019_a_0033 Title: USACE_CENAN_NAR1_2019_a_0033_1.jpg Rated Item: 2. Encroachments Caption: Rating: Minimally Acceptable; Remarks: The two existing Westchester County Sewer manholes (SMH) in ponding area #2 were to be lowered 2 ft and hydrostatically sealed. The manhole cover on the southern most SMH has open vent and pick holes. The northern SMH unobservable in 2019. ; Action: Investigate that the SMH's were modified according to the project plans.; Station_1: 7+10U; ; ; Photo taken prior to the 2019 inspection.</p>

<p>Inspect ID: NAR1_2019_a_0033 Title: USACE_CENAN_NAR1_2019_a_0033_2.jpg Rated Item: 2. Encroachments Caption: Rating: Minimally Acceptable; Remarks: The two existing Westchester County Sewer manholes (SMH) in ponding area #2 were to be lowered 2 ft and hydrostatically sealed. The manhole cover on the southern most SMH has open vent and pick holes. The northern SMH unobservable in 2019. ; Action: Investigate that the SMH's were modified according to the project plans.; Station_1: 7+10U; ; ; Photo taken prior to the 2019 inspection.</p>

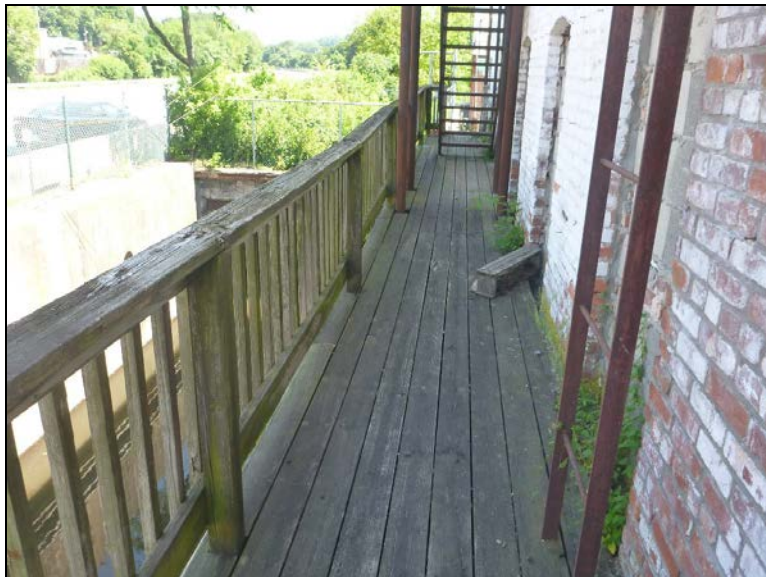
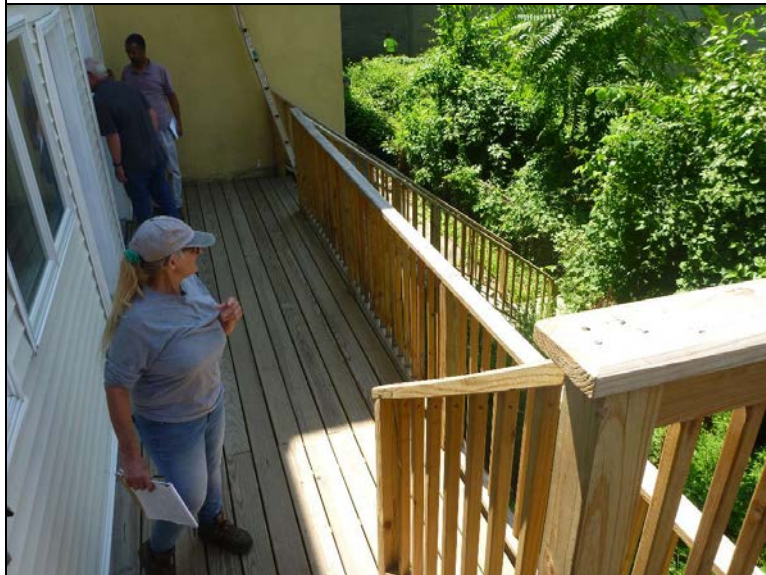
Inspect ID: NAR1_2019_a_0065 **Title:** USACE_CENAN_NAR1_2019_a_0065_1.jpg
Rated Item: 2. Encroachments **Caption:** Rating: Minimally Acceptable; Remarks:
 Access way to Ponding Area #1 has deteriorated. A large portion of the lower deck was recently replaced, but missing and warped floorboards remain in the upper walkway. It is believed that the deck is privately owned.; Action: Encourage the owner to continue deck repairs so inspectors and emergency personnel maintain access to the ponding area and floodwall.; Station_1: 0+90U

Inspect ID: NAR1_2019_a_0065 **Title:** USACE_CENAN_NAR1_2019_a_0065_2.jpg
Rated Item: 2. Encroachments **Caption:** Rating: Minimally Acceptable; Remarks:
 Access way to Ponding Area #1 has deteriorated. A large portion of the lower deck was recently replaced, but missing and warped floorboards remain in the upper walkway. It is believed that the deck is privately owned.; Action: Encourage the owner to continue deck repairs so inspectors and emergency personnel maintain access to the ponding area and floodwall.; Station_1: 0+90U

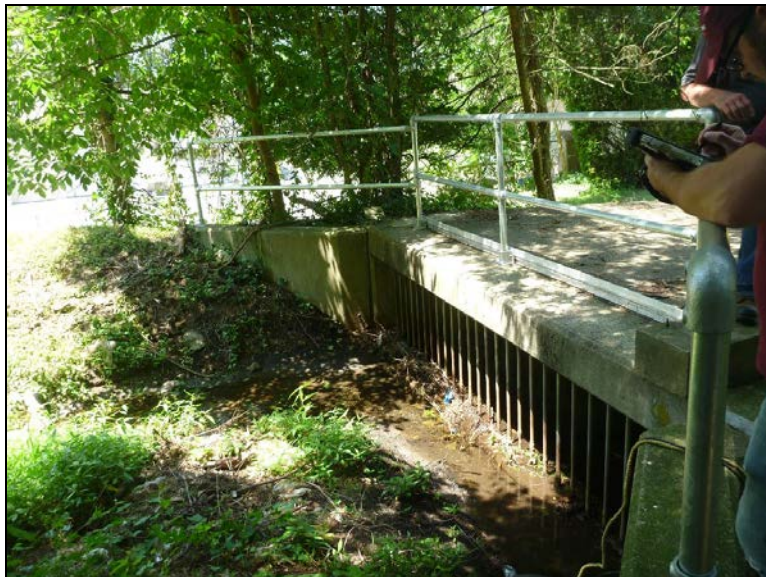
Inspect ID: NAR1_2019_a_0092 **Title:** USACE_CENAN_NAR1_2019_a_0092_1.jpg
Rated Item: 2. Encroachments **Caption:** Rating: Minimally Acceptable; Remarks: Safety railing installed on top of inlet structure to comply with new OSHA regulations.; Action: Seek authorization from USACE for encroachment.; Station_1: 2+70C

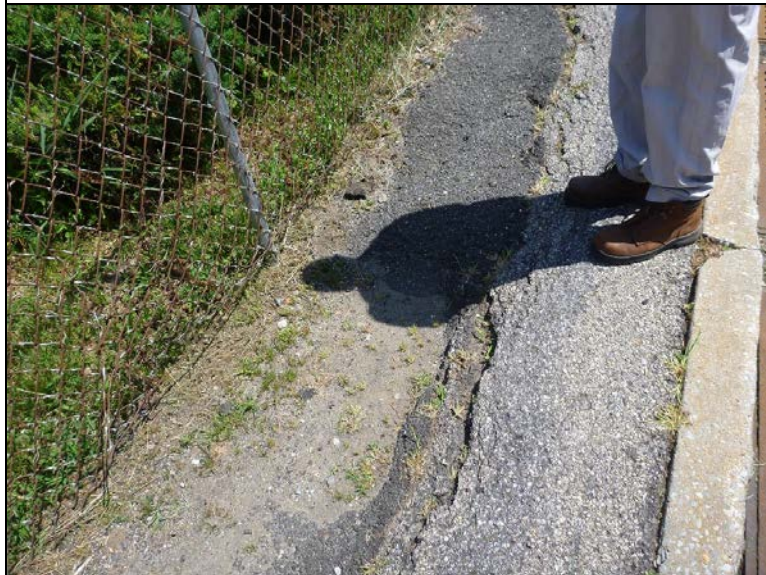
Inspect ID: NAR1_2019_a_0082 **Title:** USACE_CENAN_NAR1_2019_a_0082_1.jpg
Rated Item: 7. Foundation of Concrete Structures (Such as culverts, inlet and discharge structures, or gatewells.) **Caption:** Rating: Unacceptable; Remarks: Small sinkhole above 30 inch drainage culvert at drop inlet #4. ; Action: Video inspection conducted in 2013 did not include this pipe section. Perform crawler type video inspection for possible leaks. Repair as needed and restore backfill around drainage culvert to finished grade.; Station_1: 6+05A; ; ;

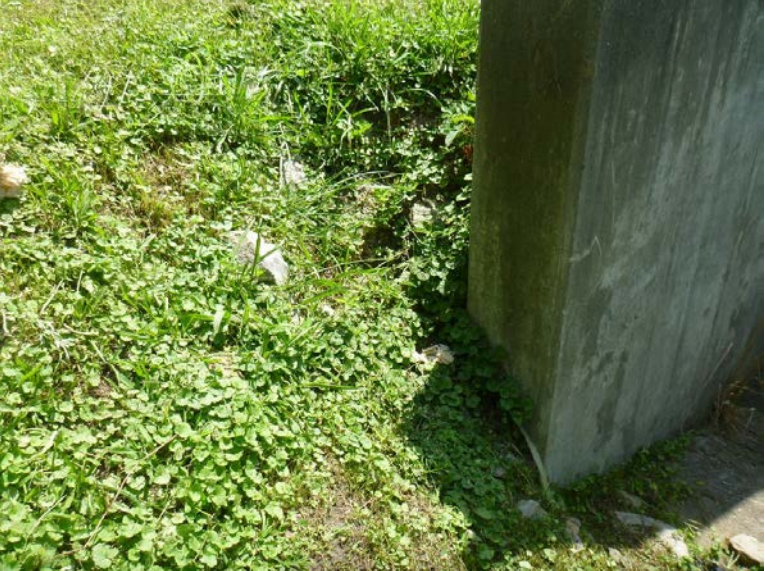
<p>Inspect ID: NAR1_2019_a_0083 Title: USACE_CENAN_NAR1_2019_a_0083_1.jpg Rated Item: 7. Foundation of Concrete Structures (Such as culverts, inlet and discharge structures, or gatewells.) Caption: Rating: Minimally Acceptable; Remarks: Minor erosion behind headwall of outlet structure #2.; Action: Repair erosion and restore according to USACE guidelines.; Station_1: 5+05A</p>

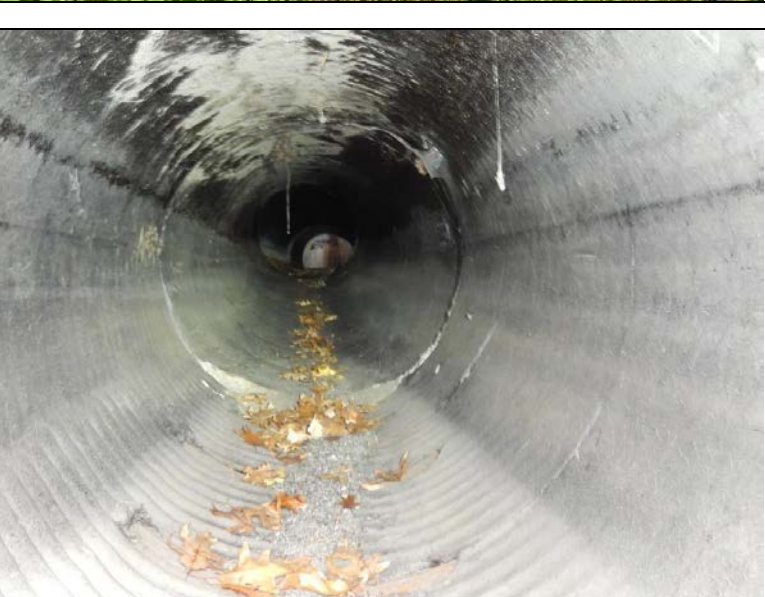
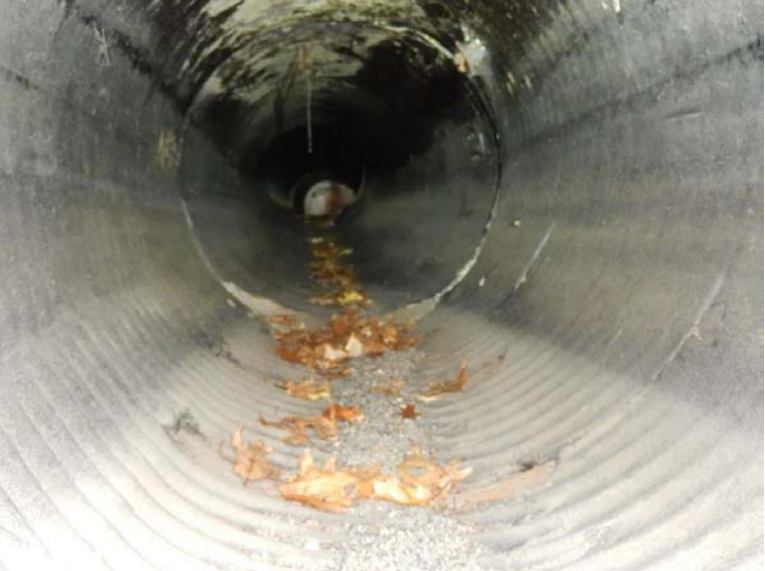
<p>Inspect ID: NAR1_2019_a_0085 Title: USACE_CENAN_NAR1_2019_a_0085_1.jpg Rated Item: 9. Culverts/ Discharge Pipes Caption: Rating: Unacceptable; Remarks: Alignment of 36" CMP underneath the Saw Mill River Road (interceptor ditch #1) is warped between drop inlet #3 and outlet structure #2. No video inspection has been conducted within the last five years. Could not inspect in 2019.; Action: Video inspection conducted in 2013 did not include this pipe section. Perform crawler type video inspection for details of damage and remediate accordingly.; Station_1: 5+05A; Photo taken prior to the 2019 inspection.</p>

<p>Inspect ID: NAR1_2019_a_0085 Title: USACE_CENAN_NAR1_2019_a_0085_2.jpg Rated Item: 9. Culverts/ Discharge Pipes Caption: Rating: Unacceptable; Remarks: Alignment of 36" CMP underneath the Saw Mill River Road (interceptor ditch #1) is warped between drop inlet #3 and outlet structure #2. No video inspection has been conducted within the last five years. Could not inspect in 2019.; Action: Video inspection conducted in 2013 did not include this pipe section. Perform crawler type video inspection for details of damage and remediate accordingly.; Station_1: 5+05A; Photo taken prior to the 2019 inspection.</p>
