Flood Damage Reduction Segment / System Inspection Report

Name of Segment / System: Ardsley Flood Control Project

Date Report Prepared: 7/17/2019

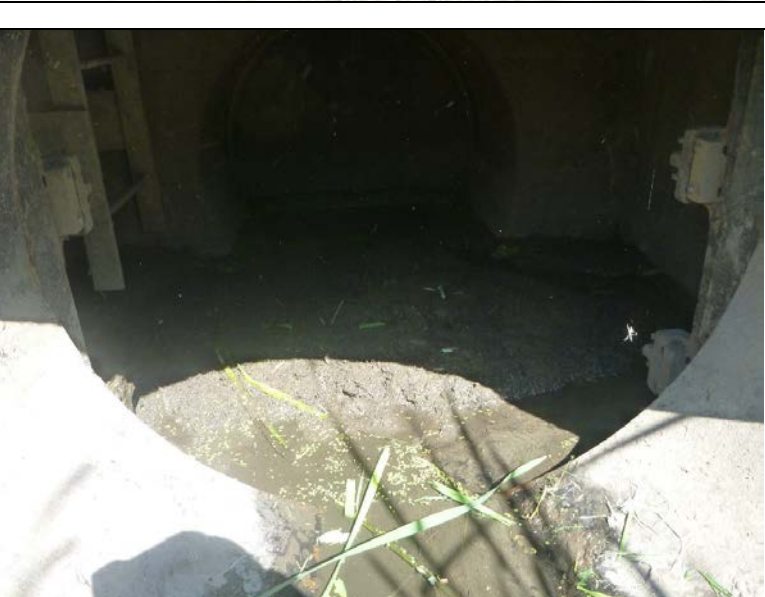
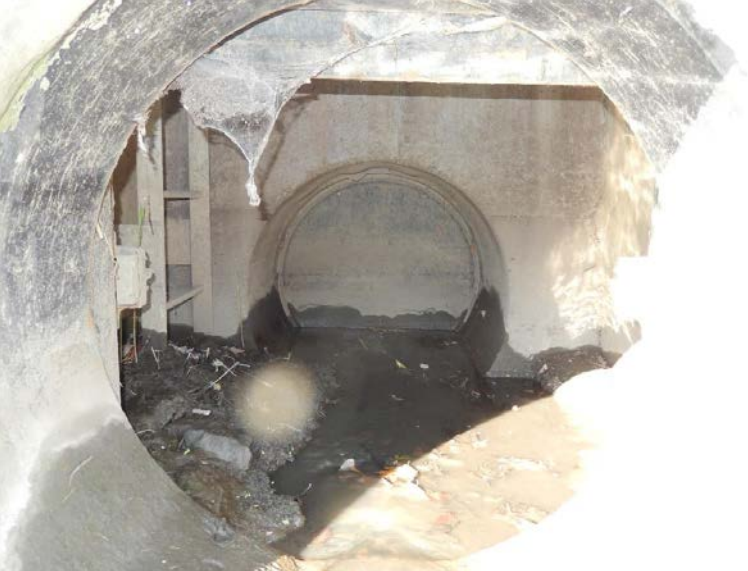
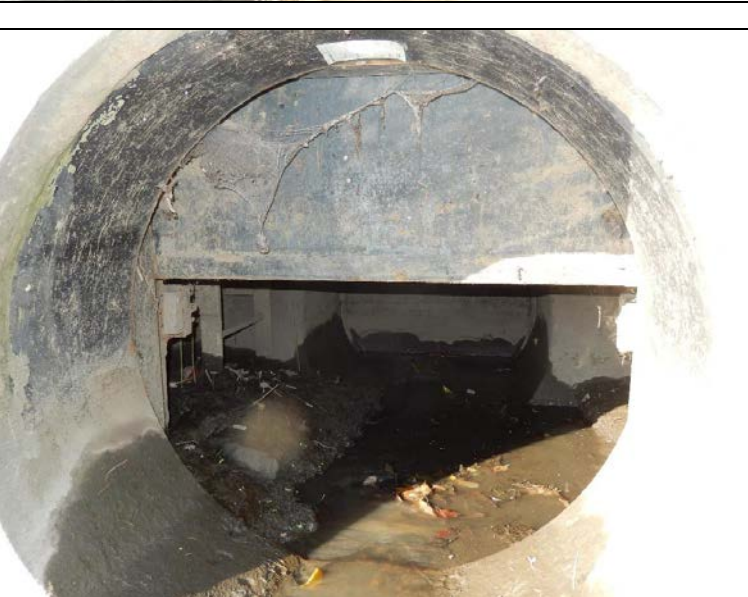
<p>Inspect ID: NAR1_2019_a_0034 Title: USACE_CENAN_NAR1_2019_a_0034_1.jpg Rated Item: 10. Sluice/ Slide Gates Caption: Rating: Minimally Acceptable; Remarks: DS # 4 sluice gate operated during 2016 inspection. Cannot fully close due to sediment at bottom of structure. NYSDEC plans to replace the crank with an electric motor. ; Action: Remove sediment and debris.; Station_1: 6+85U; ; ;</p>

<p>Inspect ID: NAR1_2019_a_0034 Title: USACE_CENAN_NAR1_2019_a_0034_2.jpg Rated Item: 10. Sluice/ Slide Gates Caption: Rating: Minimally Acceptable; Remarks: DS # 4 sluice gate operated during 2016 inspection. Cannot fully close due to sediment at bottom of structure. NYSDEC plans to replace the crank with an electric motor. ; Action: Remove sediment and debris.; Station_1: 6+85U; ; ; Photo taken prior to 2019 inspection.</p>

<p>Inspect ID: NAR1_2019_a_0034 Title: USACE_CENAN_NAR1_2019_a_0034_3.jpg Rated Item: 10. Sluice/ Slide Gates Caption: Rating: Minimally Acceptable; Remarks: DS # 4 sluice gate operated during 2016 inspection. Cannot fully close due to sediment at bottom of structure. NYSDEC plans to replace the crank with an electric motor. ; Action: Remove sediment and debris.; Station_1: 6+85U; ; ; Photo taken prior to 2019 inspection.</p>

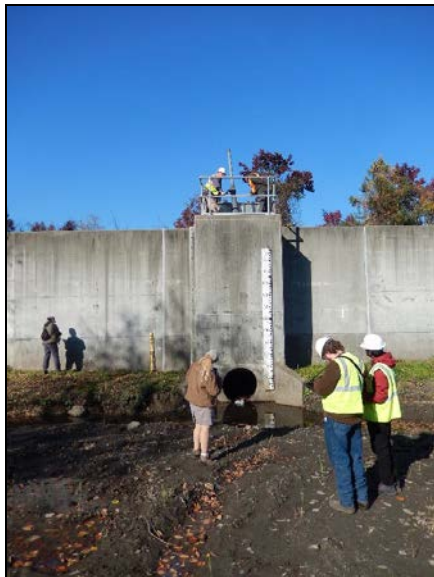
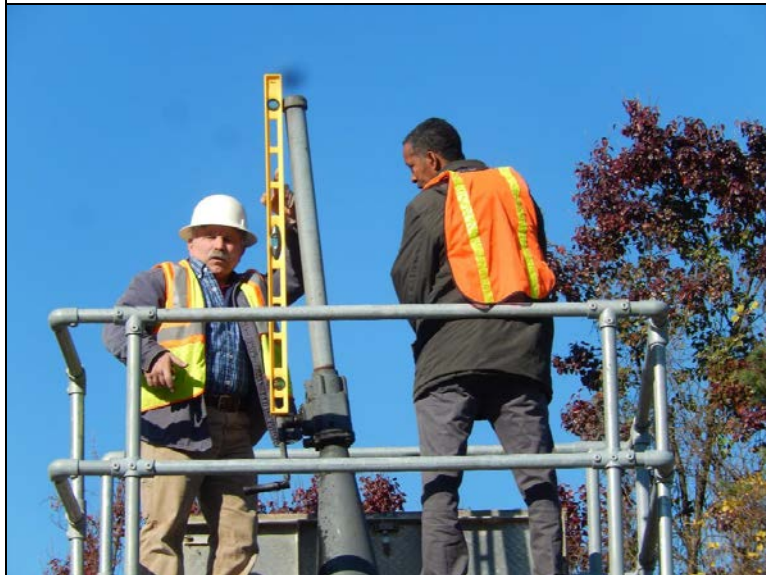
Inspect ID: NAR1_2019_a_0043 **Title:** USACE_CENAN_NAR1_2019_a_0043_1.jpg
Rated Item: 10. Sluice/ Slide Gates **Caption:** Rating: Unacceptable; Remarks: DS#3 valve riser is out of plumb and gate unable to close or operate properly. NYSDEC plans to replace the crank with an electric motor and straighten the gate.; Action: Repair/replace damaged valve riser and restore operation as planned.; Station_1: 5+15U; Photo taken prior to the 2019 inspection.

Inspect ID: NAR1_2019_a_0043 **Title:** USACE_CENAN_NAR1_2019_a_0043_2.jpg
Rated Item: 10. Sluice/ Slide Gates **Caption:** Rating: Unacceptable; Remarks: DS#3 valve riser is out of plumb and gate unable to close or operate properly. NYSDEC plans to replace the crank with an electric motor and straighten the gate.; Action: Repair/replace damaged valve riser and restore operation as planned.; Station_1: 5+15U; Photo taken prior to the 2019 inspection.

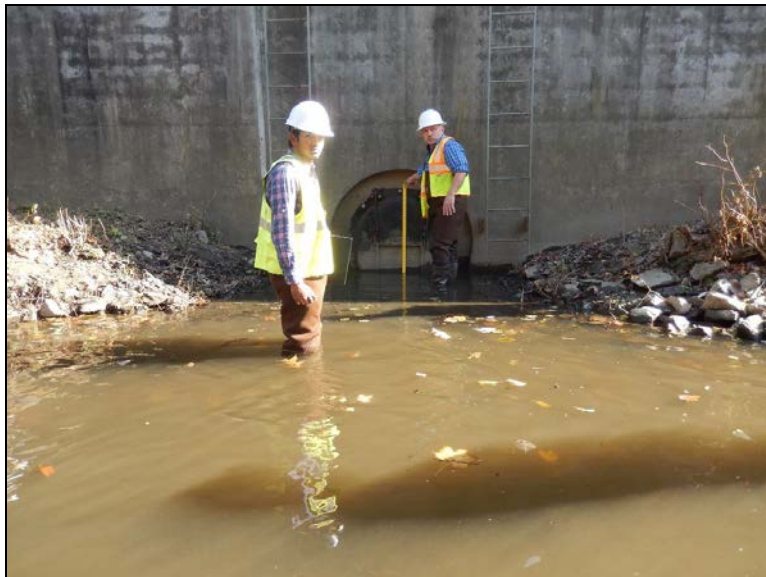
Inspect ID: NAR1_2019_a_0035 **Title:** USACE_CENAN_NAR1_2019_a_0035_1.jpg
Rated Item: 11. Flap Gates/ Flap Valves/ Pinch Valves **Caption:** Rating: Minimally Acceptable; Remarks: Flap gate of drainage structure #4 is partially blocked by sediment deposition. Could not access in 2019.; Action: Remove sediment in accordance with USACE guidelines.; Station_1: 6+85U; Photo taken prior to the 2019 inspection.

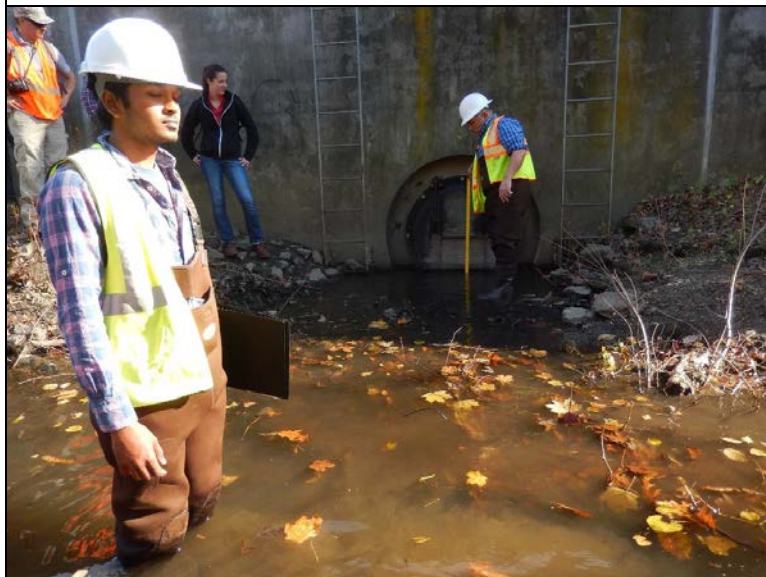
Inspect ID: NAR1_2019_a_0041 **Title:** USACE_CENAN_NAR1_2019_a_0041_1.jpg
Rated Item: 11. Flap Gates/ Flap Valves/ Pinch Valves **Caption:** Rating: Minimally Acceptable; Remarks: Flap gate of DS#3 is blocked by sediment deposition. Could not access in 2019.; Action: Remove sediment in accordance with USACE guidelines.; Station_1: 5+15U; Photo taken prior to the 2019 inspection.

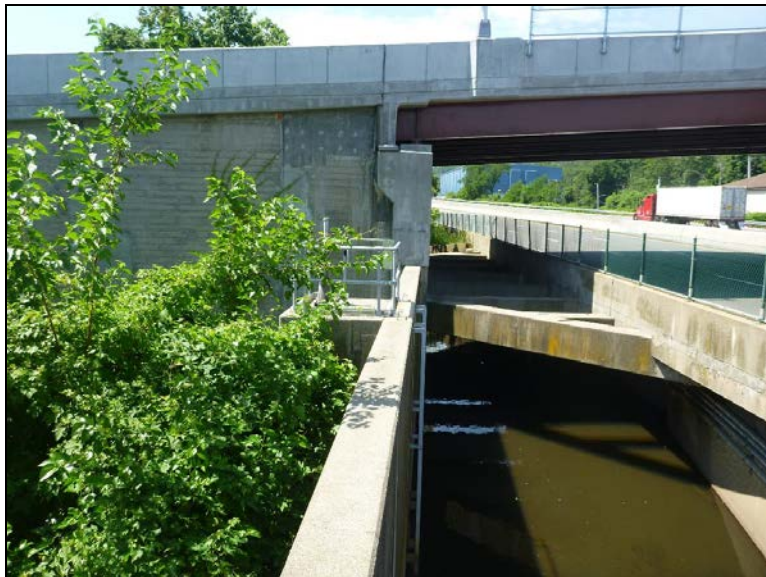
Inspect ID: NAR1_2019_a_0069 **Title:** USACE_CENAN_NAR1_2019_a_0069_1.jpg
Rated Item: 11. Flap Gates/ Flap Valves/ Pinch Valves **Caption:** Rating: Minimally Acceptable; Remarks: DS#1. Flap gate operated in 2016, but stiffly. Sediment in the way. Could not access in 2019.; Action: Clean DS#1 and lubricate flap gate.; Station_1: 0+40U

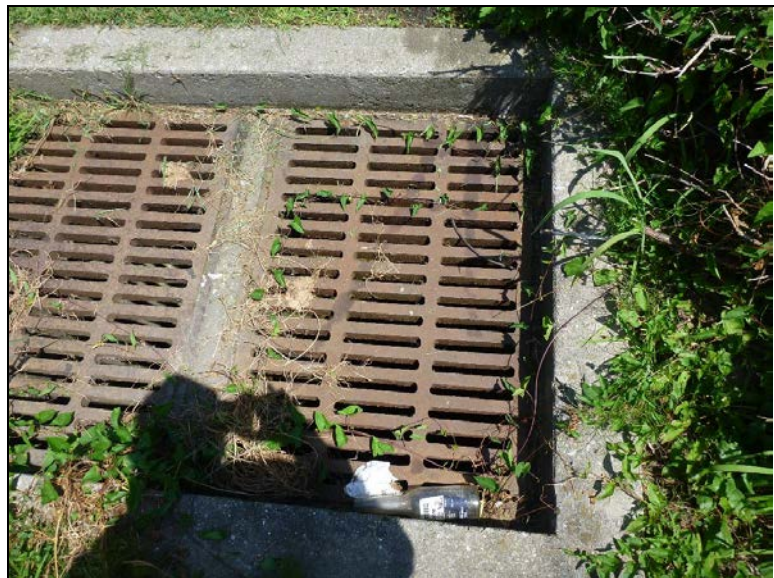
<p>Inspect ID: NAR1_2019_a_0081 Title: USACE_CENAN_NAR1_2019_a_0081_1.jpg Rated Item: 12. Trash Racks (non-mechanical) Caption: Rating: Acceptable; Remarks: Drop inlet #3 appears operable.; Action: Monitor conditions at the drop inlet.; Station_1: 5+55A</p>
