ARDSLEY

FLOOD RISK MANAGEMENT PROJECT

*FLOODWALLS, INTERIOR DRAINAGE SYSTEM AND FLOOD DAMAGE
REDUCTION CHANNEL*

2010 PERIODIC INSPECTION REPORT No.1

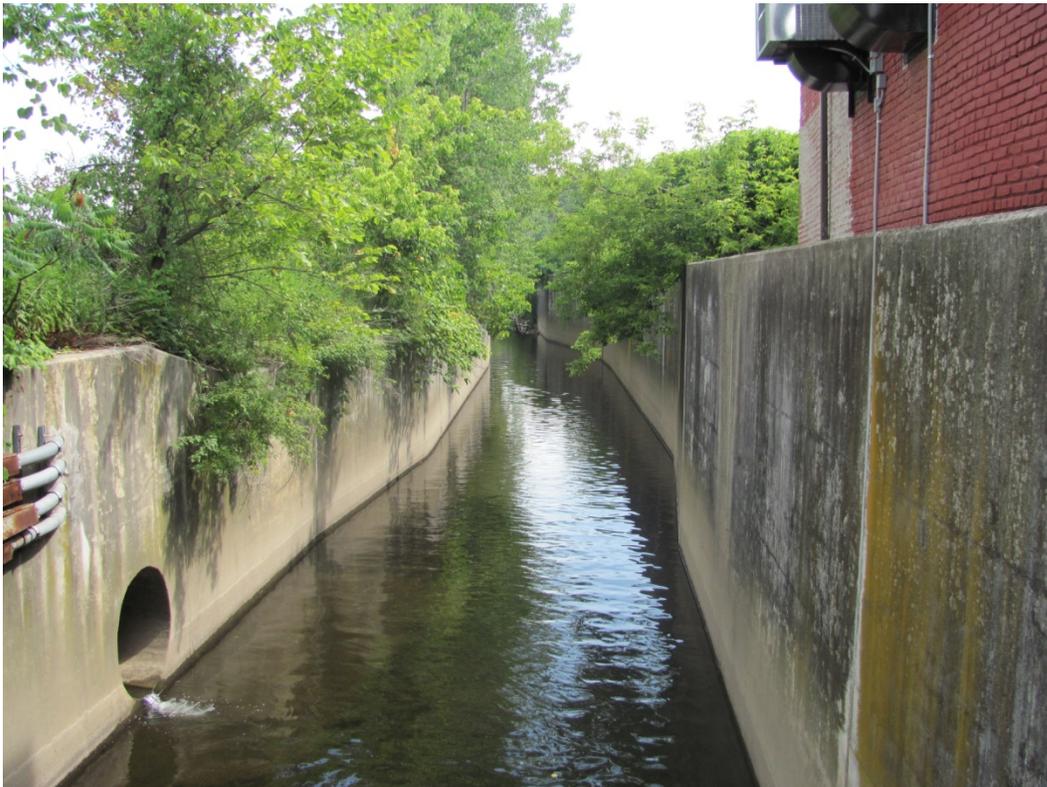
July 12, 2010. Looking upstream along the concrete channel. Vegetation encroachment on both sides of channel.

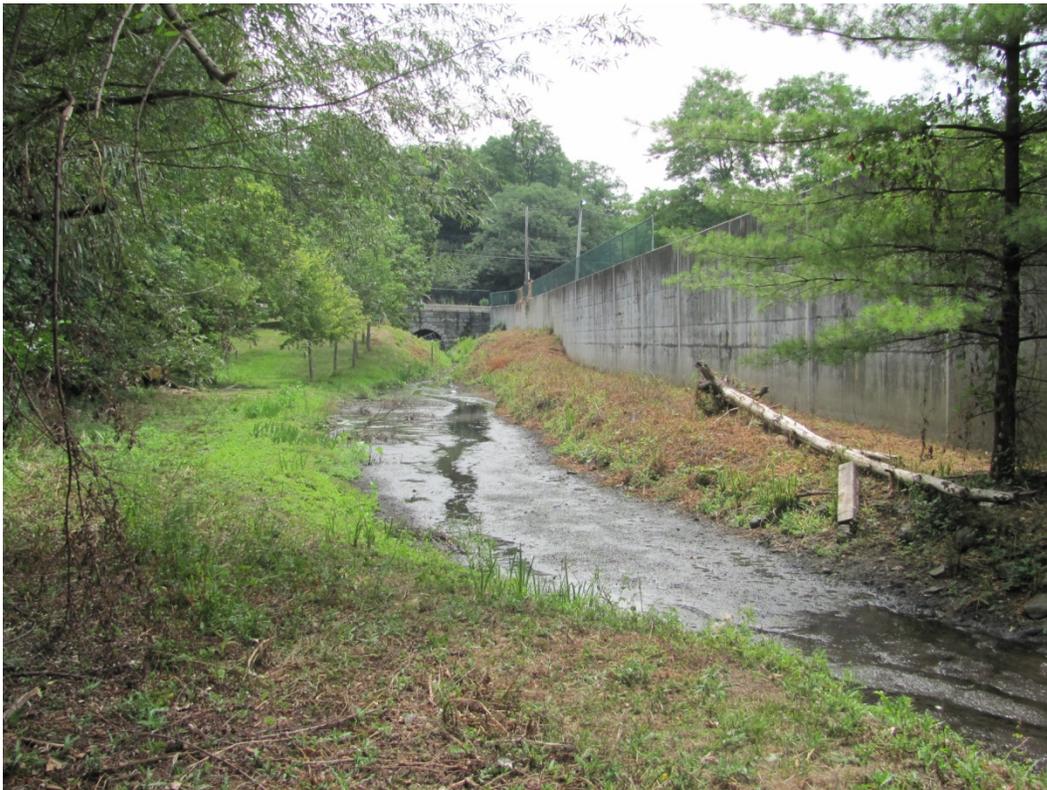
July 12, 2010. Looking upstream towards blowout tunnel. Floodwall is on the right.

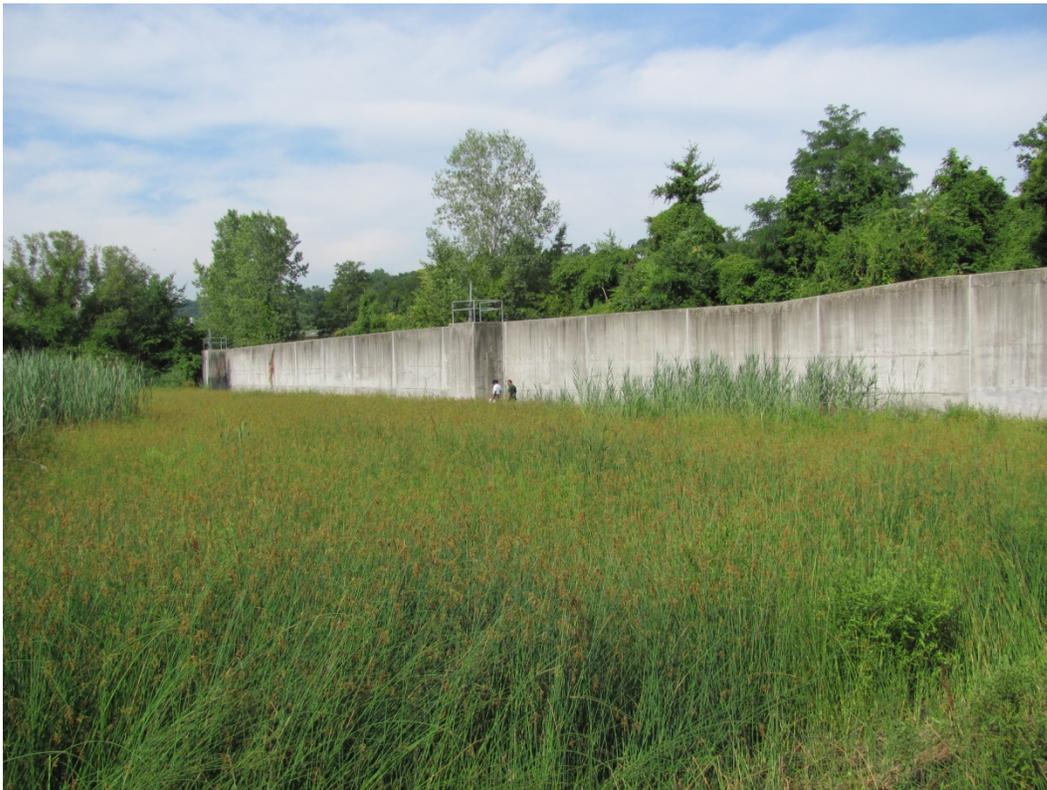
It was observed during the PI that the concrete surface of the floodwall has been recently repaired. The vegetation in ponding area #2 was found to be unmaintained.

July 12, 2010. Ponding area No. 2 overgrown with vegetation. Drainage structures #3 (far) and #4 (near) along floodwall.

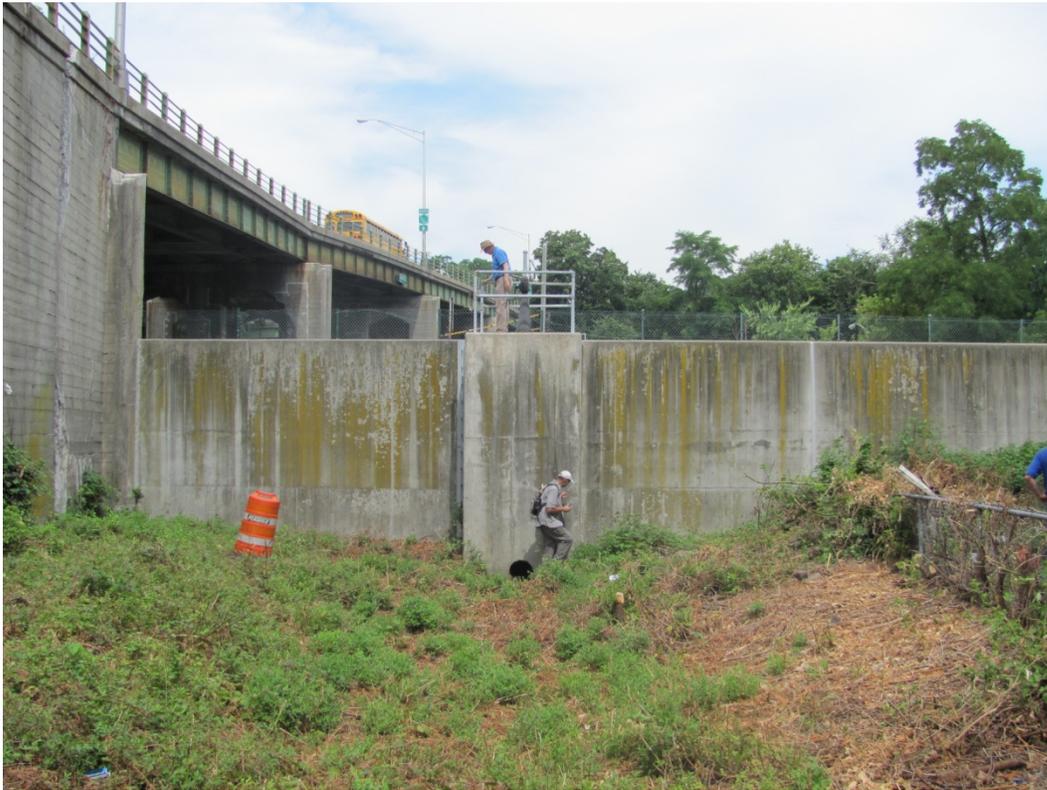
July 12, 2010. Ponding area No. 1 with drainage structure No. 1. Note vegetation in the basin and along the fence.

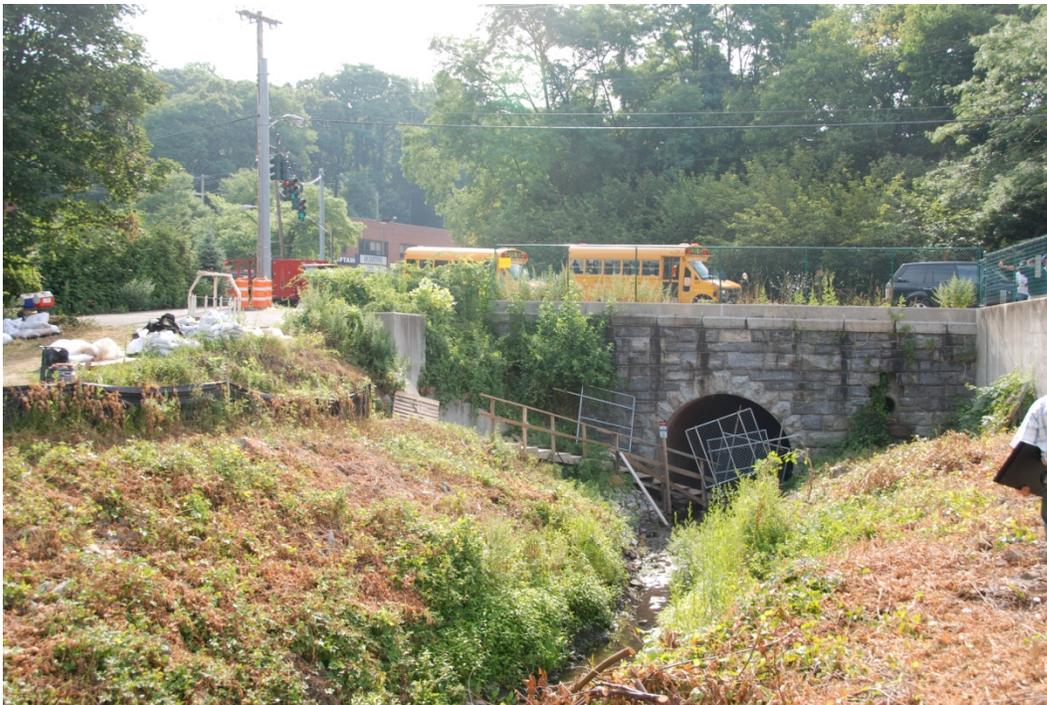
July 12, 2010. Outlet of blowoff tunnel. Grill removed and leaning against the concrete wall (photo right) to give access to NYCDEP contractor. Riprap slope covered with vegetation.

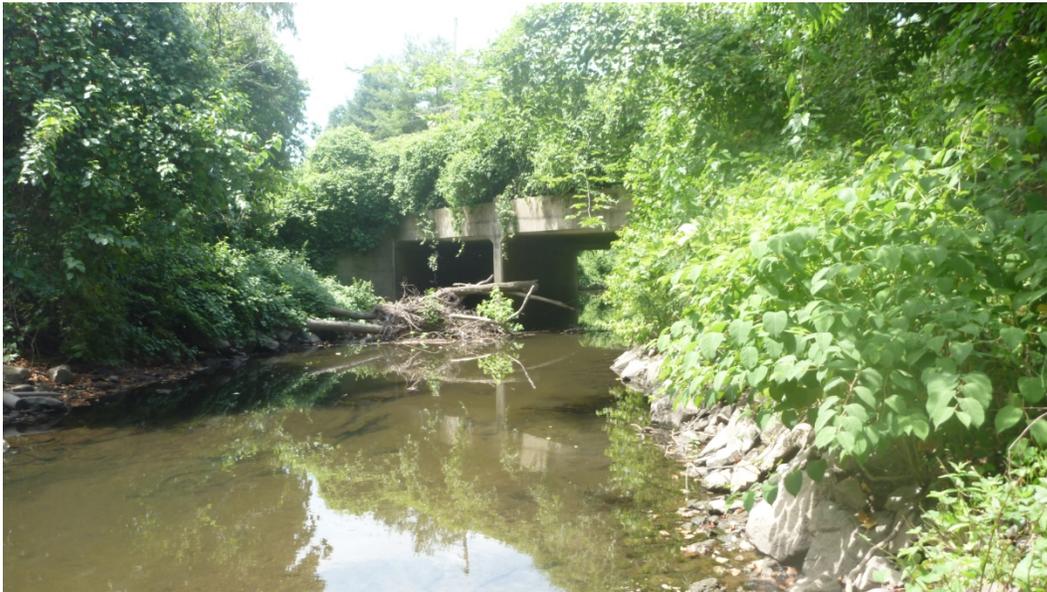
July 12, 2010. Downstream along earthen channel improvement from immediately downstream of the Elm Street Bridge. Note dense vegetation growing along channel banks and within riprap.

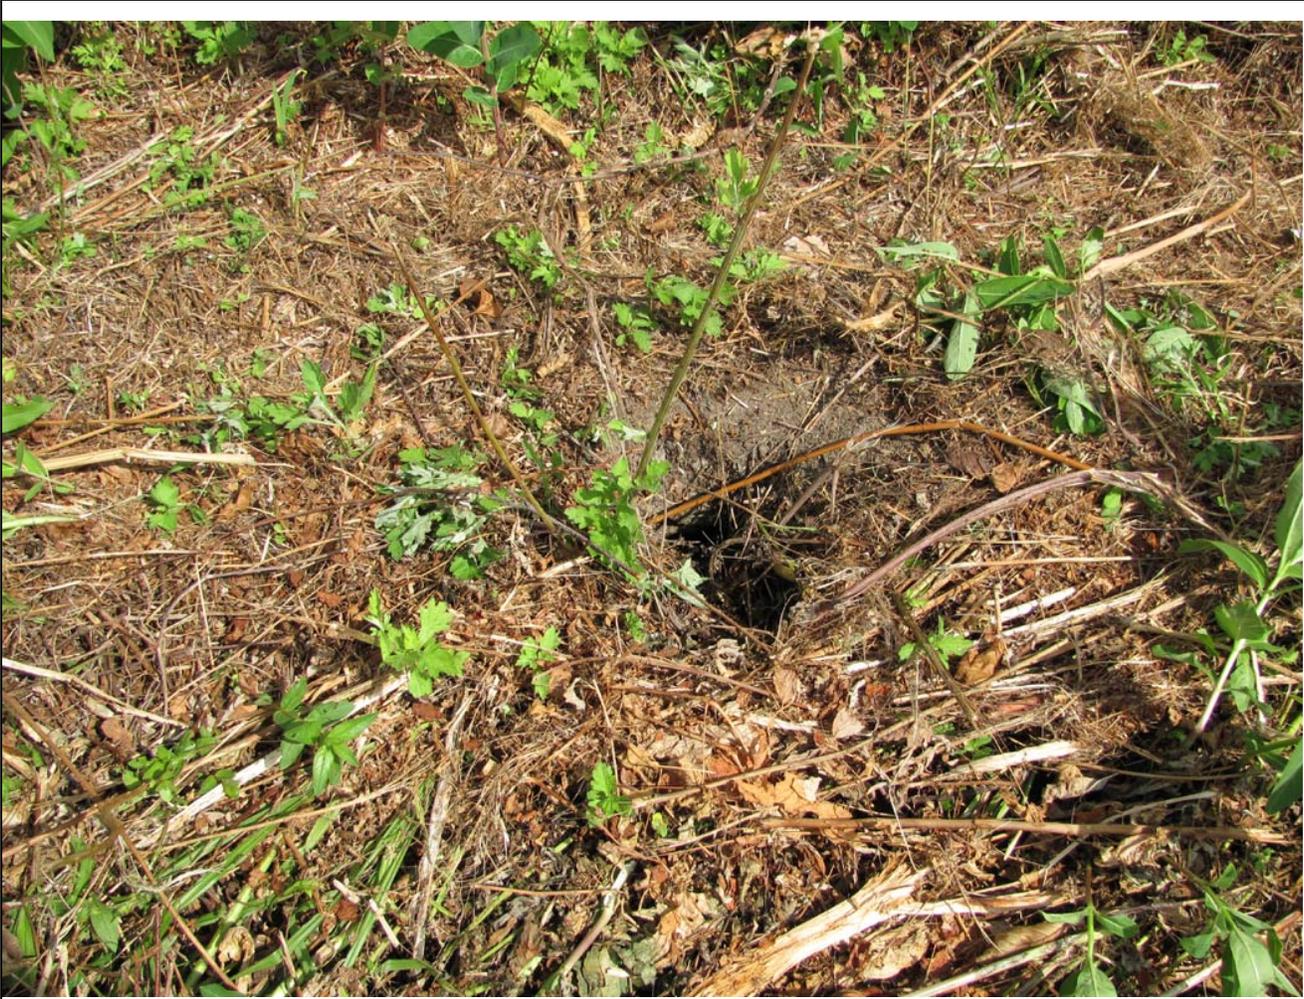
Inspect ID: NAR1_2010_a_0012 **Title:** USACE_CENAN_NAR1_2010_a_0012_1.jpg **Caption:** 6-inch-wide animal burrow located 3 feet from floodwall on the protected side.

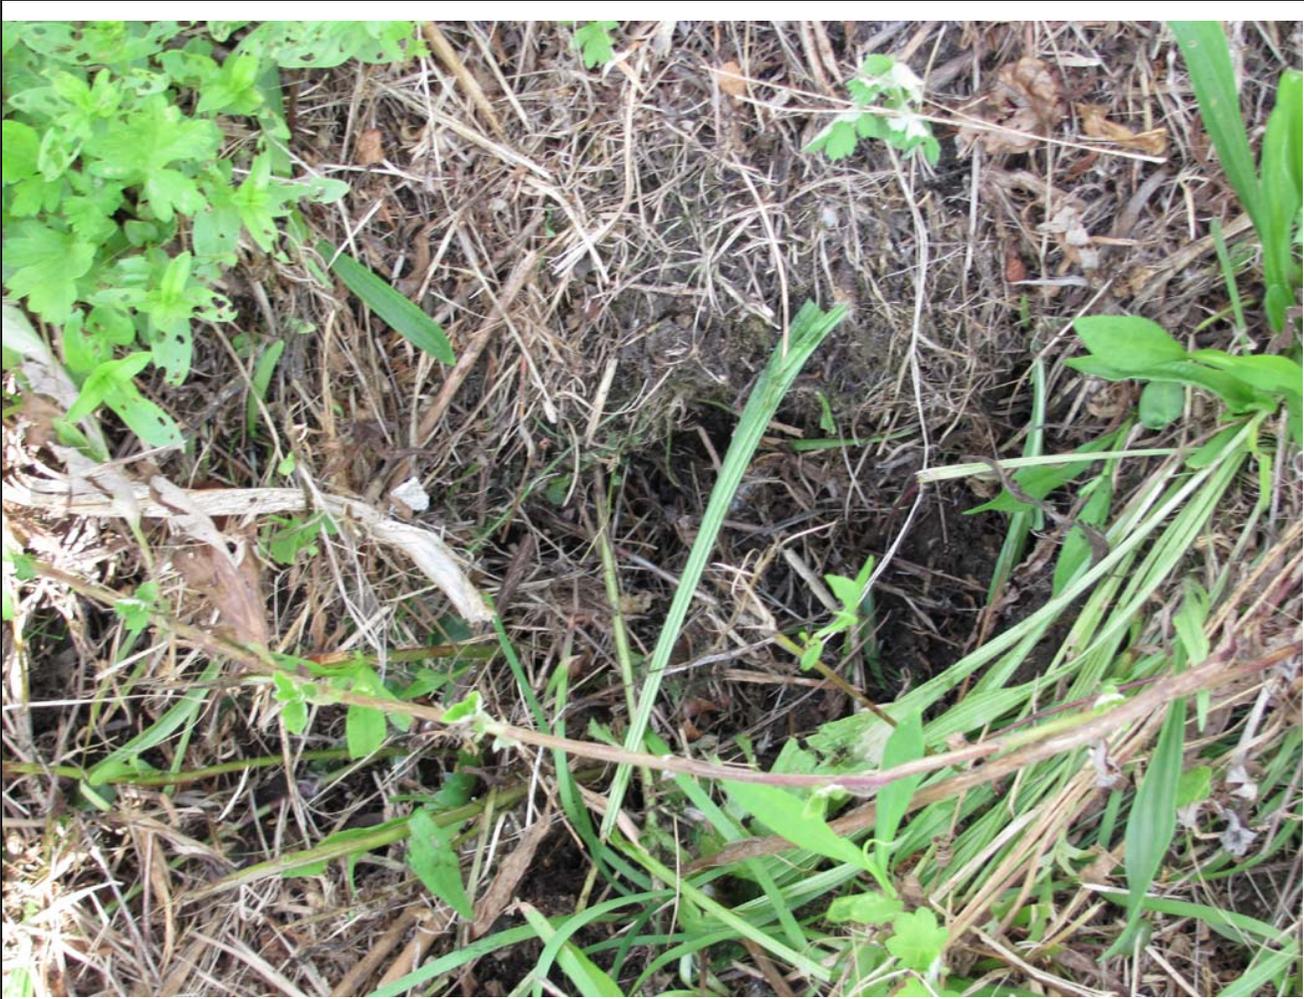
Inspect ID: NAR1_2010_a_0013 **Title:** USACE_CENAN_NAR1_2010_a_0013_1.jpg **Caption:** Animal burrow on protected side of floodwall.

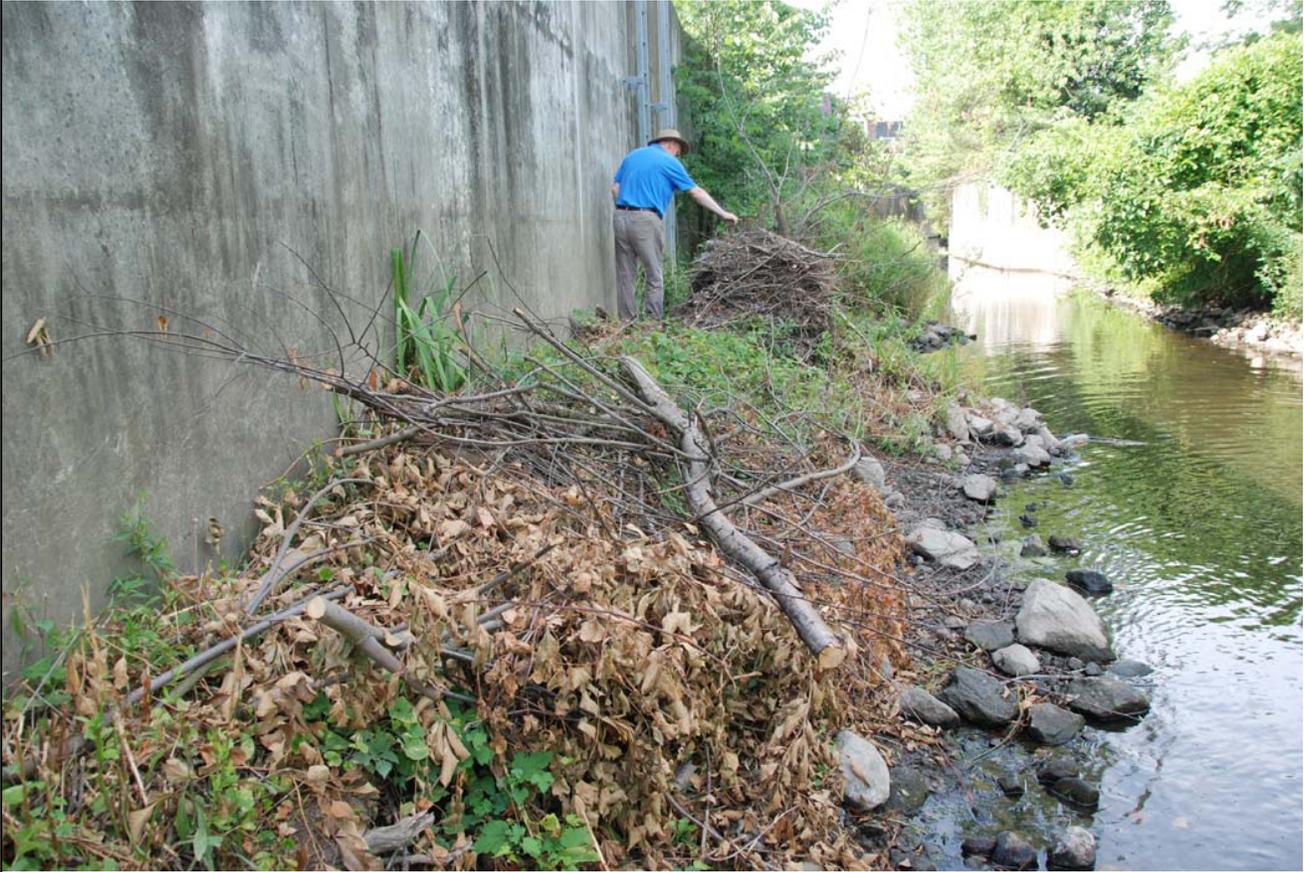
Inspect ID: NAR1_2010_a_0015 **Title:** USACE_CENAN_NAR1_2010_a_0015_1.jpg **Caption:** Debris and stumping along exposed side of floodwall.

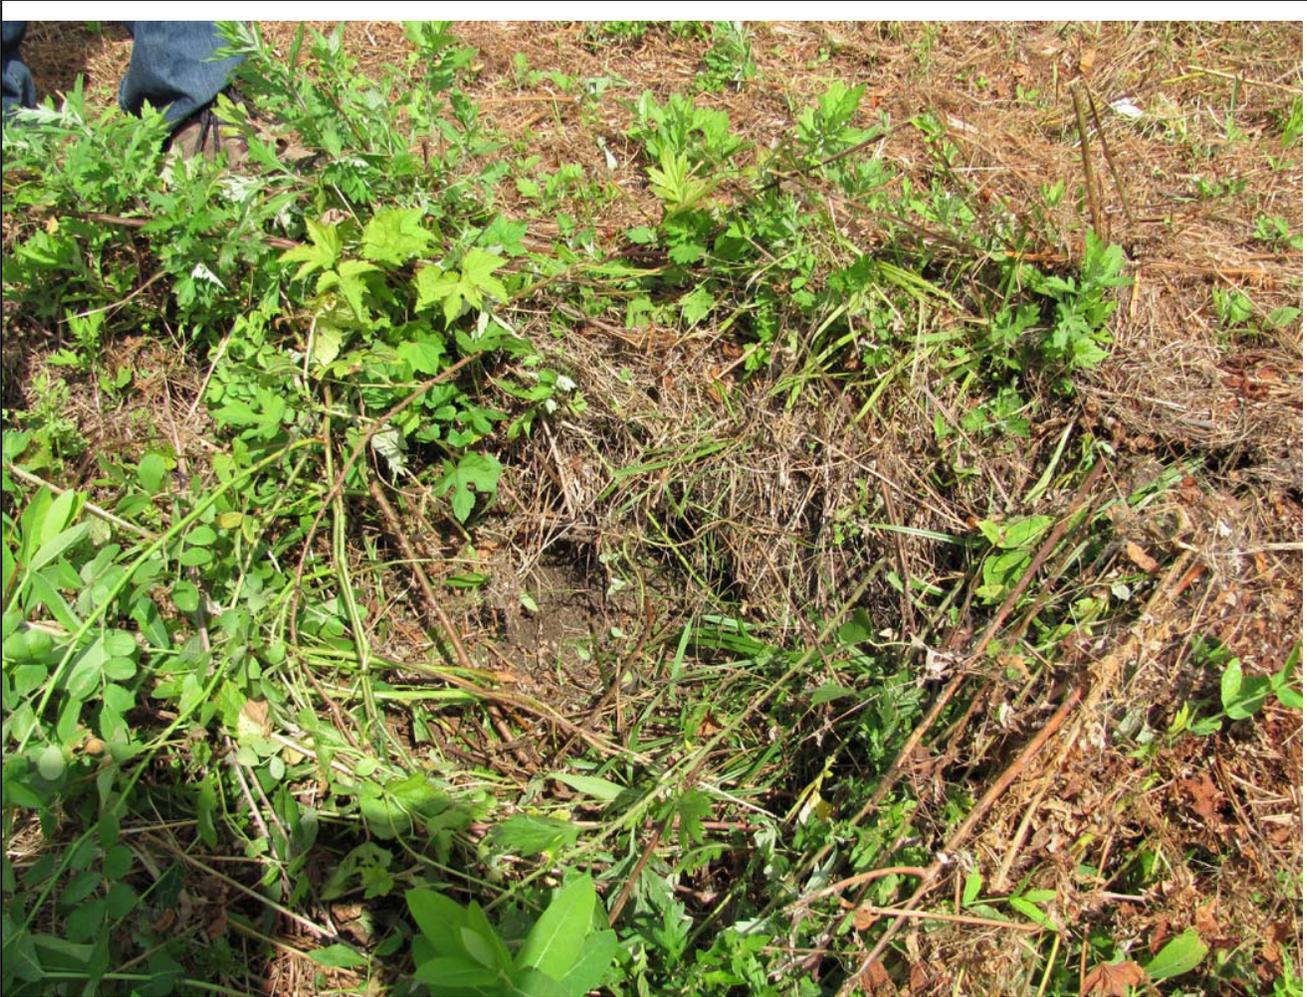
Inspect ID: NAR1_2010_a_0017 **Title:** USACE_CENAN_NAR1_2010_a_0017_1.jpg **Caption:** Large burrow on the protected side of the floodwall.

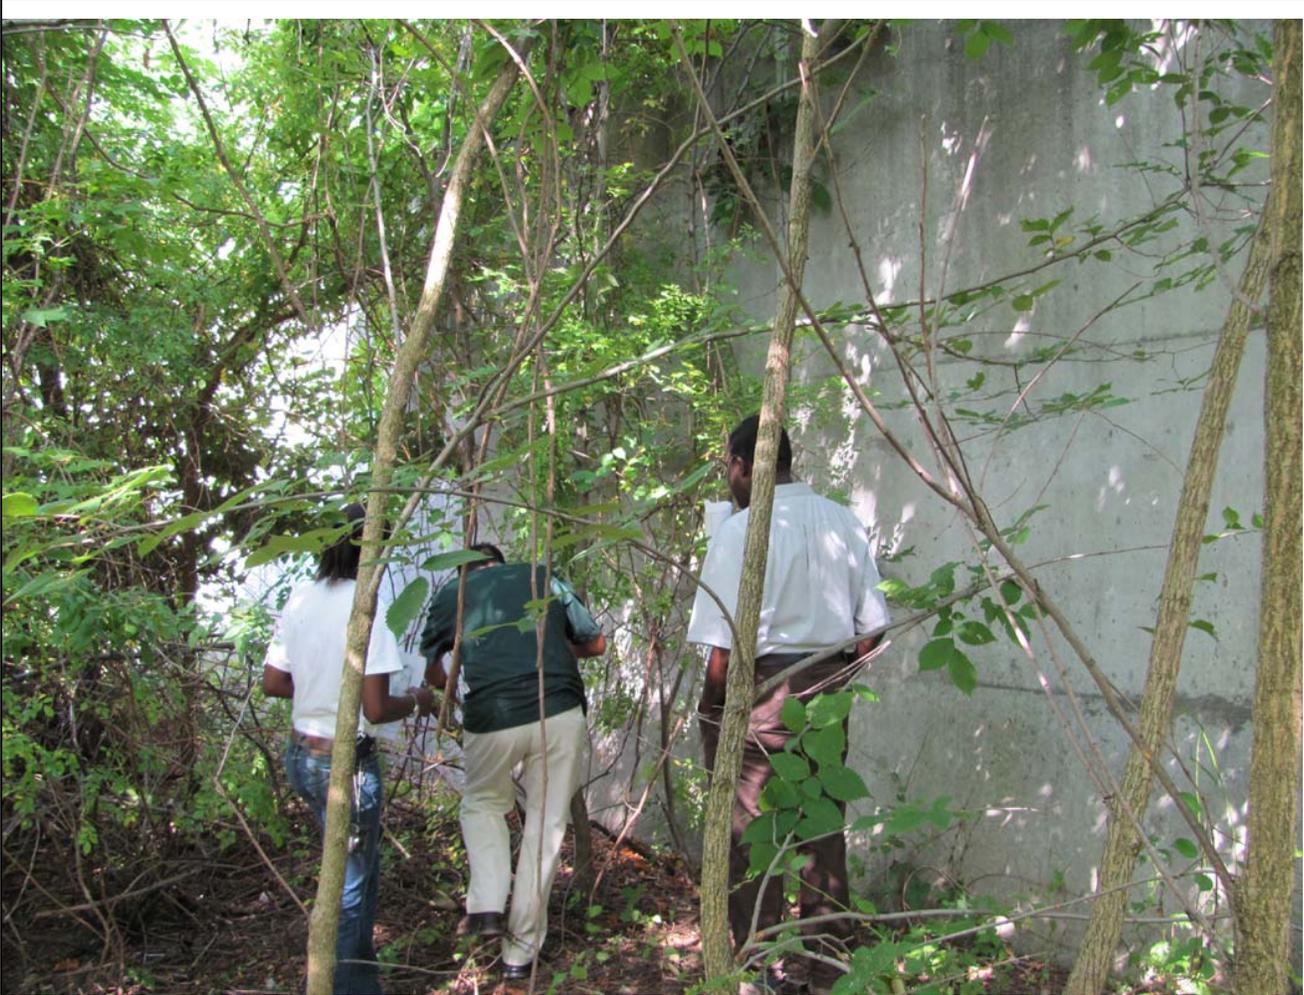
Inspect ID: NAR1_2010_a_0018 **Title:** USACE_CENAN_NAR1_2010_a_0018_1.jpg **Caption:** South of DS#3 significant vegetation (vines and trees) grow along the protected side of the floodwall for about 200 ft.

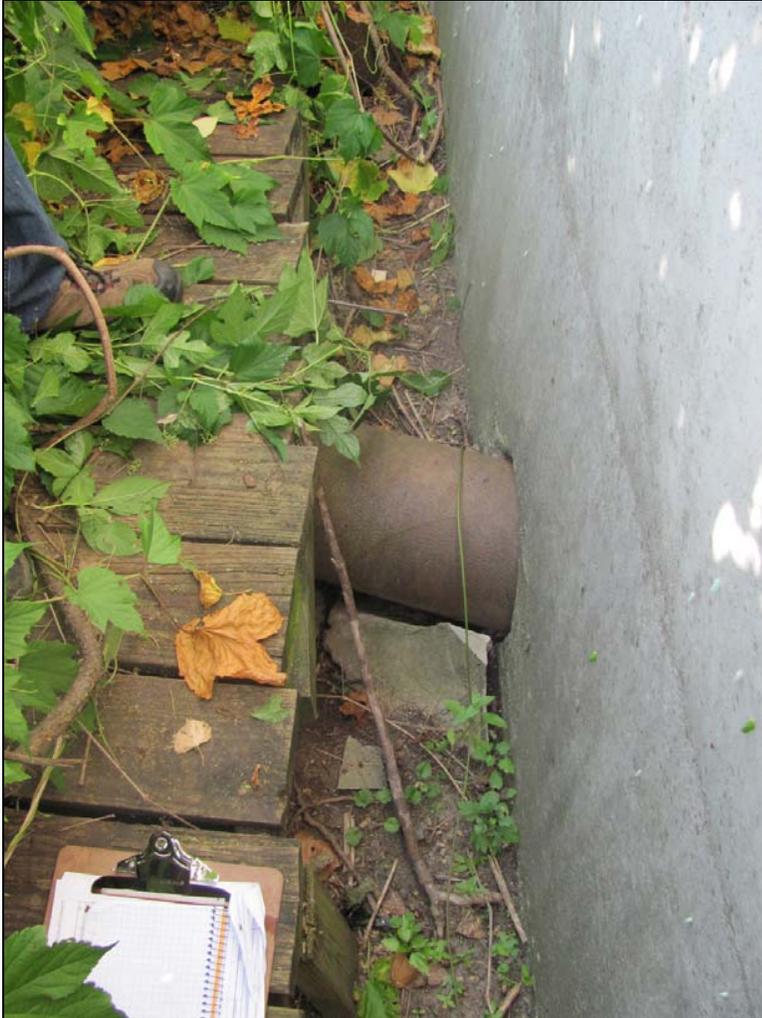
Inspect ID: NAR1_2010_a_0019 **Title:** USACE_CENAN_NAR1_2010_a_0019_1.jpg **Caption:** Pipe penetration of floodwall not on approved plans.

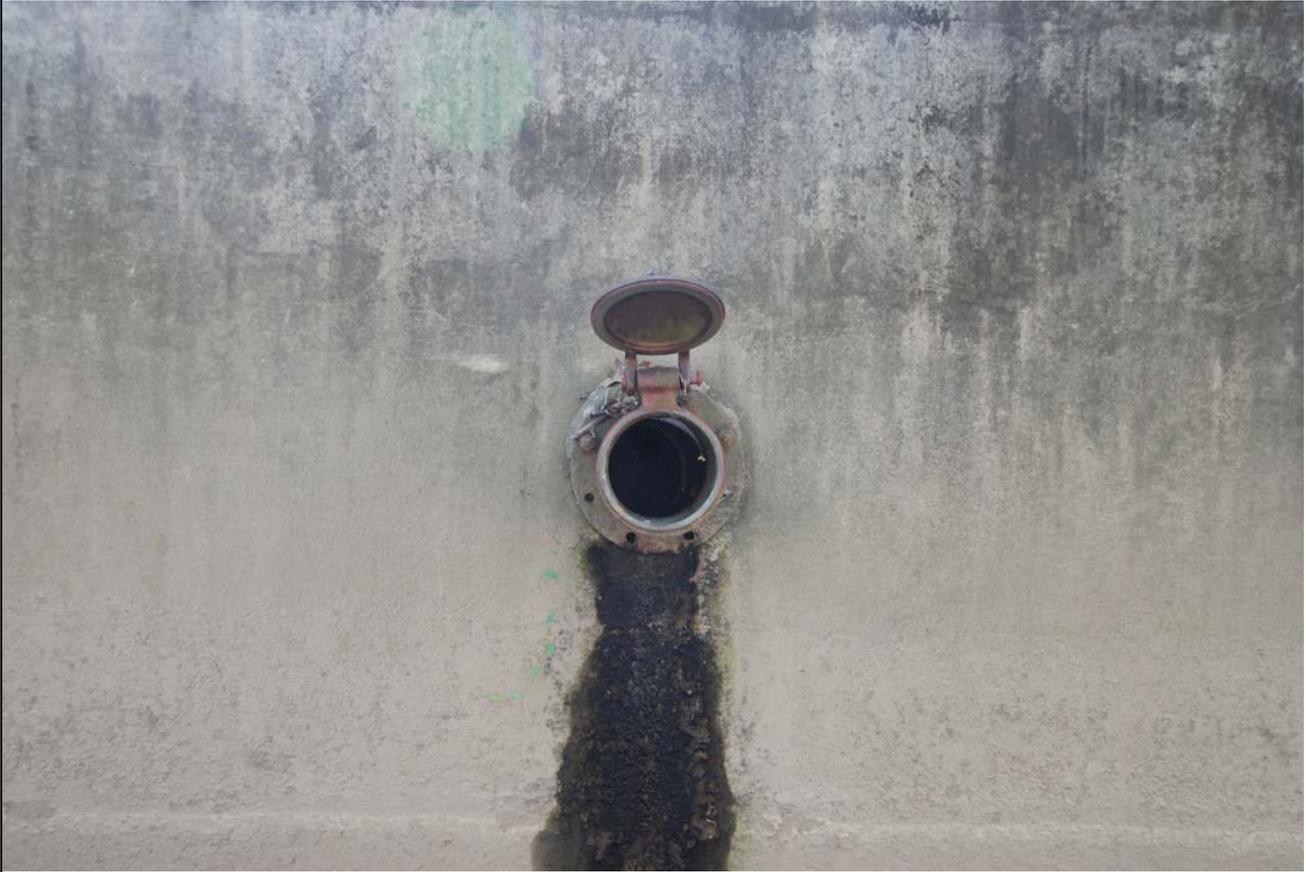
Inspect ID: NAR1_2010_a_0019 **Title:** USACE_CENAN_NAR1_2010_a_0019_2.jpg **Caption:** Undocumented drain pipe. 8" flap gate is very stiff and won't close on its own. Needs lubrication.

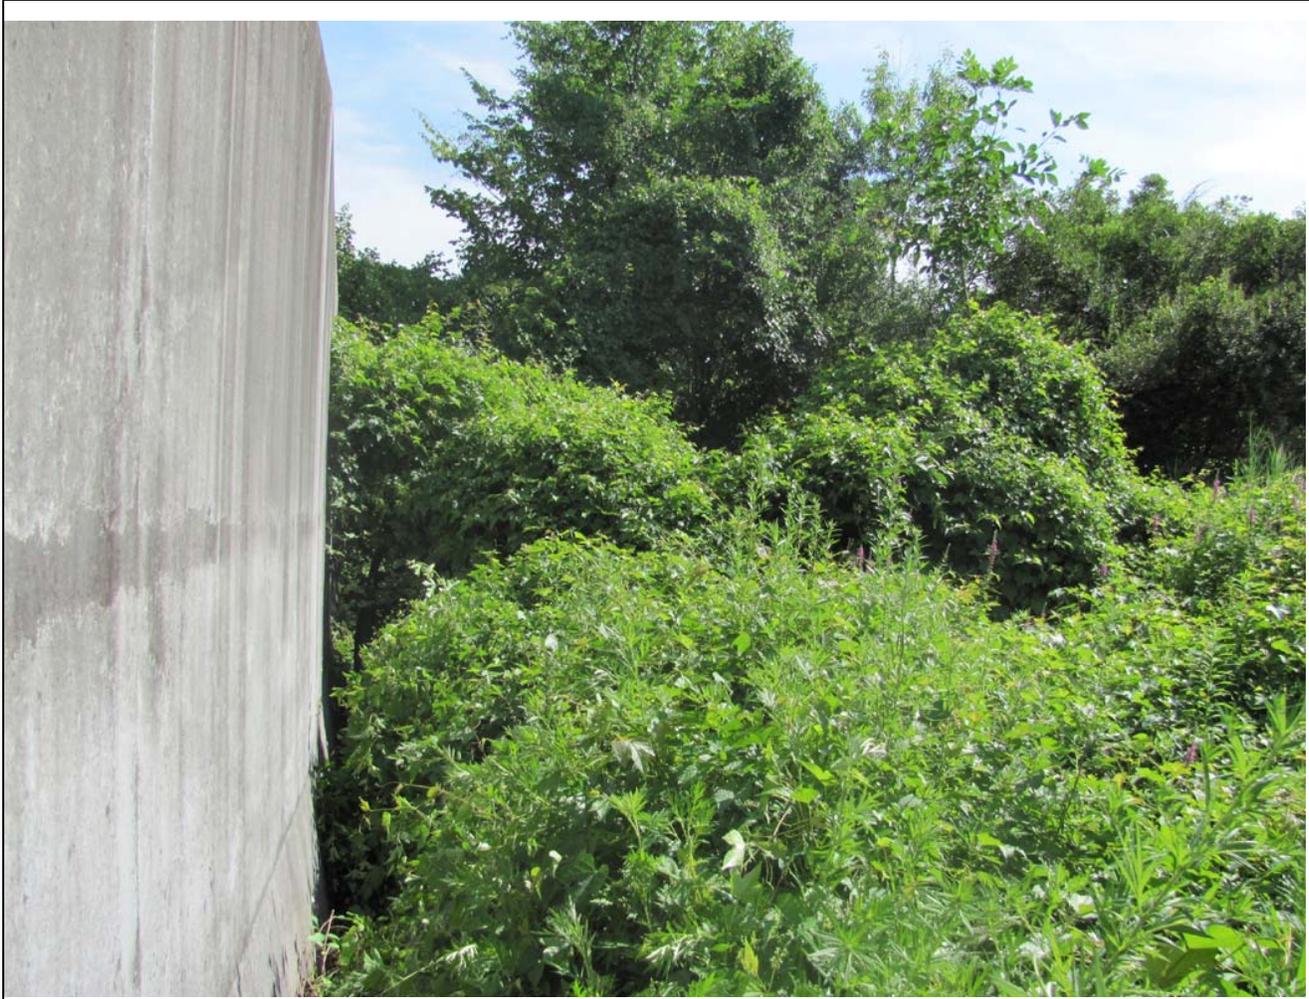
Inspect ID: NAR1_2010_a_0020 **Title:** USACE_CENAN_NAR1_2010_a_0020_1.jpg **Caption:** Thick vegetation encroachment along protected side of floodwall.

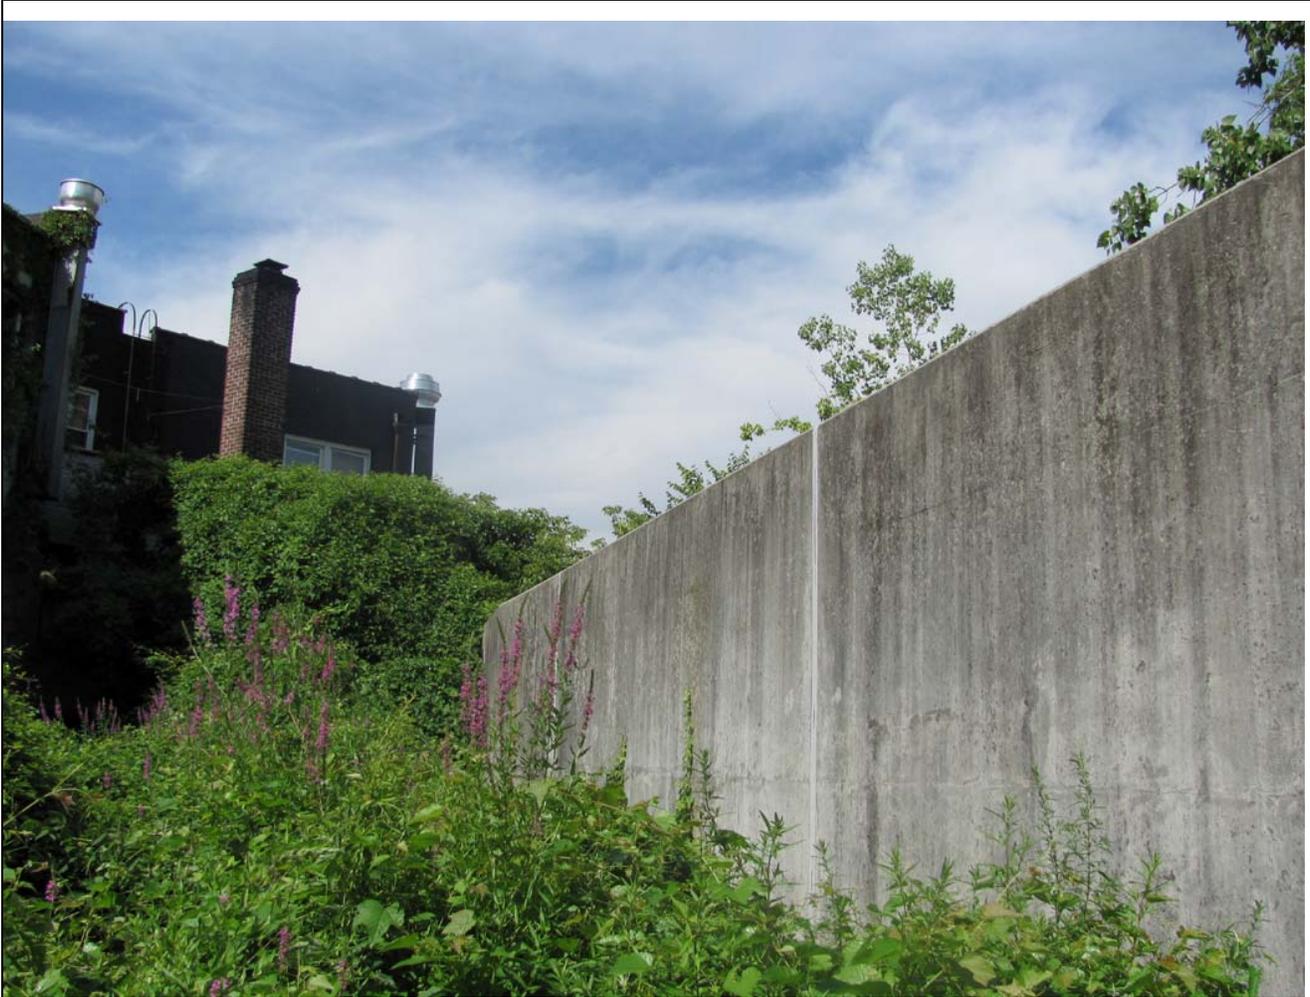
Inspect ID: NAR1_2010_a_0020 **Title:** USACE_CENAN_NAR1_2010_a_0020_2.jpg **Caption:** Thick vegetation encroachment along protected side of floodwall. South of this point the inspection team was unable to inspect the protected side of the floodwall because of the dense vegetation.

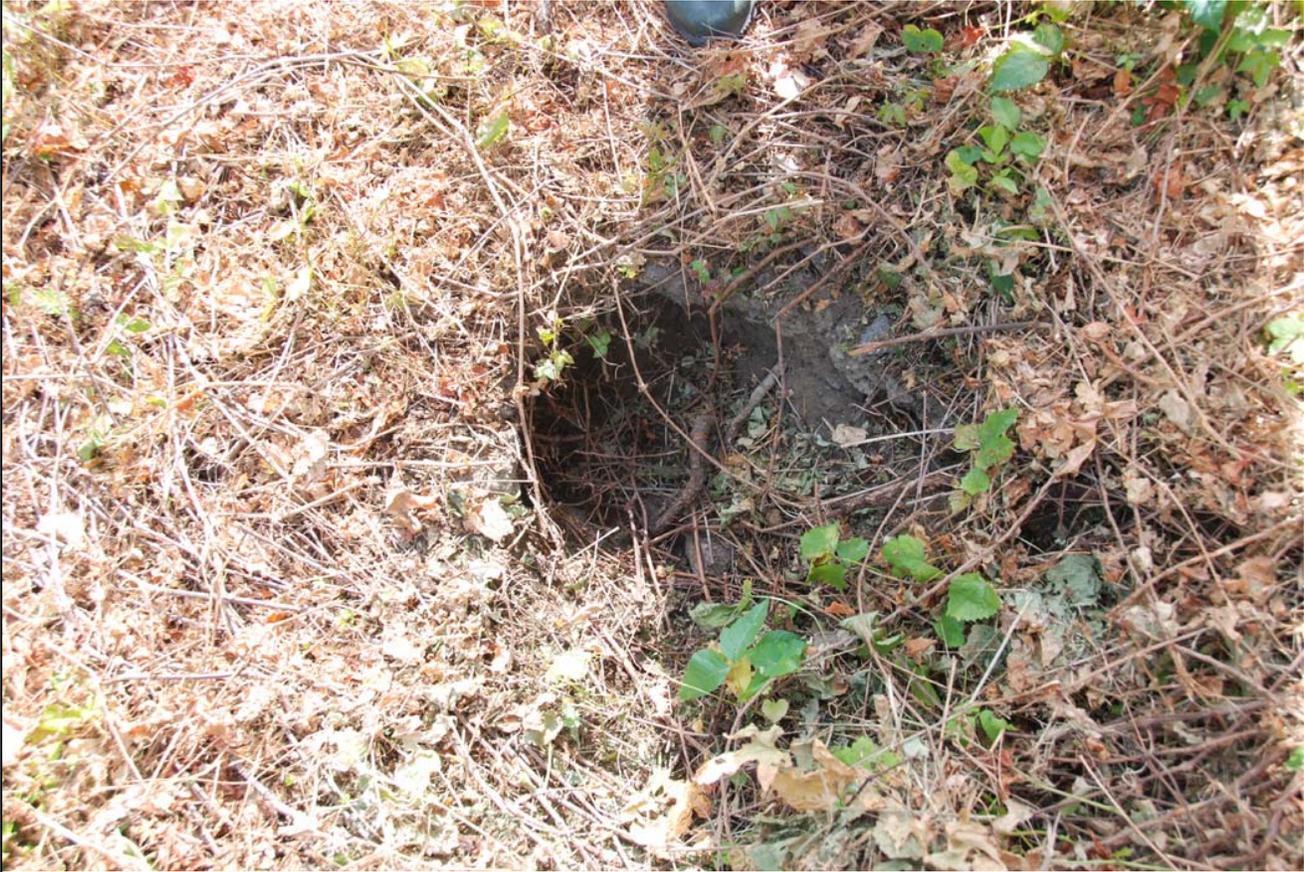
Inspect ID: NAR1_2010_a_0004 **Title:** USACE_CENAN_NAR1_2010_a_0004_1.jpg **Caption:** Animal burrow on the exposed side of the floodwall.

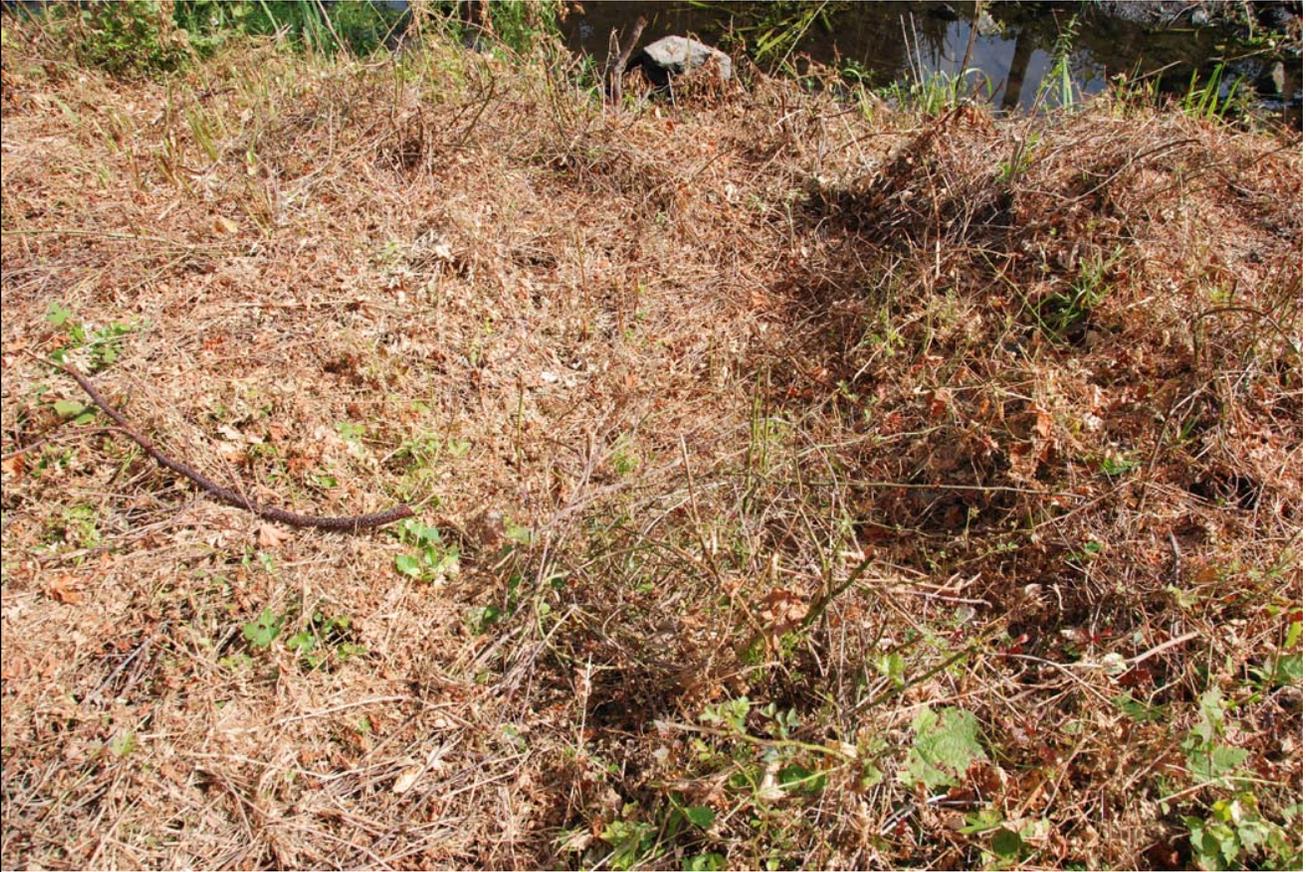
Inspect ID: NAR1_2010_a_0005 **Title:** USACE_CENAN_NAR1_2010_a_0005_1.jpg **Caption:** The embankment slope on the exposed side has a depression 5 ft. from floodwall, 6 ft. wide and 3 ft. deep. It may be the result of removing a tree.

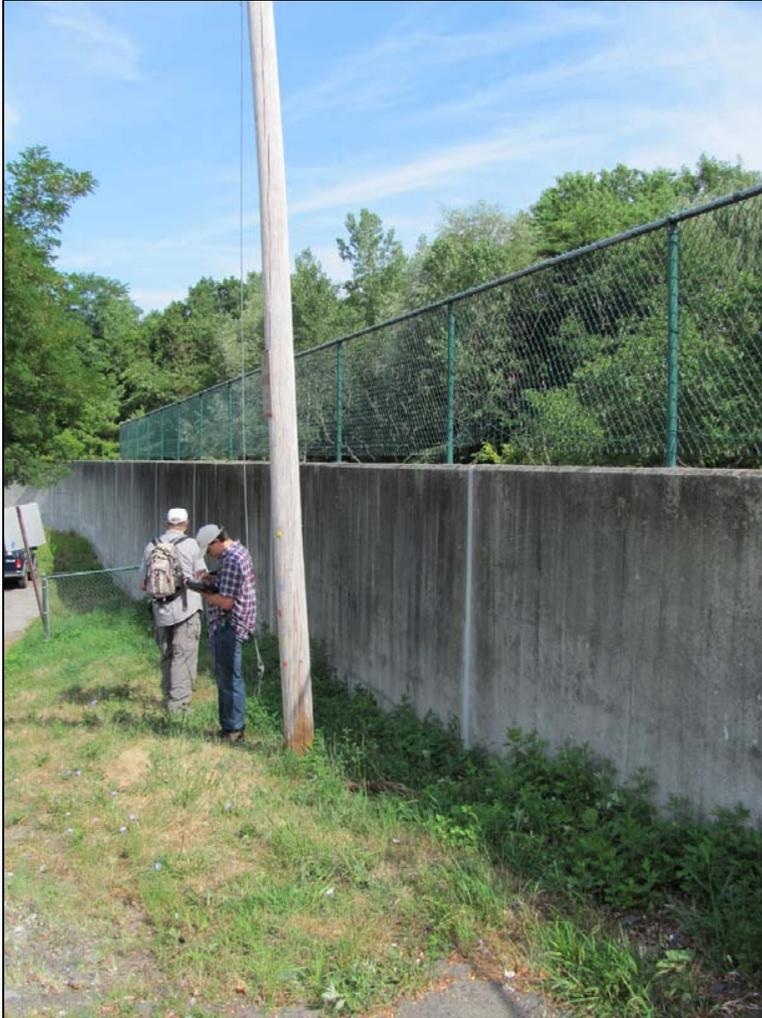
Inspect ID: NAR1_2010_a_0006 **Title:** USACE_CENAN_NAR1_2010_a_0006_1.jpg **Caption:** Utility pole within 4 ft. of the floodwall on the protected side.

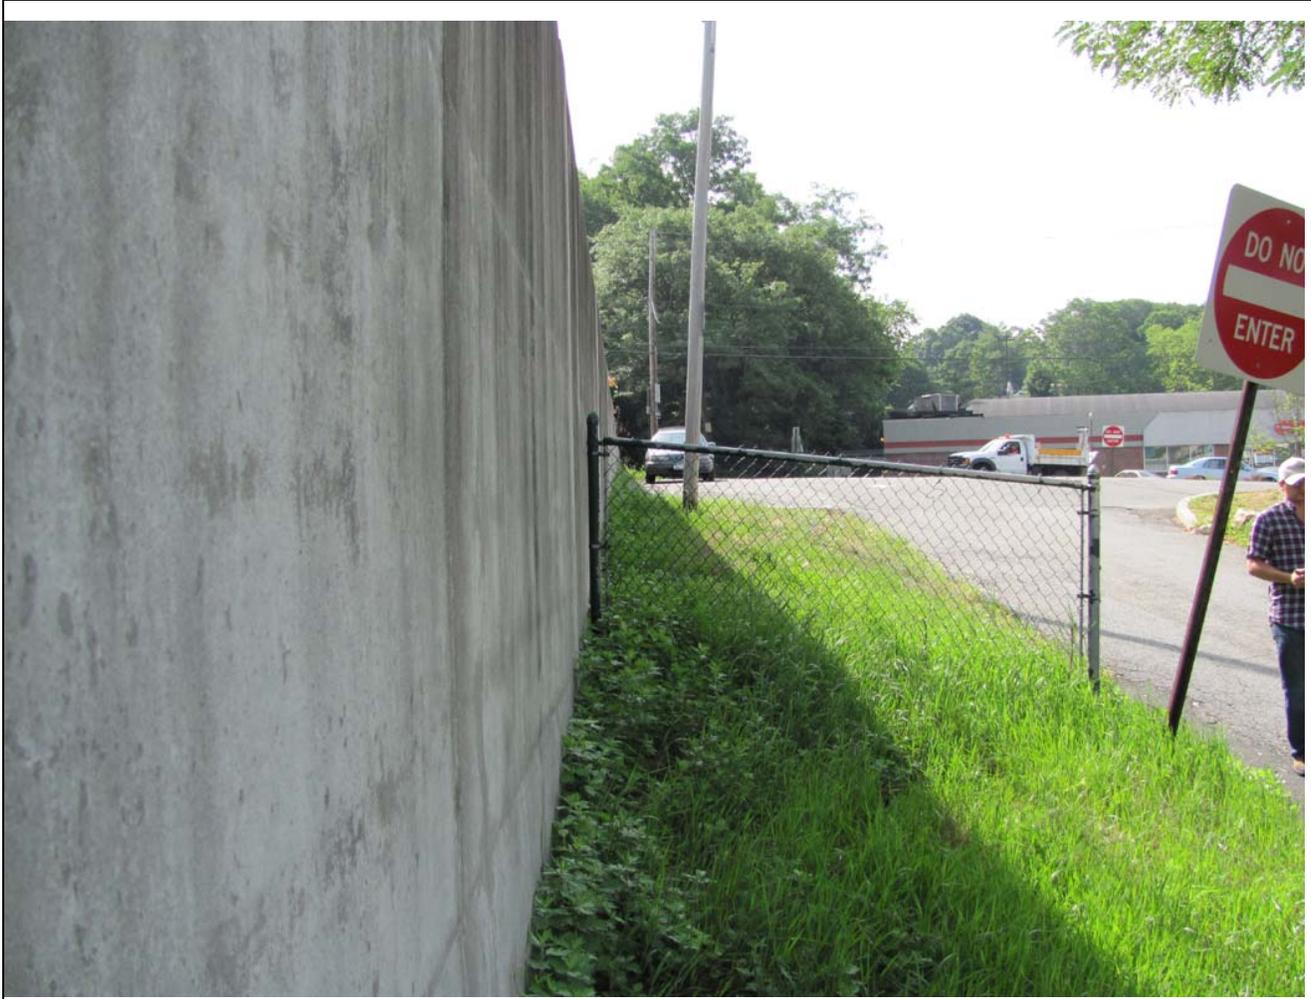
Inspect ID: NAR1_2010_a_0007 **Title:** USACE_CENAN_NAR1_2010_a_0007_1.jpg **Caption:** Chain link fence encroaching on the protected side of the floodwall. Extends 6 ft. out from the floodwall.

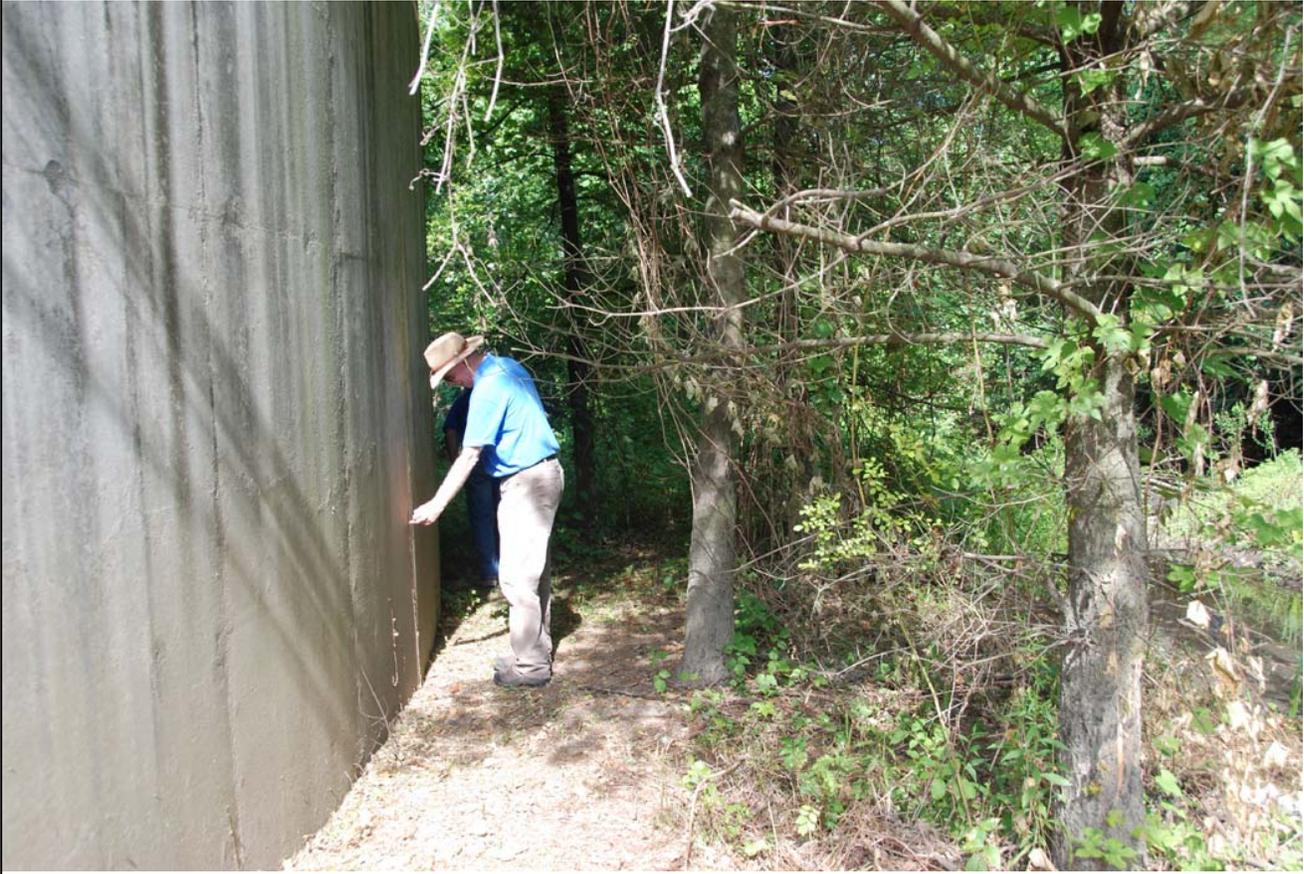
Inspect ID: NAR1_2010_a_0008 **Title:** USACE_CENAN_NAR1_2010_a_0008_1.jpg **Caption:** Near the west end of the blow-off channel there are large trees growing within 15 ft of the exposed side of the floodwall.

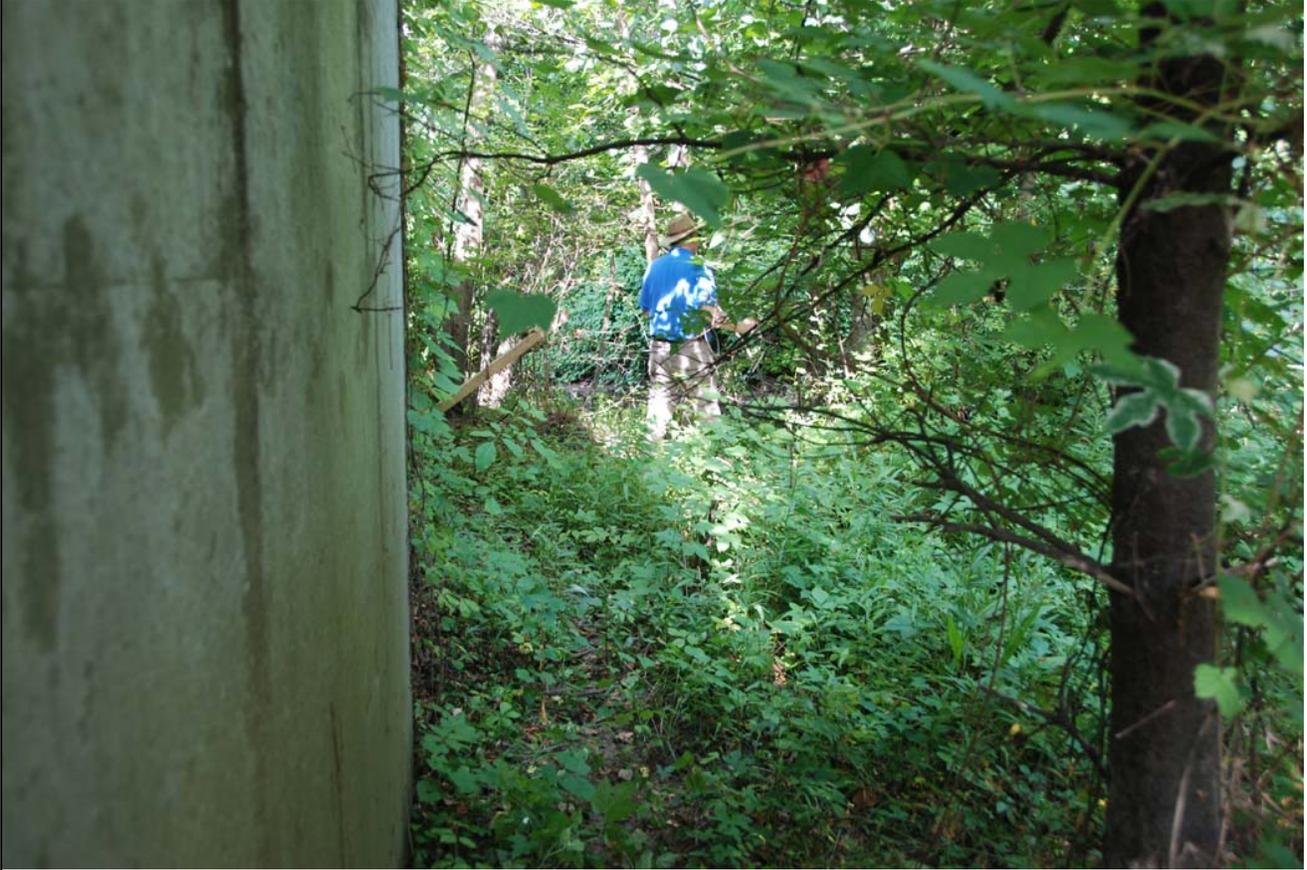
Inspect ID: NAR1_2010_a_0009 **Title:** USACE_CENAN_NAR1_2010_a_0009_1.jpg **Caption:** Adjacent to the Saw Mill River dense vegetation and trees are growing within 15 ft of the exposed side of the floodwall. Trees here range from 5 to 30 ft. in height.
