ARDSLEY

FLOOD RISK MANAGEMENT PROJECT

*FLOODWALLS, INTERIOR DRAINAGE SYSTEM AND FLOOD DAMAGE
REDUCTION CHANNEL*

2010 PERIODIC INSPECTION REPORT No.1

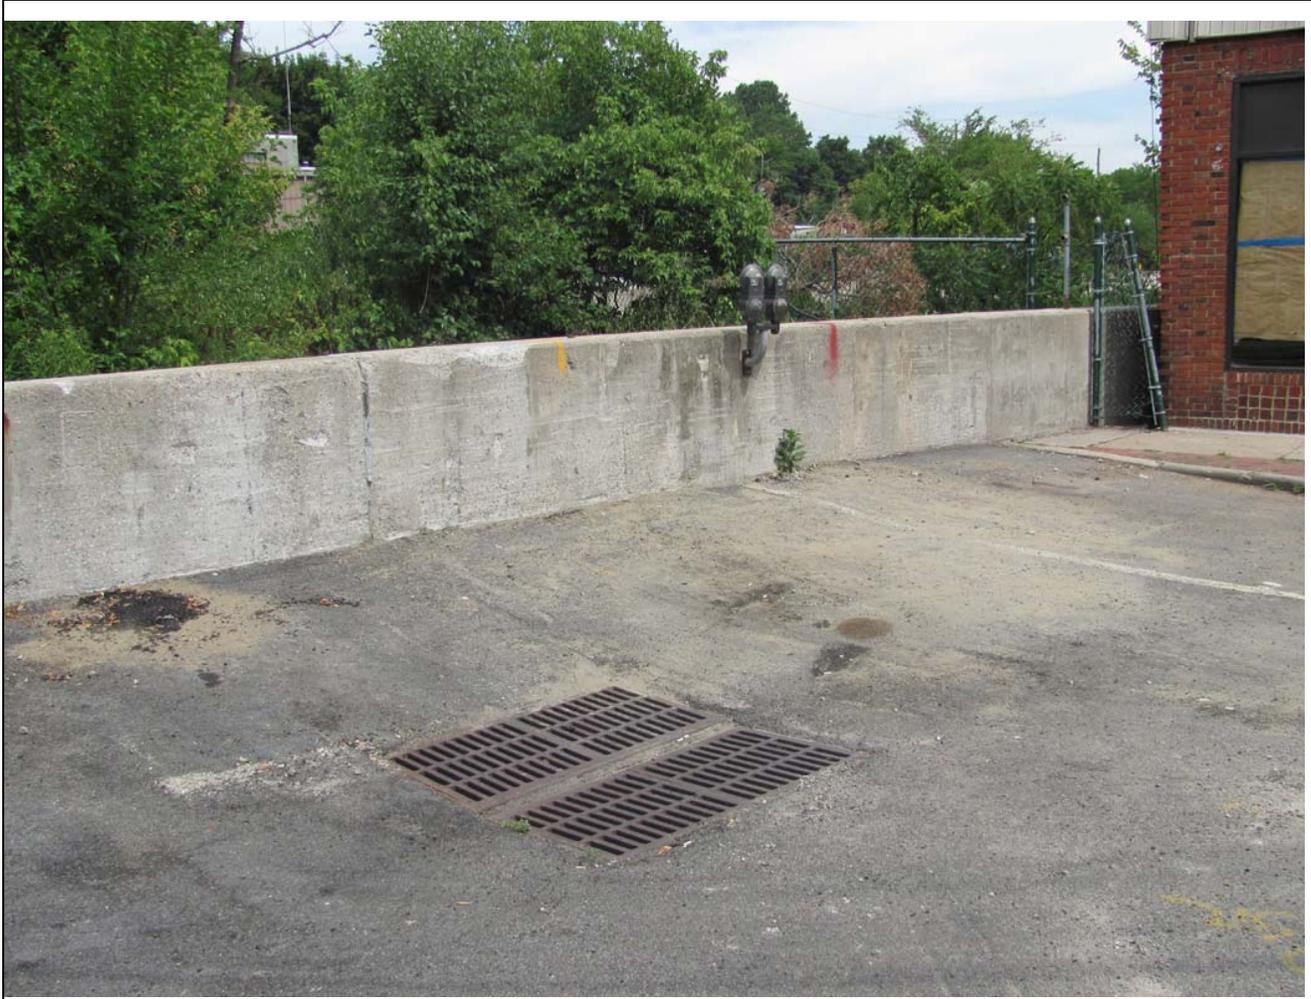
Inspect ID: NAR1_2010_a_0021 **Title:** USACE_CENAN_NAR1_2010_a_0021_2.jpg **Caption:** Drainage at Ardsley Square may not be properly abandoned.

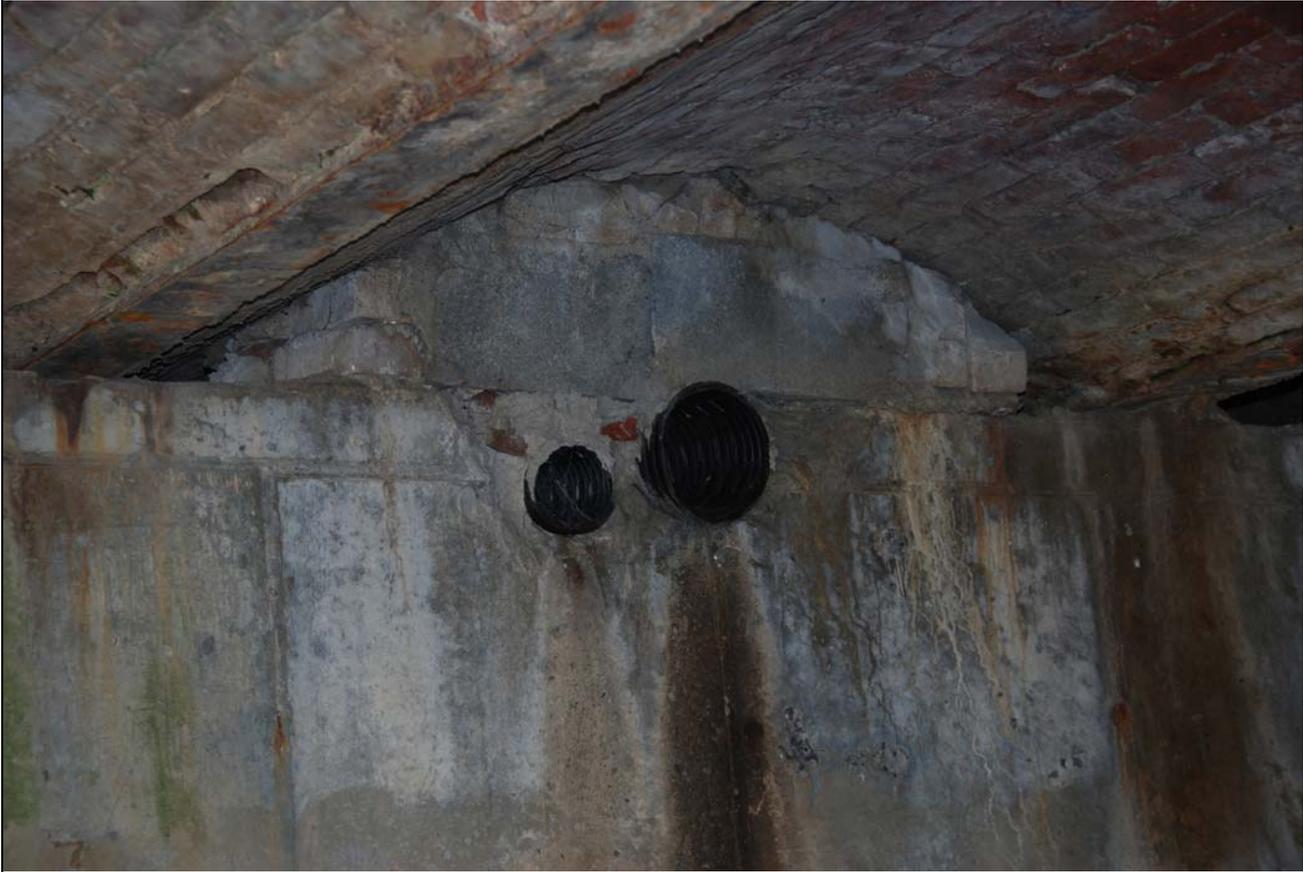
Inspect ID: NAR1_2010_a_0021 **Title:** USACE_CENAN_NAR1_2010_a_0021_1.jpg **Caption:** Two new corrugated ADS drain pipes (8" & 4") at top of the old Ardsley bridge abutment. These drains may be on the as-built drawings (see sheet CC-ARD-417).

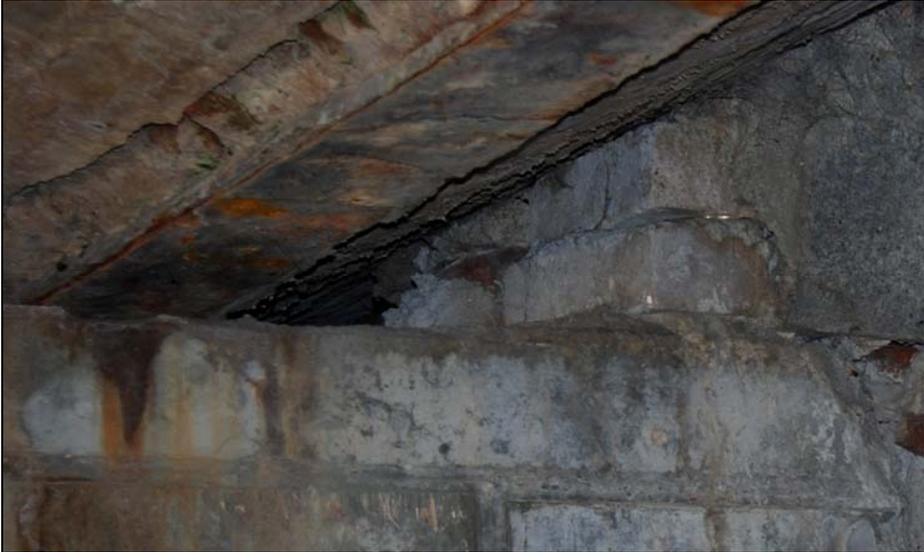
Inspect ID: NAR1_2010_a_0022 **Title:** USACE_CENAN_NAR1_2010_a_0022_1.jpg **Caption:** Gap between arched superstructure of Old Ashford Avenue Bridge deck and top of floodwall.

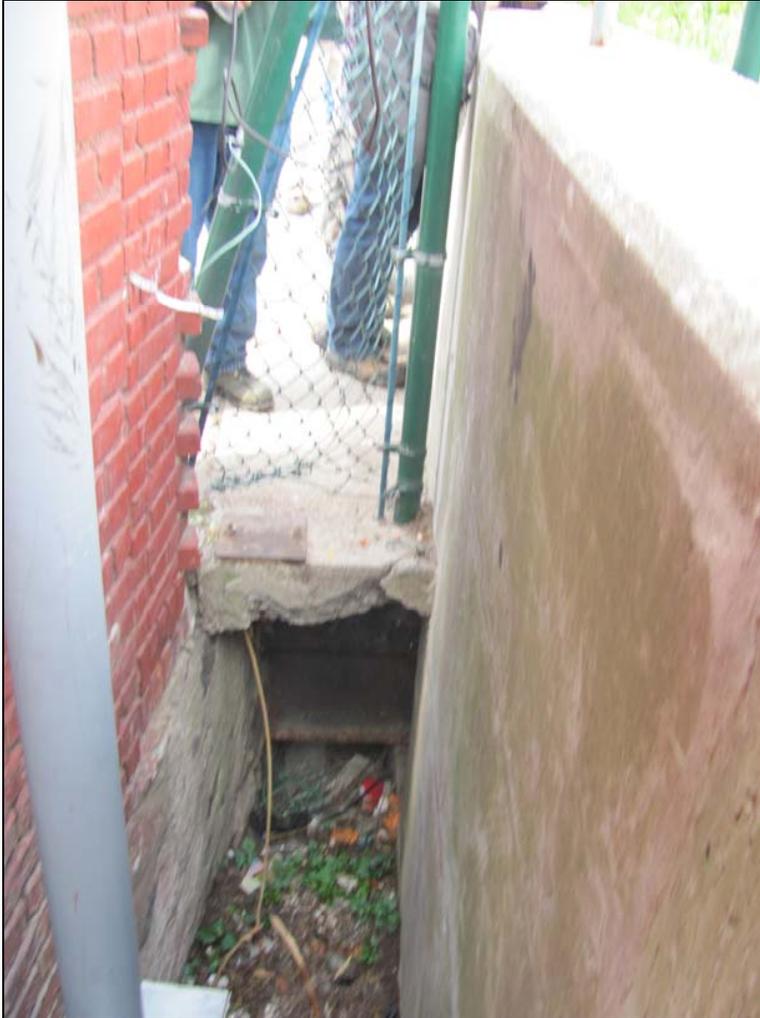
Inspect ID: NAR1_2010_a_0022 **Title:** USACE_CENAN_NAR1_2010_a_0022_2.jpg **Caption:** Void beneath horizontal steel supporting the Old Ashford Avenue Bridge, Potential connection to voids between top of floodwall and brick arch in bridge.

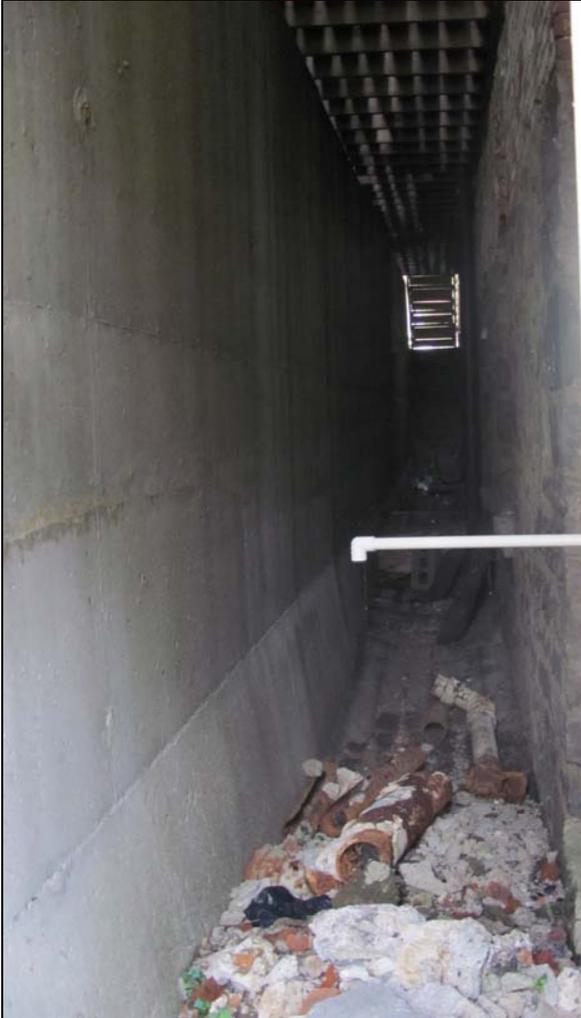
Inspect ID: NAR1_2010_a_0022 **Title:** USACE_CENAN_NAR1_2010_a_0022_3.jpg **Caption:** View from ponding area #1 northward under wood walkway looking towards Ardsley Square. Potential connection to voids between top of floodwall and brick arch in bridge.

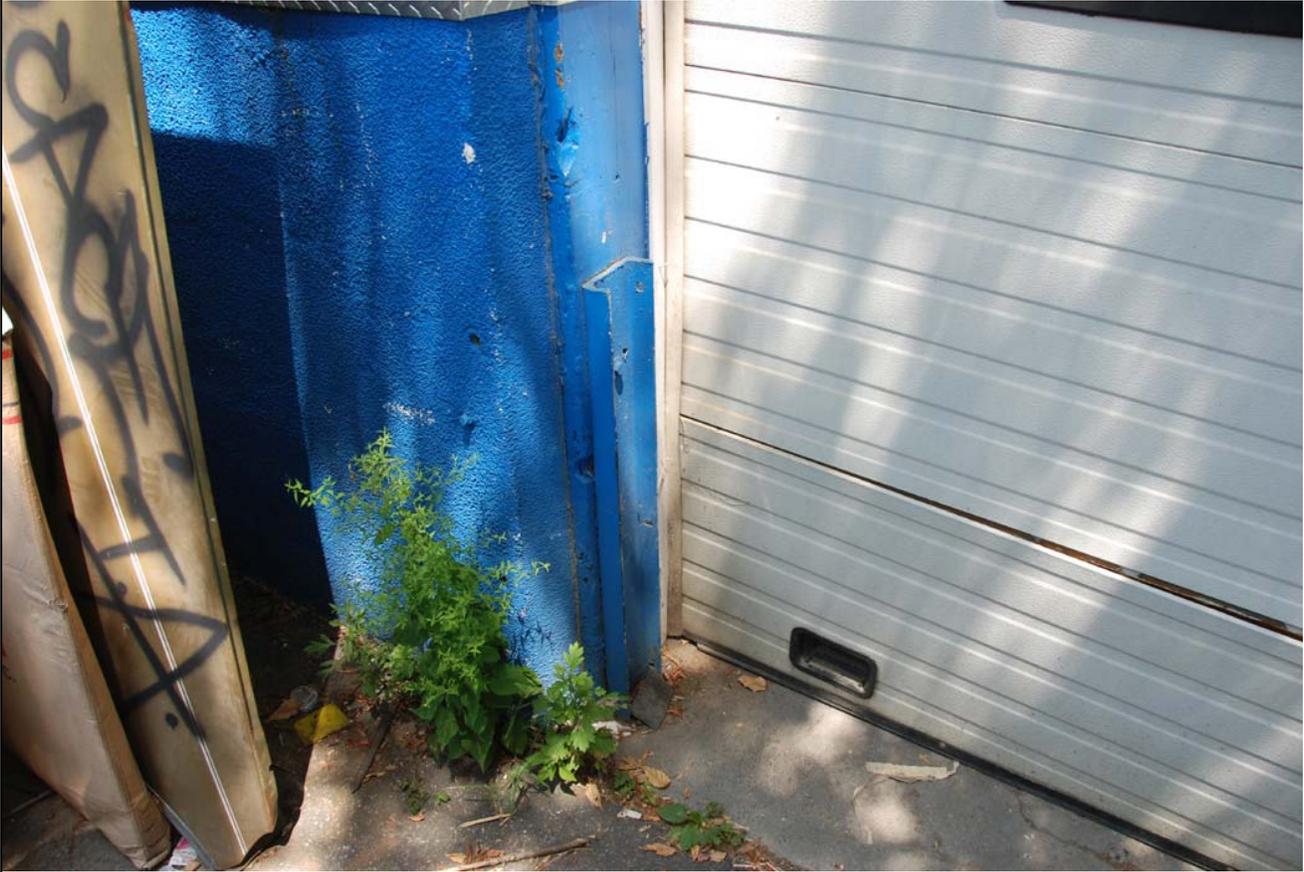
Inspect ID: NAR1_2010_a_0058 **Title:** USACE_CENAN_NAR1_2010_a_0058_2.jpg **Caption:** Building #4: remains of channel to receive stop logs.

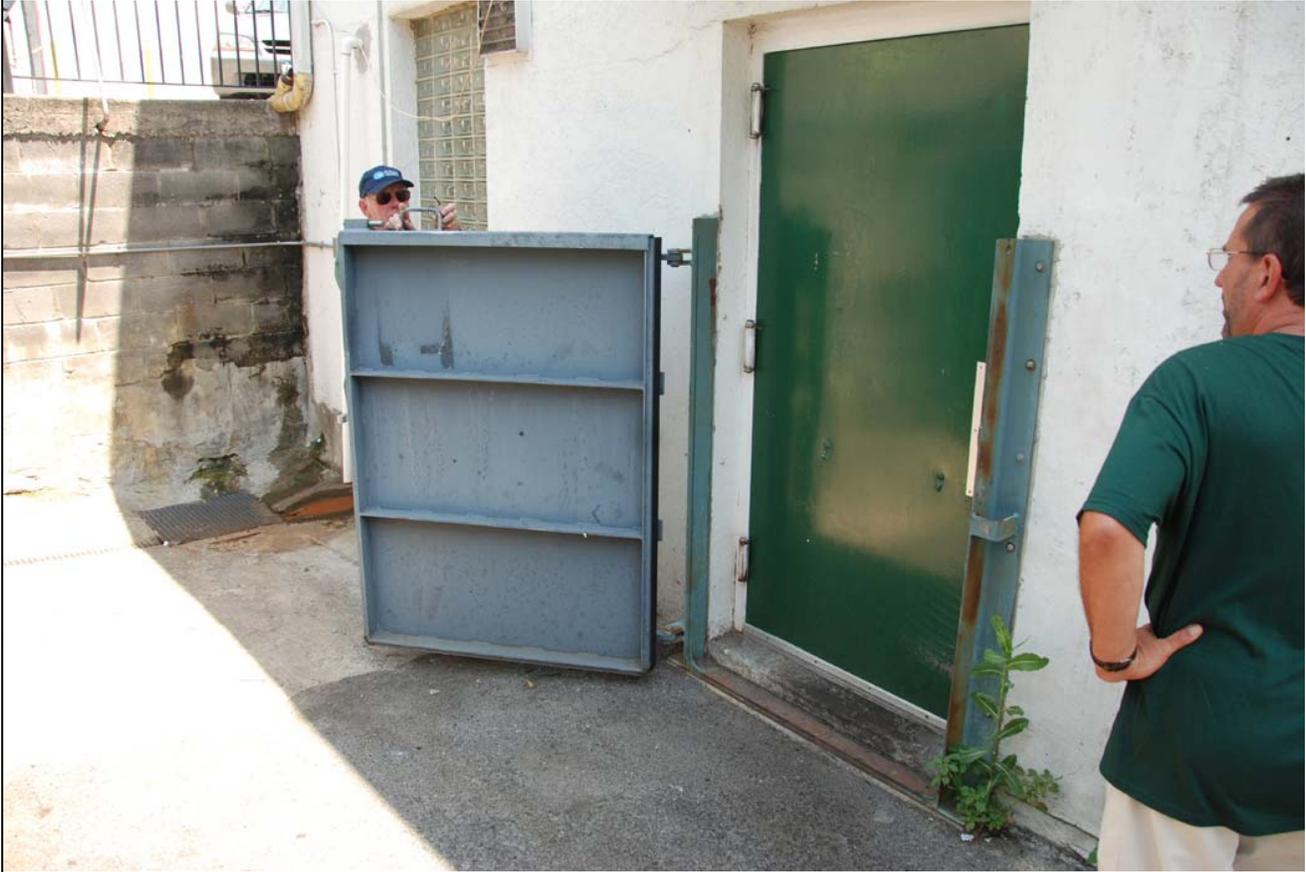
Inspect ID: NAR1_2010_a_0062 **Title:** USACE_CENAN_NAR1_2010_a_0062_1.jpg **Caption:** Building #1 with flood shield installed protecting door.

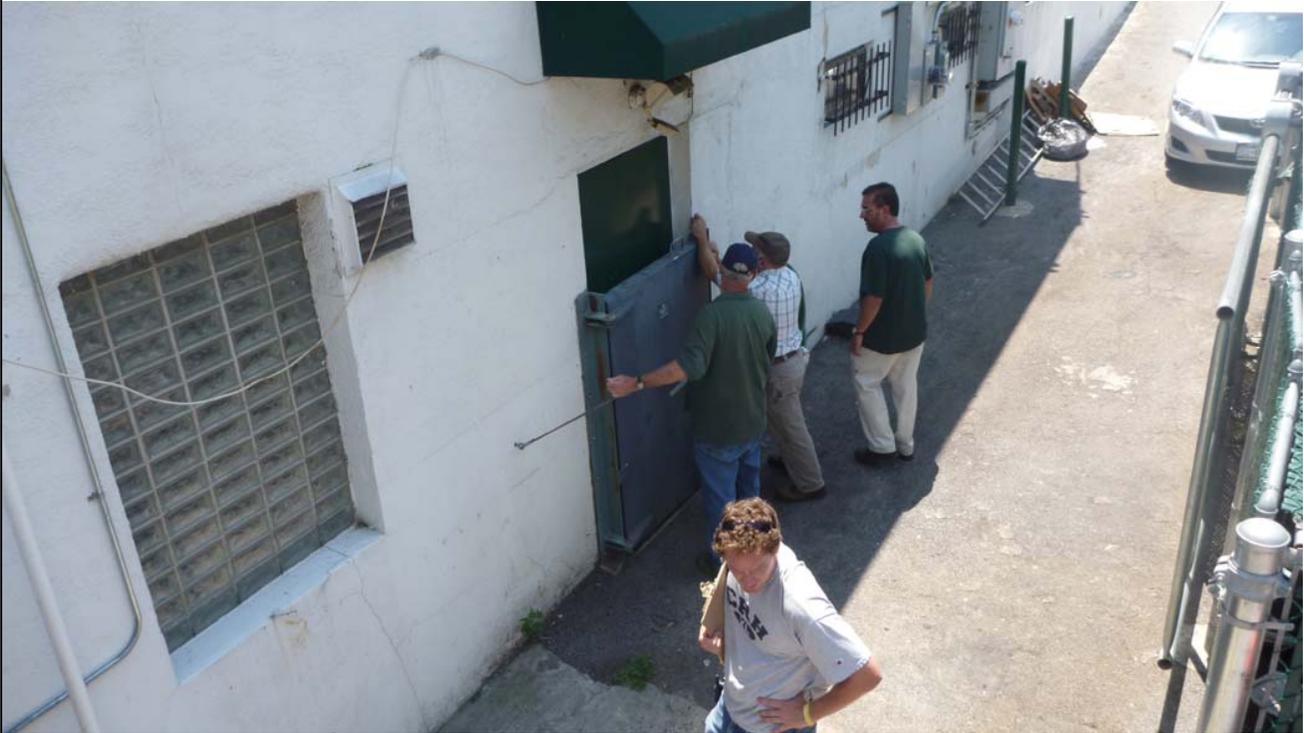
Inspect ID: NAR1_2010_a_0062 **Title:** USACE_CENAN_NAR1_2010_a_0062_2.jpg **Caption:** Building # 1 flood shield door protection and glazed window blocks.

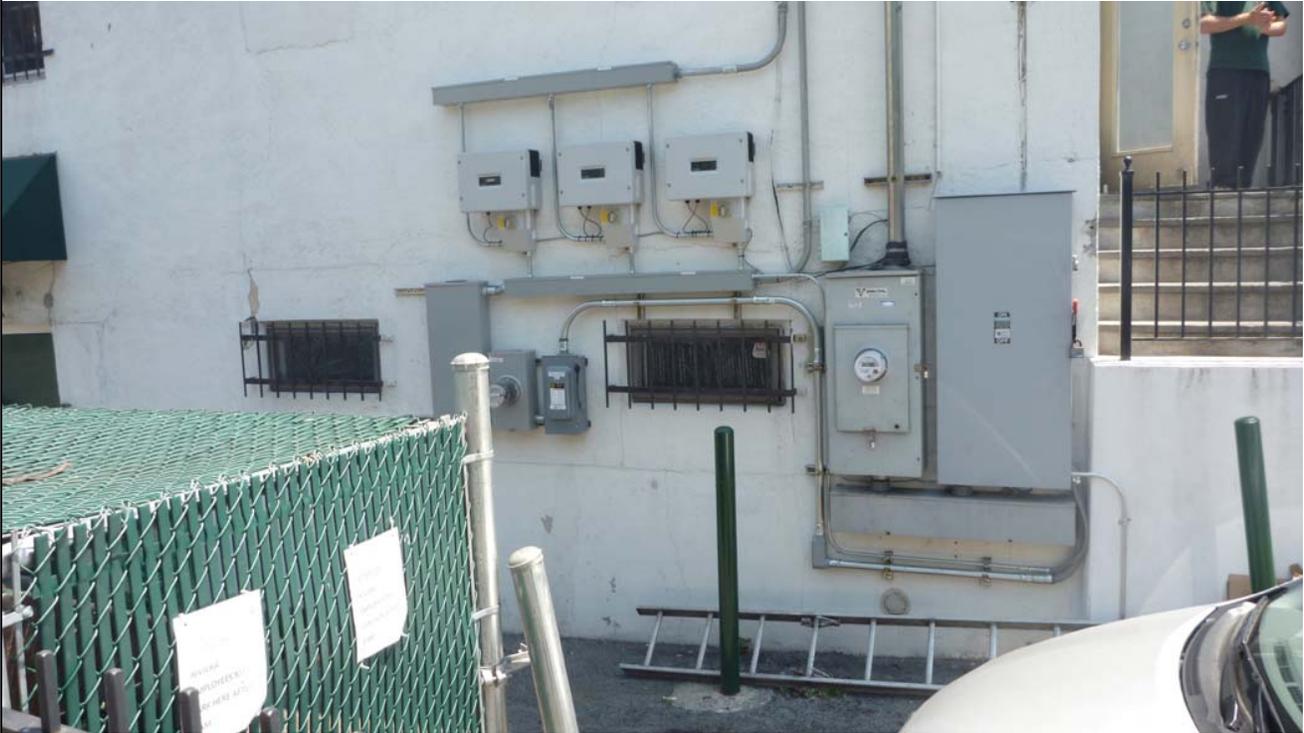
Inspect ID: NAR1_2010_a_0063 **Title:** USACE_CENAN_NAR1_2010_a_0063_1.jpg **Caption:** Electric service not above elevation of flood protection. The level of flood protection is about 6-8 inches below the top of the wall at the right side of the photo.

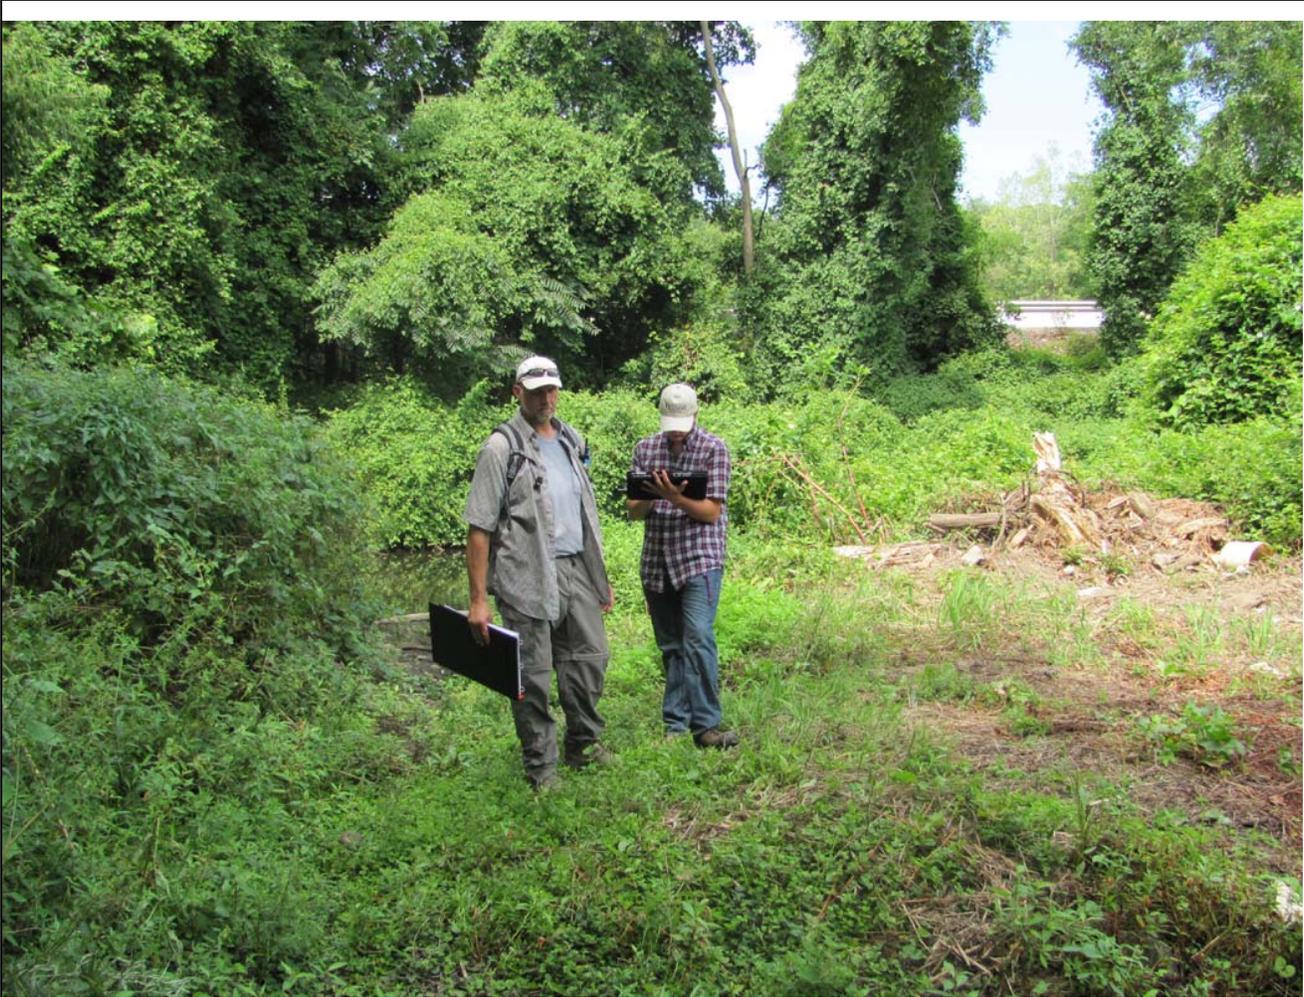
Inspect ID: NAR1_2010_a_0040 **Title:** USACE_CENAN_NAR1_2010_a_0040_1.jpg **Caption:** Interceptor ditch #1 appears to have been filled.

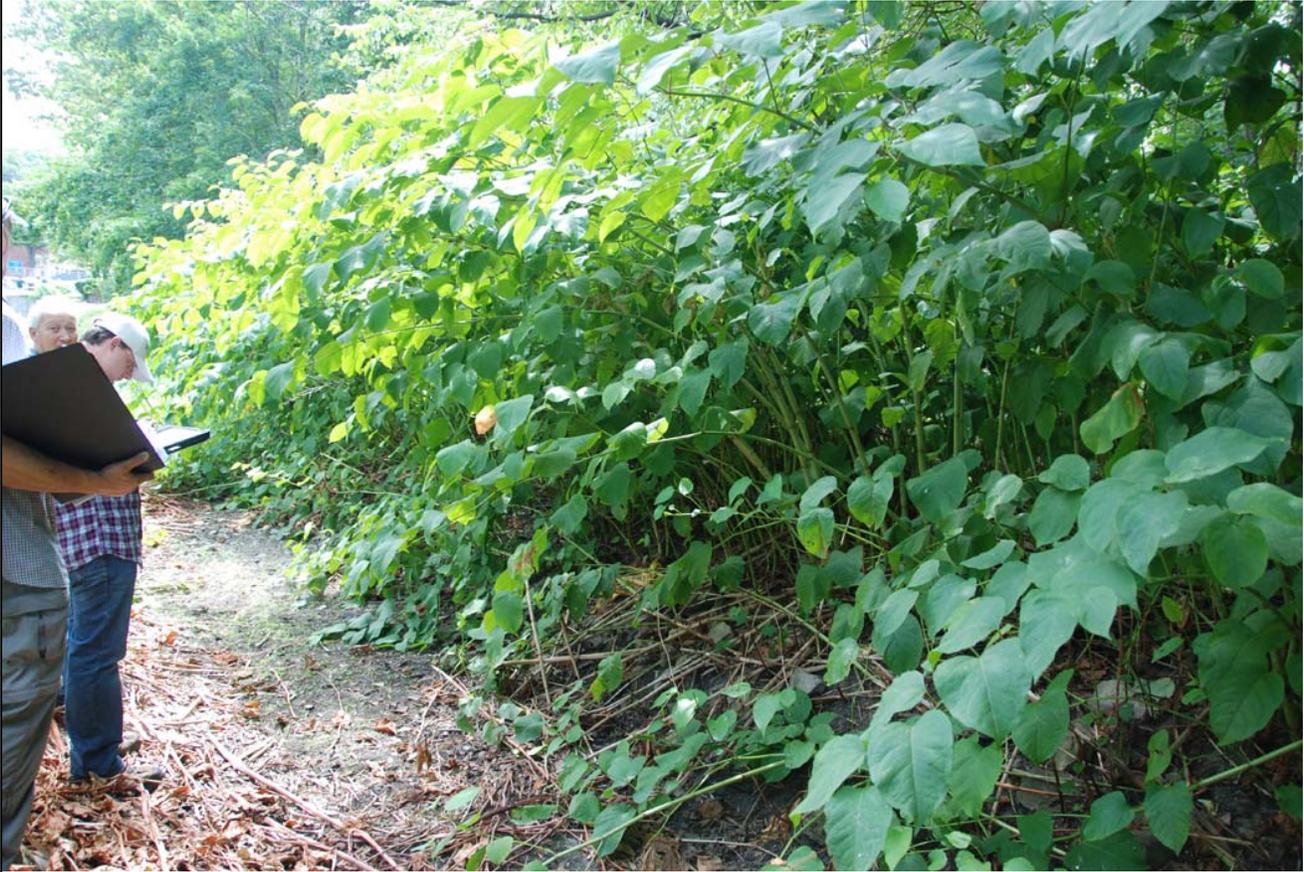
Inspect ID: NAR1_2010_a_0042 **Title:** USACE_CENAN_NAR1_2010_a_0042_1.jpg **Caption:** Vegetation encroachment along interceptor ditch #1.

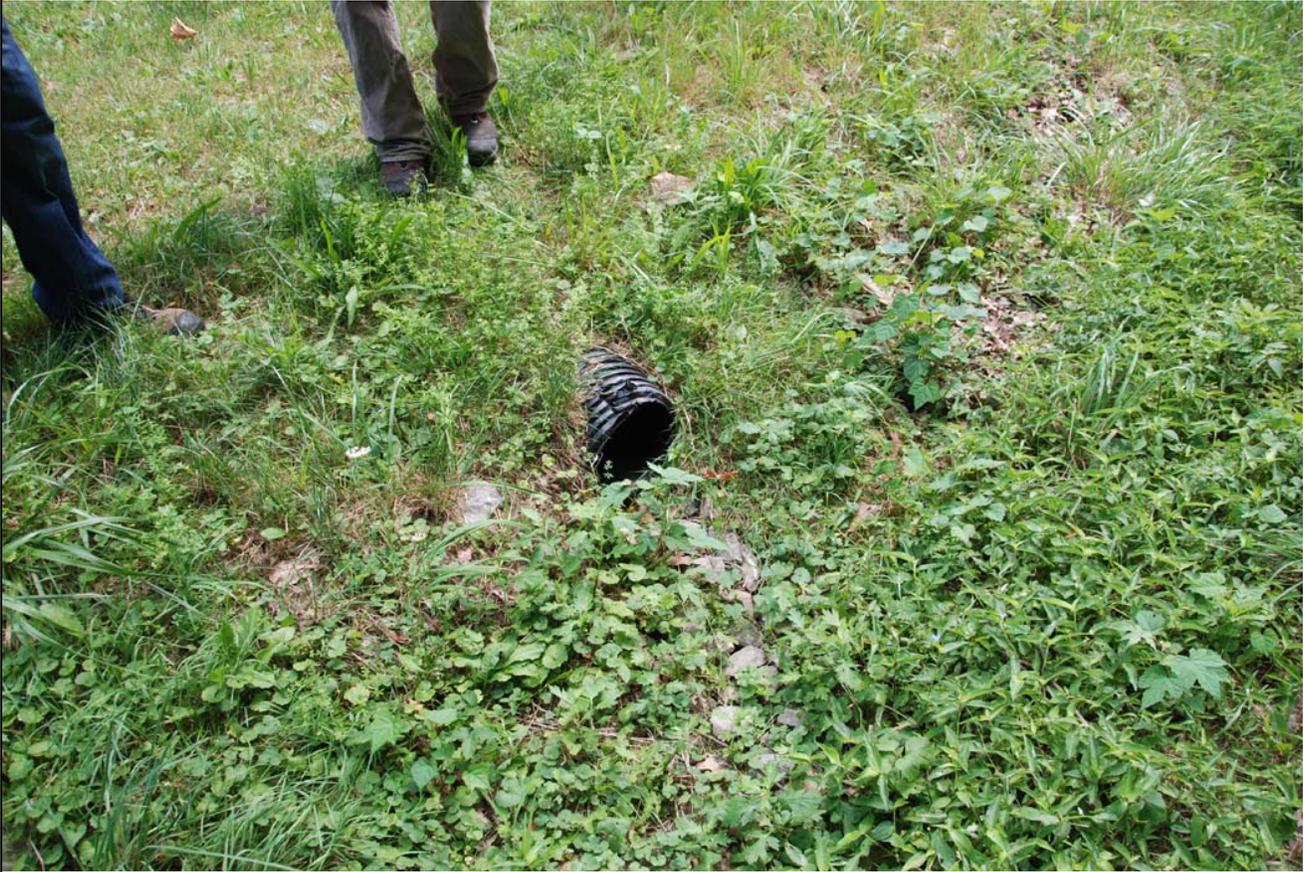
Inspect ID: NAR1_2010_a_0043 **Title:** USACE_CENAN_NAR1_2010_a_0043_1.jpg **Caption:** Encroachment - ADS drainage pipe discharging into interceptor ditch #1.

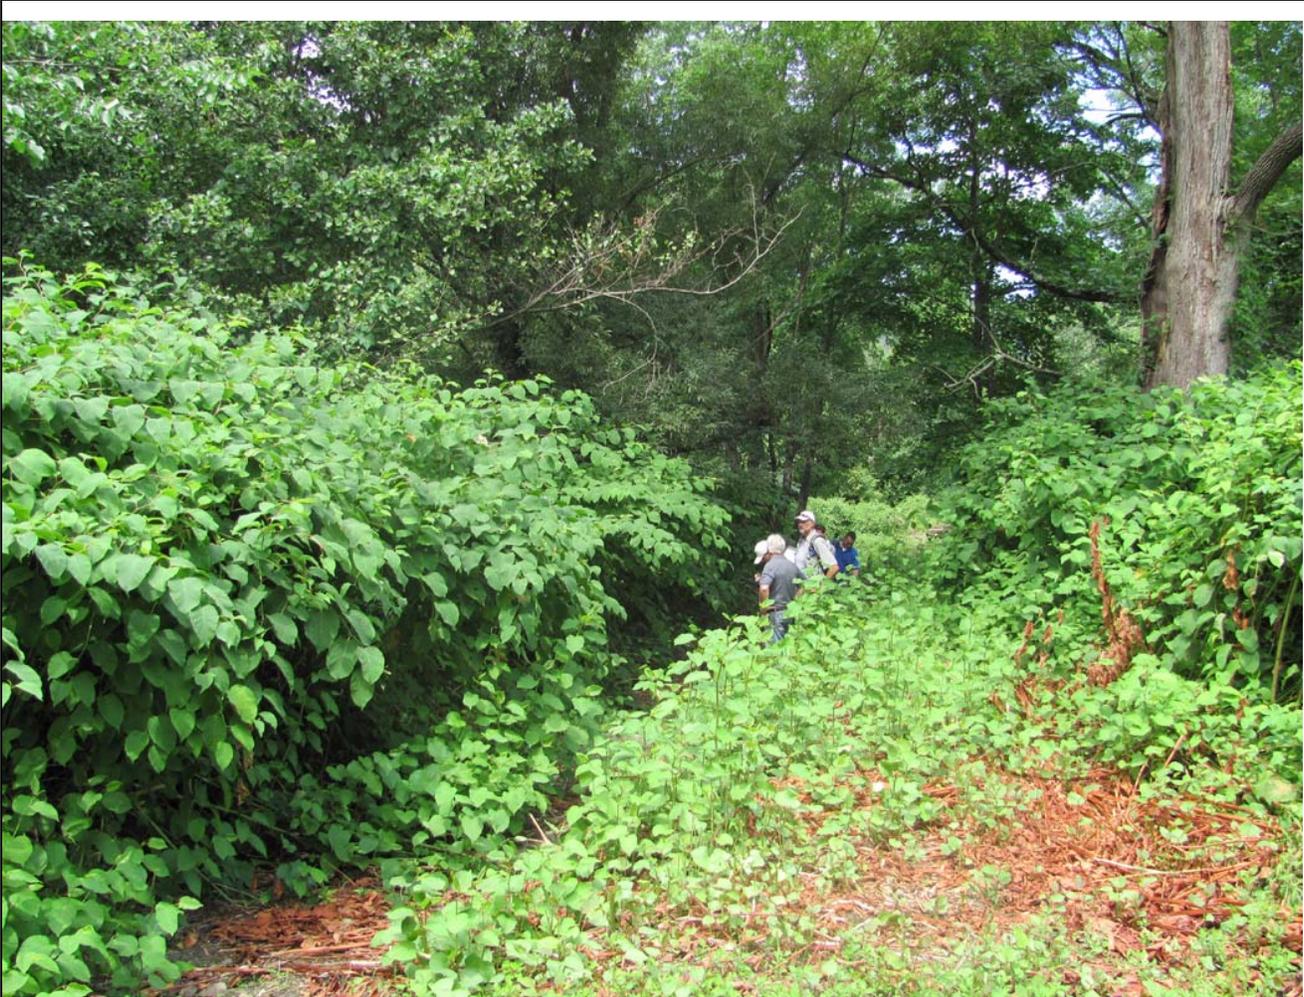
Inspect ID: NAR1_2010_a_0044 **Title:** USACE_CENAN_NAR1_2010_a_0044_2.jpg **Caption:** Sedimentation and vegetation in interceptor ditch #1 that could impede flow.

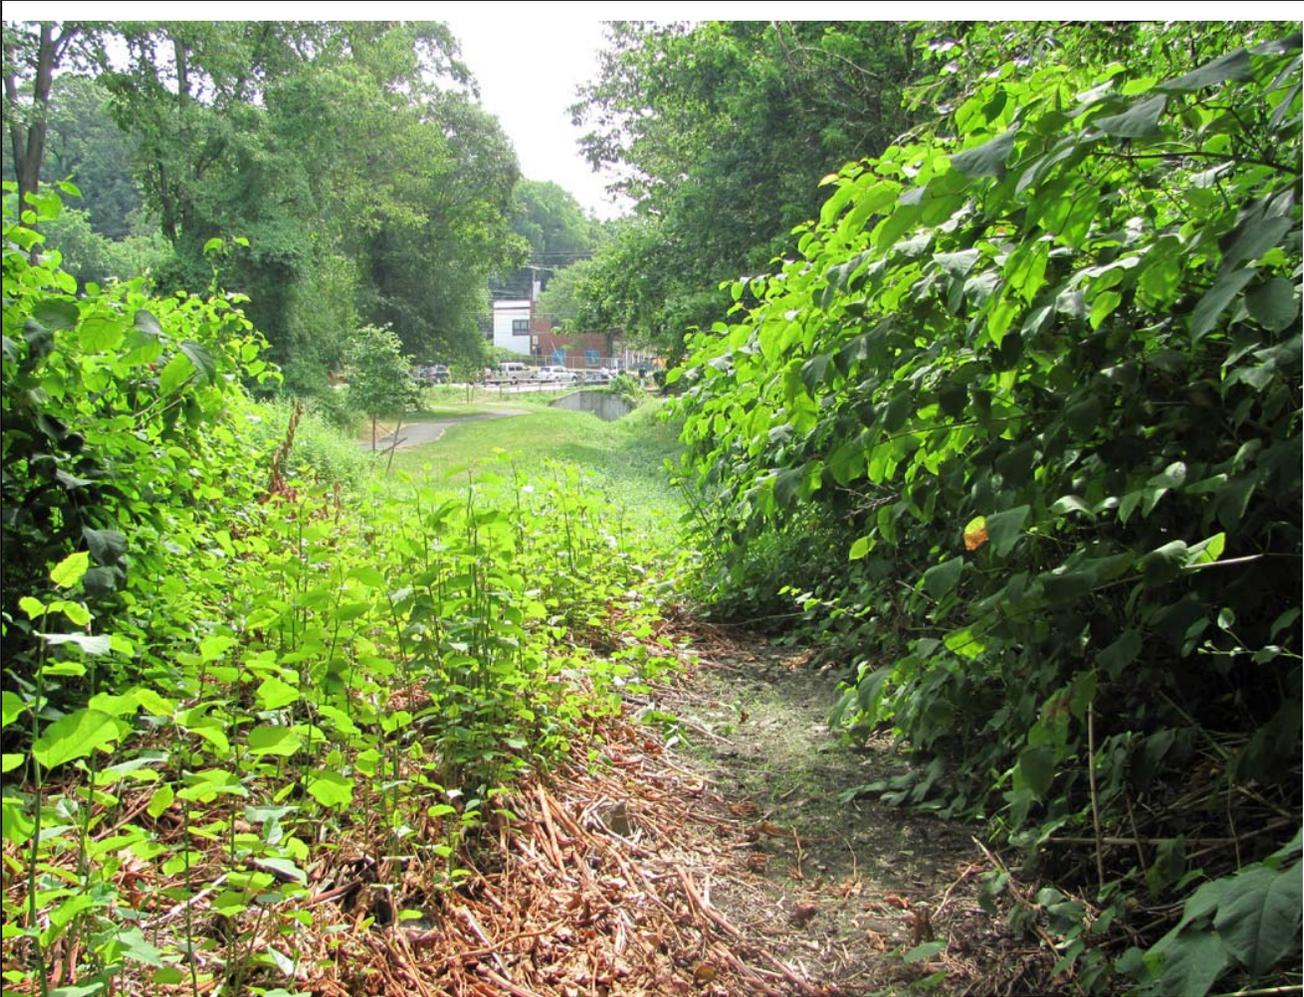
Inspect ID: NAR1_2010_a_0044 **Title:** USACE_CENAN_NAR1_2010_a_0044_1.jpg **Caption:** Sedimentation and vegetation in interceptor ditch #1 that could impede flow.

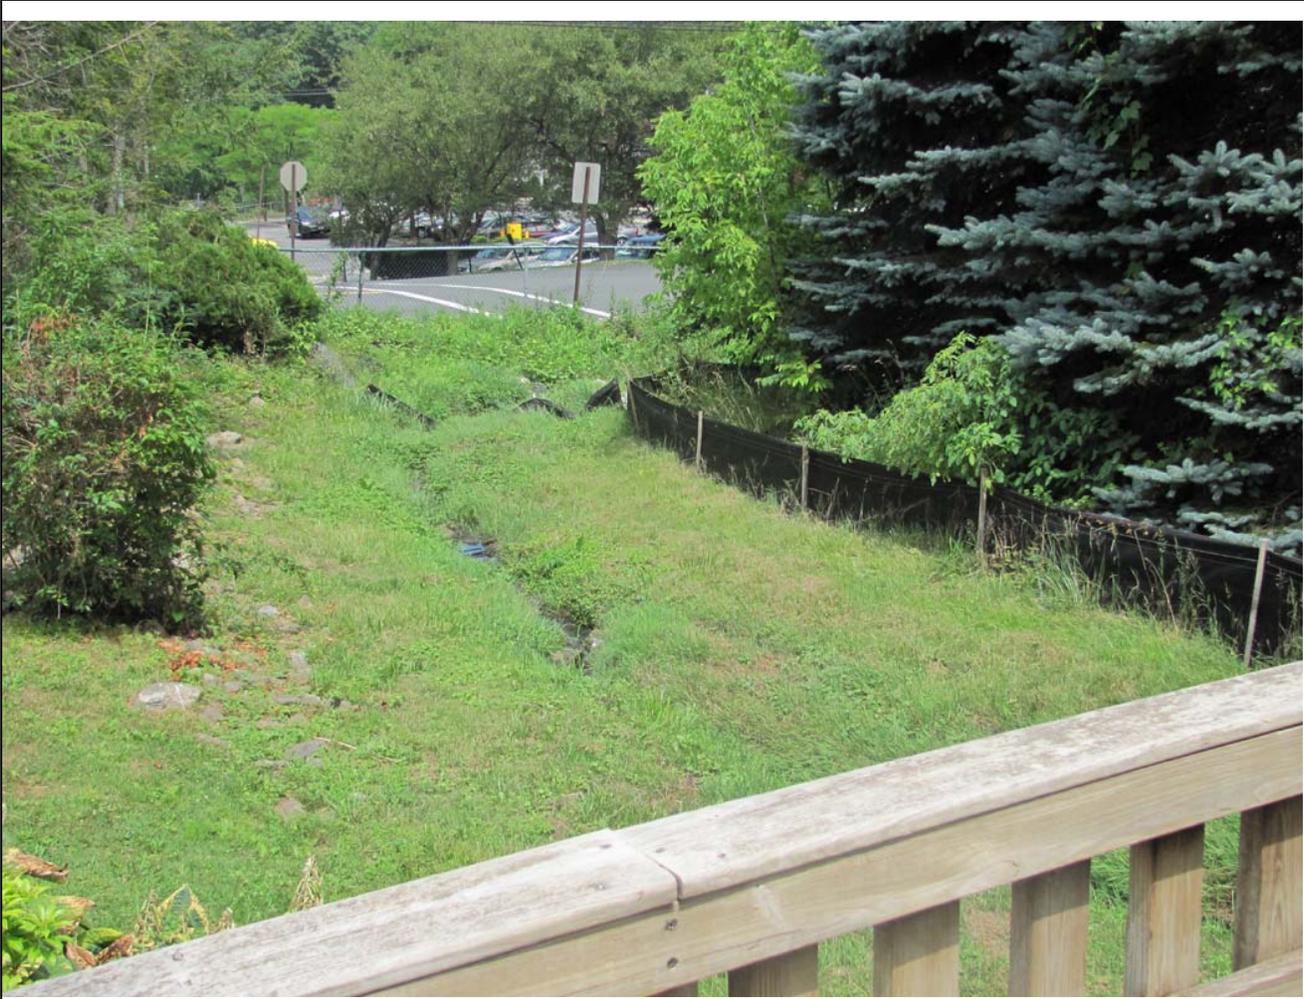
Inspect ID: NAR1_2010_a_0046 **Title:** USACE_CENAN_NAR1_2010_a_0046_1.jpg **Caption:** Sediment and vegetation partially blocking flow in interceptor ditch #2, just west of American Legion Drive.

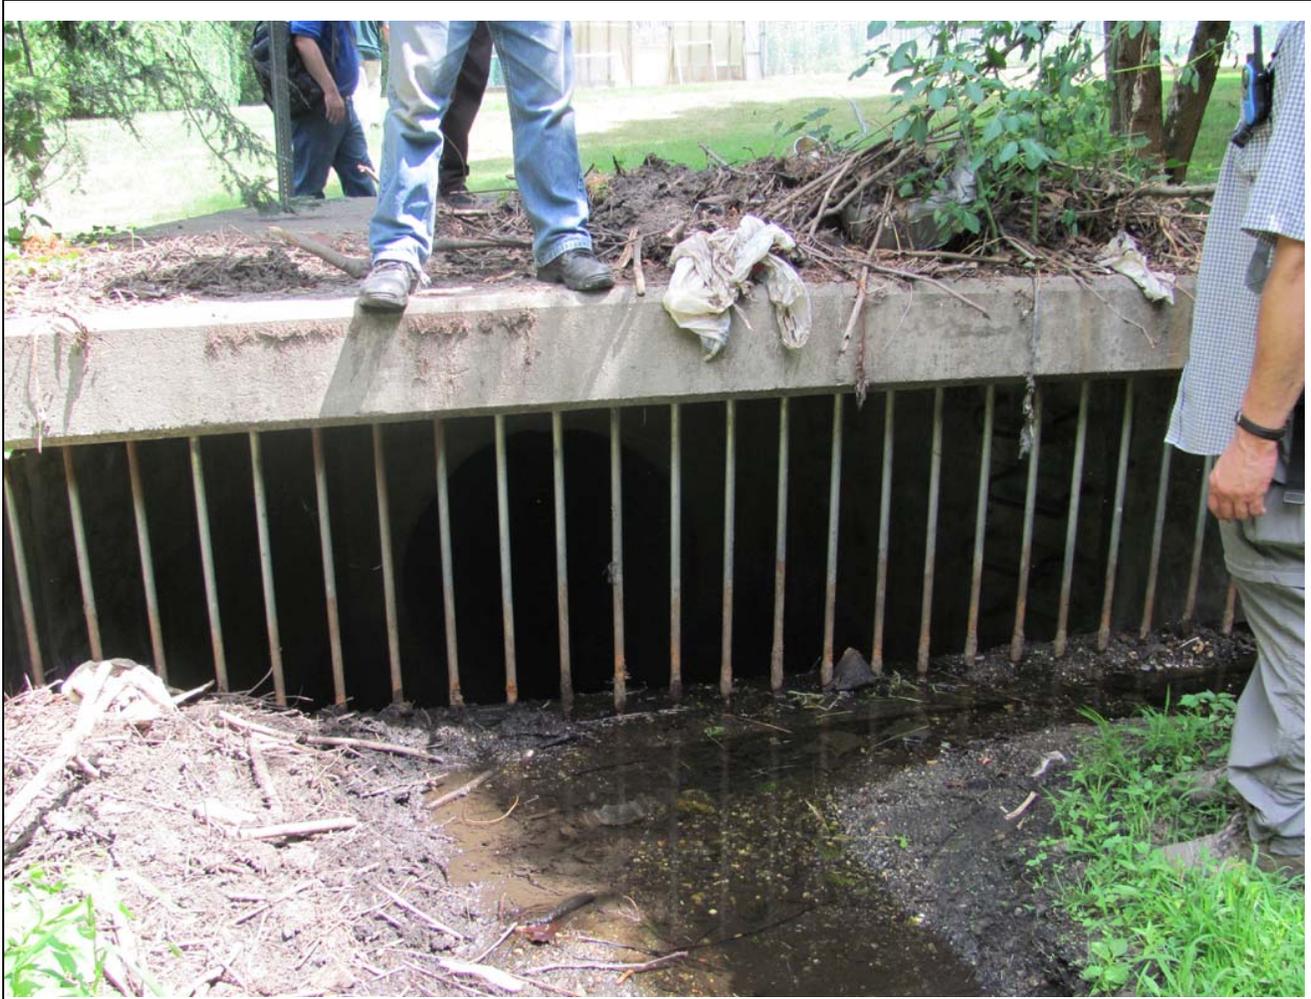
Inspect ID: NAR1_2010_a_0047 **Title:** USACE_CENAN_NAR1_2010_a_0047_1.jpg **Caption:** Sediment, debris and vegetation blocking flow through drainage structure.

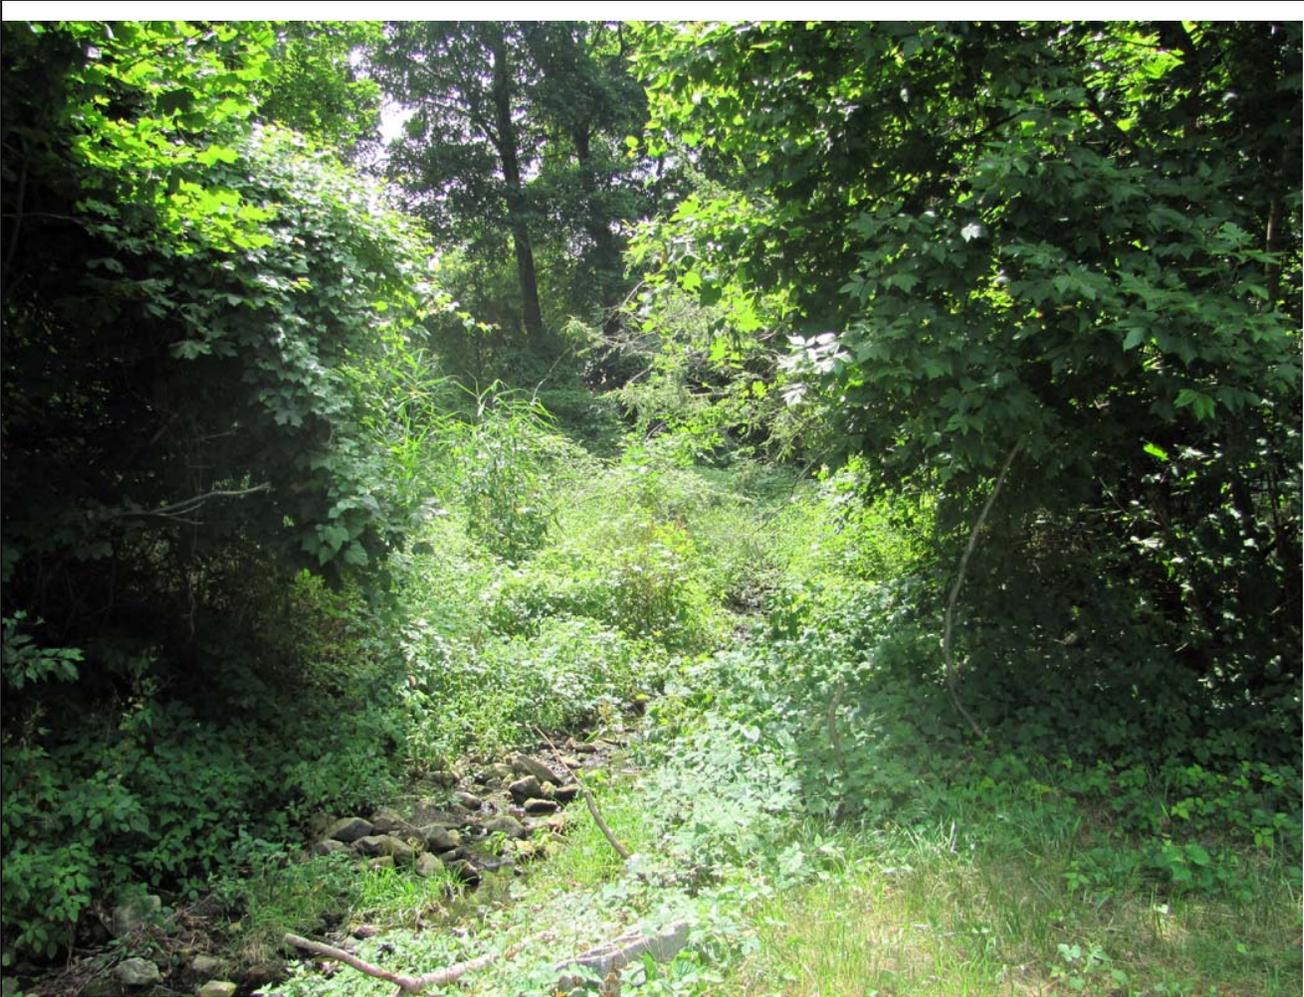
Inspect ID: NAR1_2010_a_0048 **Title:** USACE_CENAN_NAR1_2010_a_0048_1.jpg **Caption:** The start of interceptor ditch #2 contains dense vegetation.

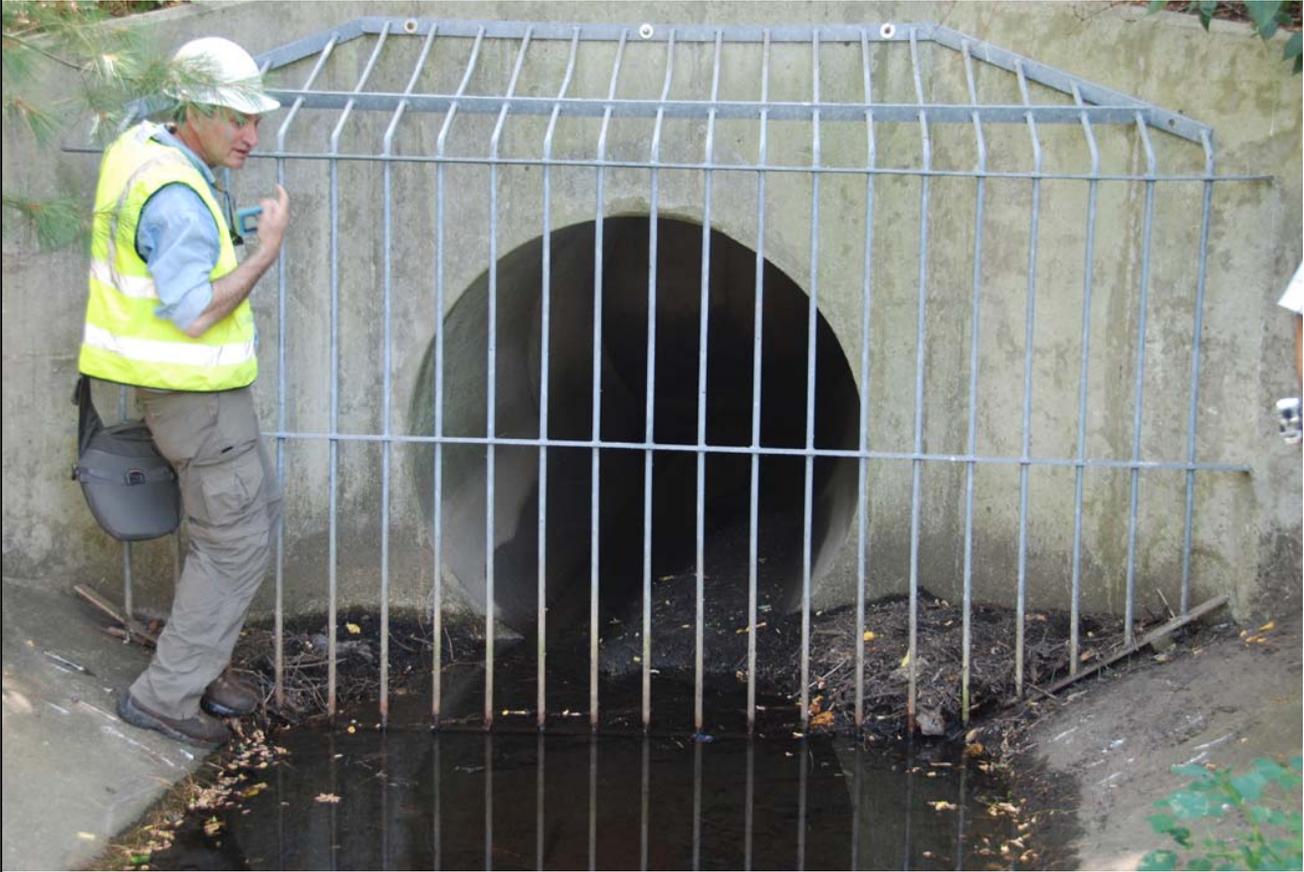
Inspect ID: NAR1_2010_a_0049 **Title:** USACE_CENAN_NAR1_2010_a_0049_1.jpg **Caption:** Trash rack for outlet structure #3 contains some debris.

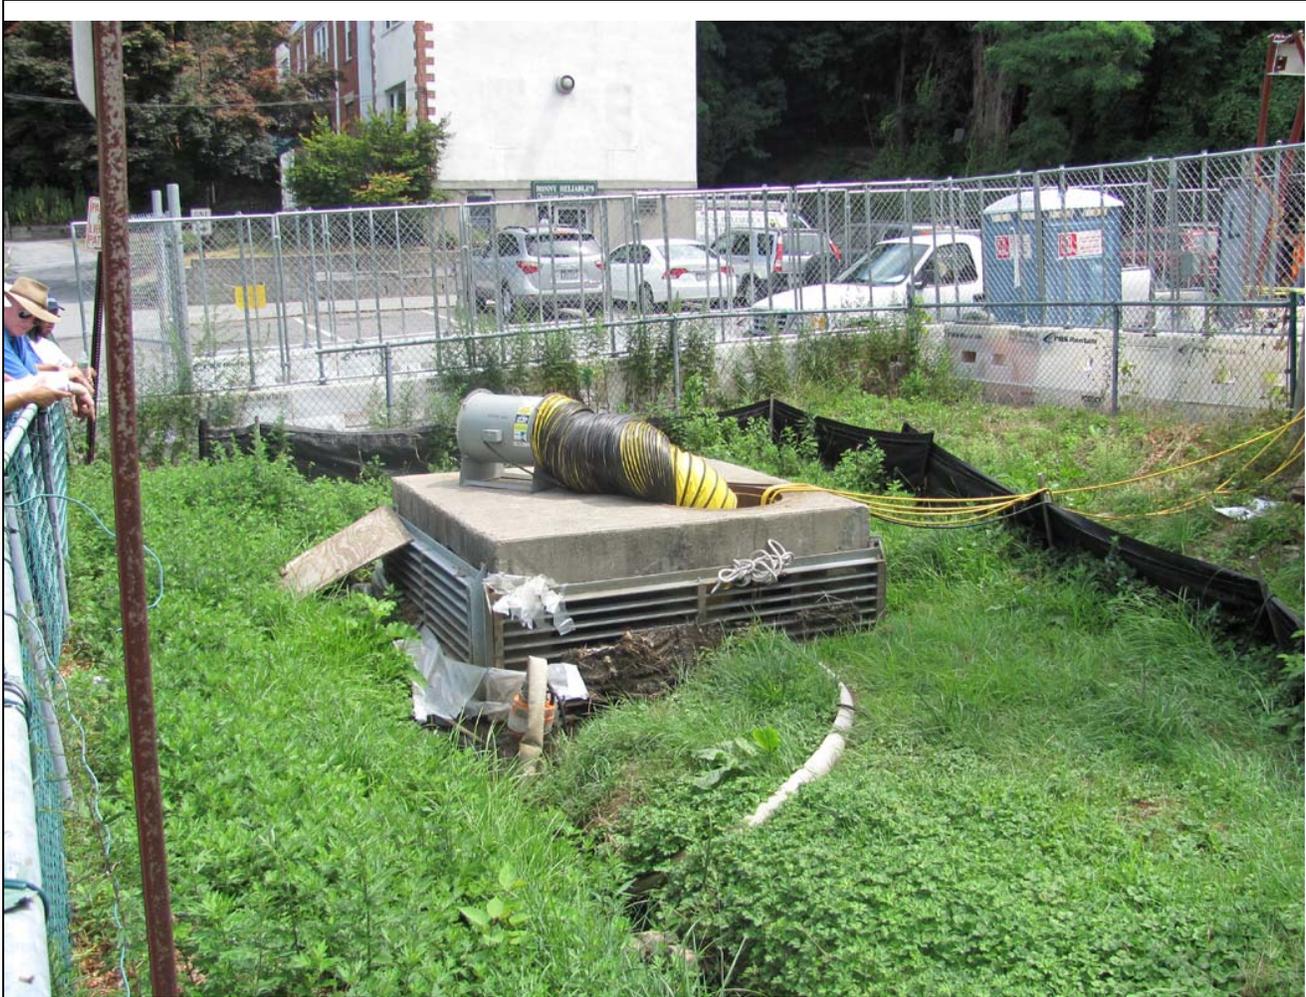
Inspect ID: NAR1_2010_a_0051 **Title:** USACE_CENAN_NAR1_2010_a_0051_1.jpg **Caption:** NYCDEP work site included the intake structure at blow off tunnel connection. We were unable to inspect the structure.

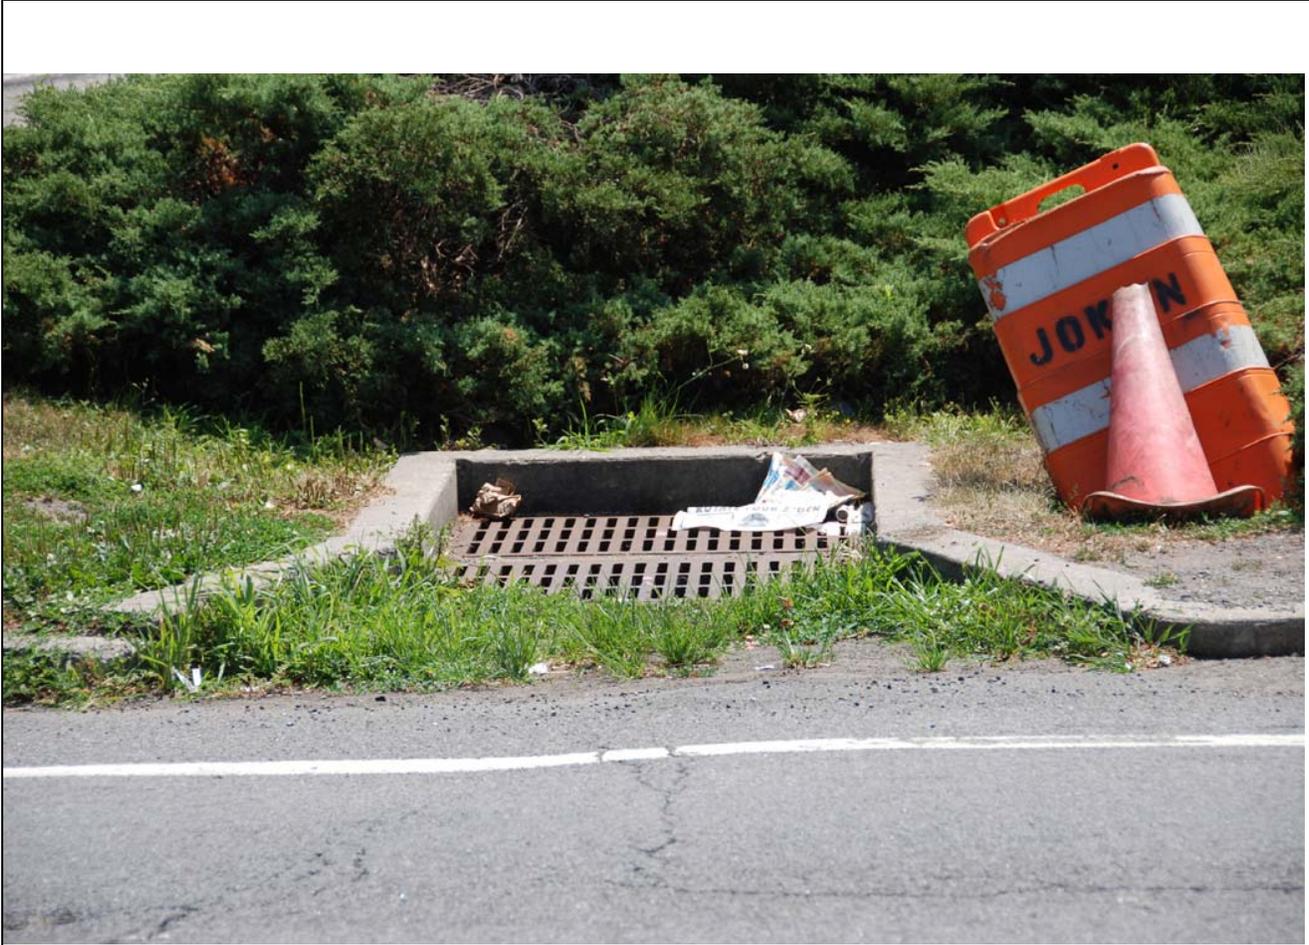
Inspect ID: NAR1_2010_a_0053 **Title:** USACE_CENAN_NAR1_2010_a_0053_1.jpg **Caption:** Drop inlet #3 has a depression next to it that may compromise its integrity.
