ARDSLEY

FLOOD RISK MANAGEMENT PROJECT

*FLOODWALLS, INTERIOR DRAINAGE SYSTEM AND FLOOD DAMAGE
REDUCTION CHANNEL*

2010 PERIODIC INSPECTION REPORT No.1

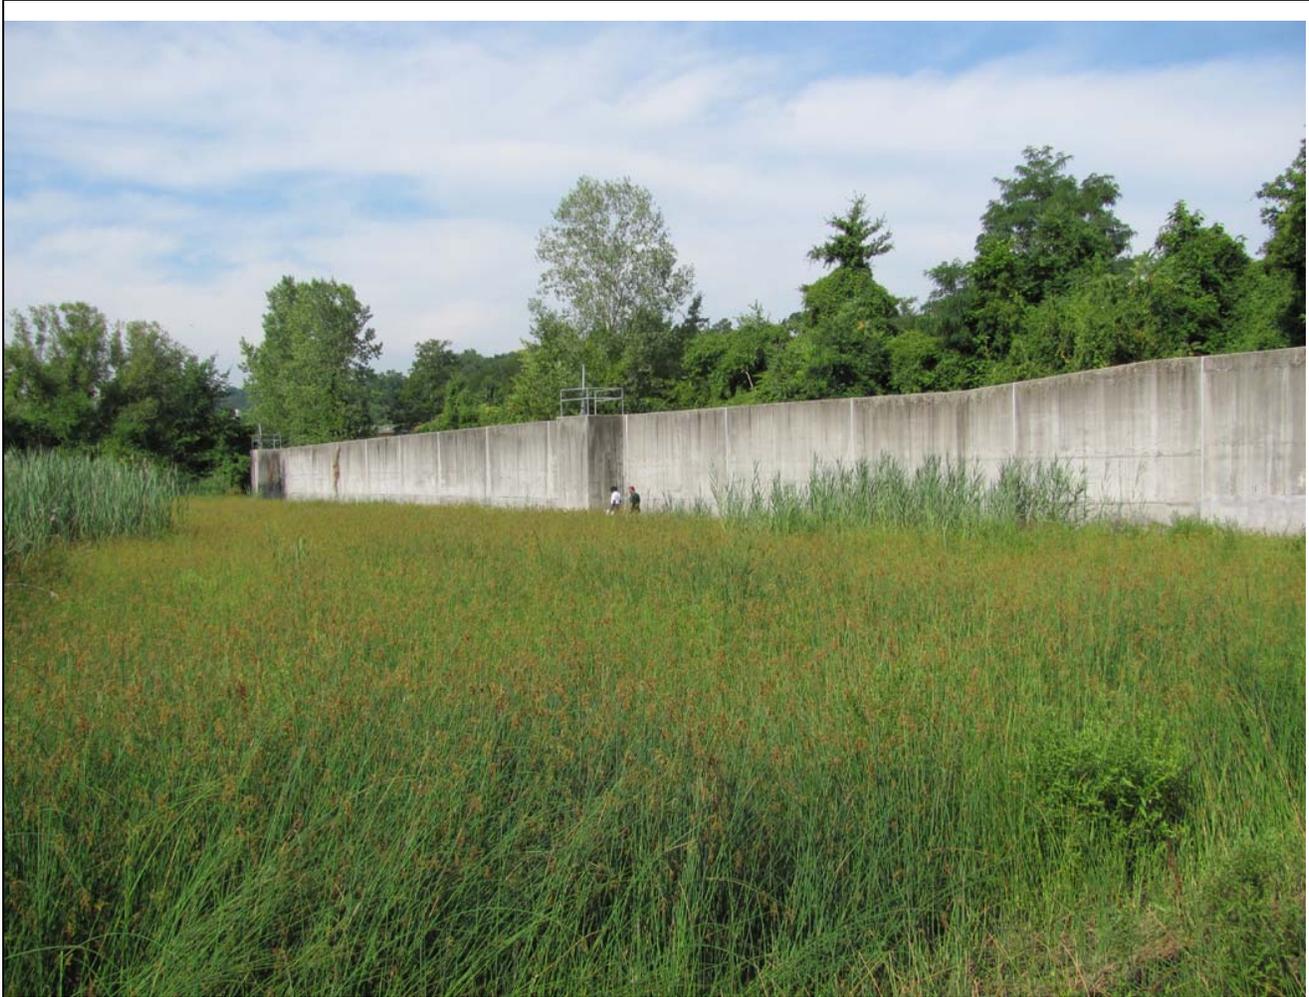
Inspect ID: NAR1_2010_a_0064 **Title:** USACE_CENAN_NAR1_2010_a_0064_1.jpg **Caption:** Dense vegetation on protected side of floodwall at ponding area #2.

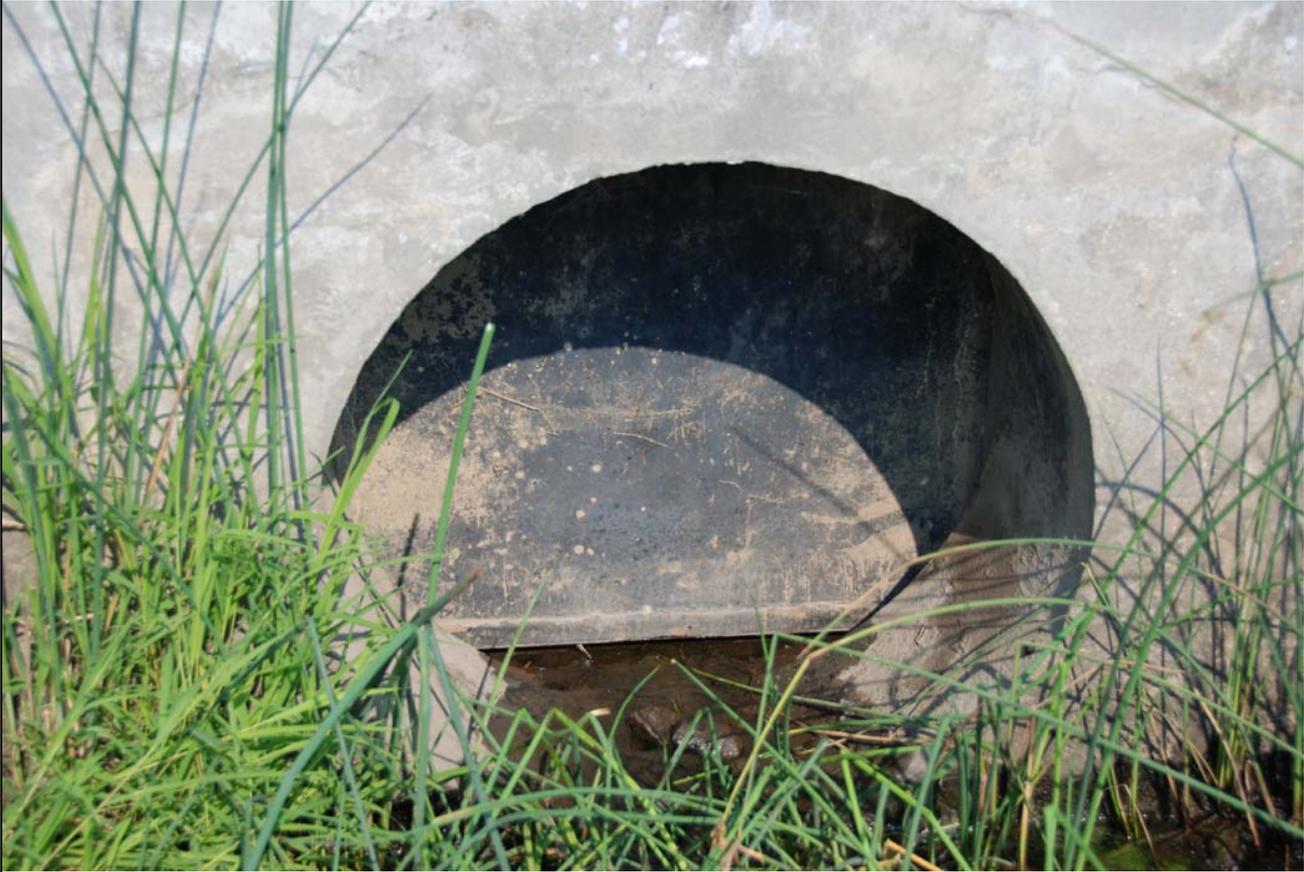
Inspect ID: NAR1_2010_a_0067 **Title:** USACE_CENAN_NAR1_2010_a_0067_1.jpg **Caption:** Drainage structure #4 sluice gate fully closed.

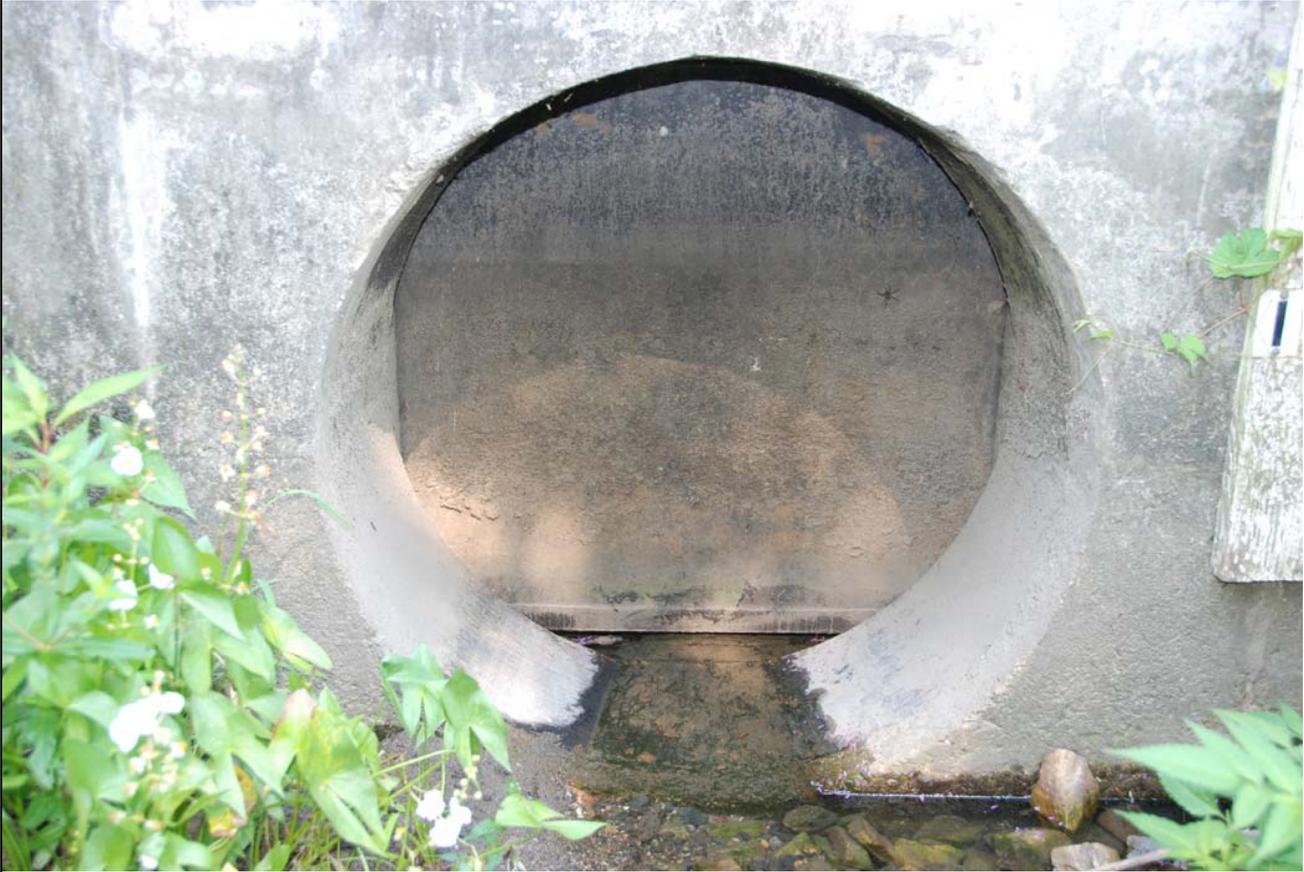
Inspect ID: NAR1_2010_a_0068 **Title:** USACE_CENAN_NAR1_2010_a_0068_1.jpg **Caption:** Obstruction preventing drainage structure #3 sluice gate from fully closing.

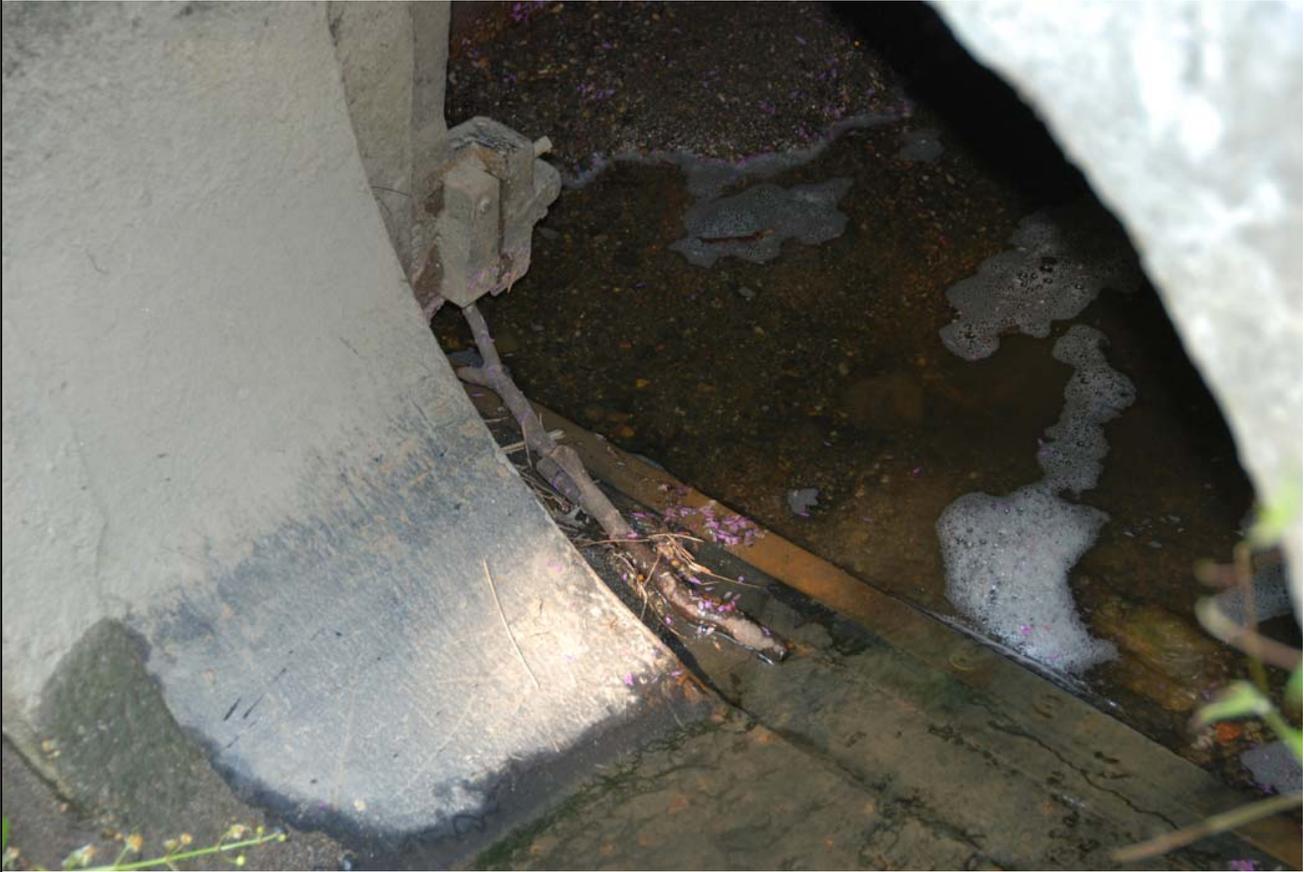
Inspect ID: NAR1_2010_a_0068 **Title:** USACE_CENAN_NAR1_2010_a_0068_2.jpg **Caption:** Obstruction (stick) preventing drainage #3 sluice gate from fully closing.

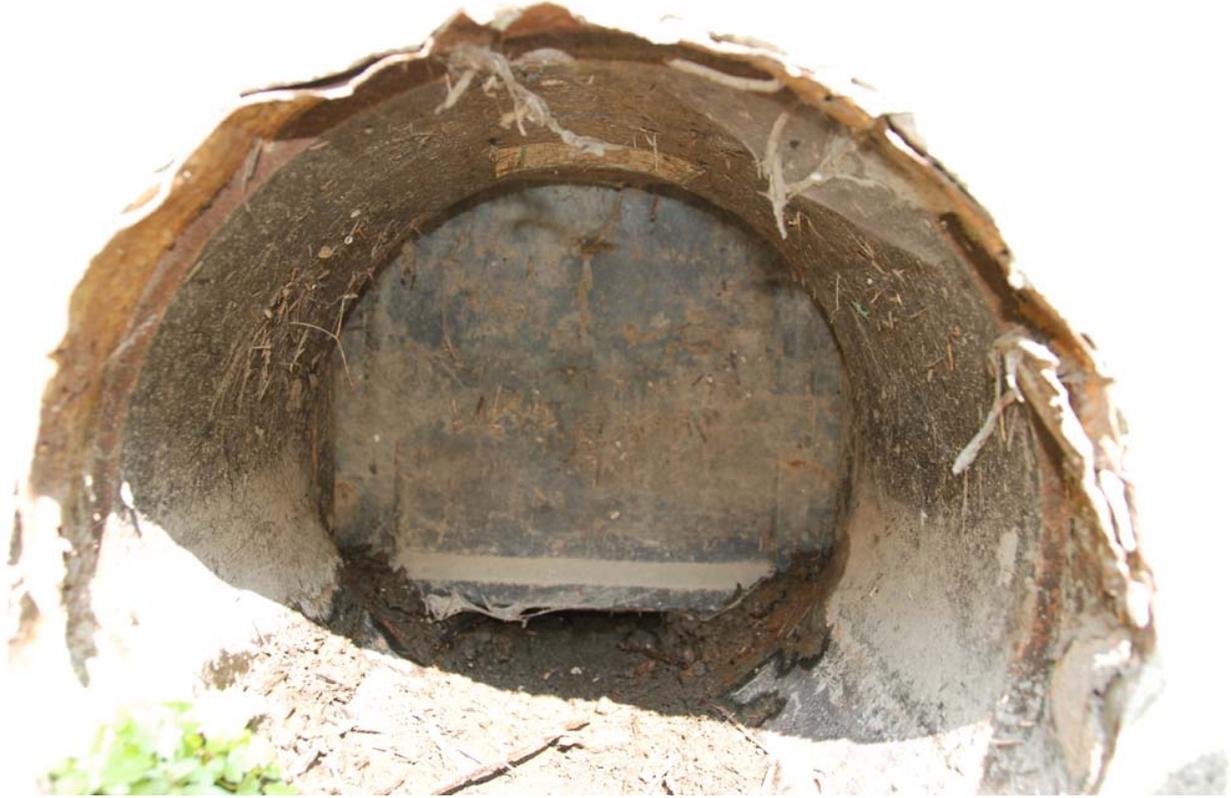
Inspect ID: NAR1_2010_a_0069 **Title:** USACE_CENAN_NAR1_2010_a_0069_1.jpg **Caption:** Sediment obstruction preventing drainage structure #1 sluice gate from fully closing.

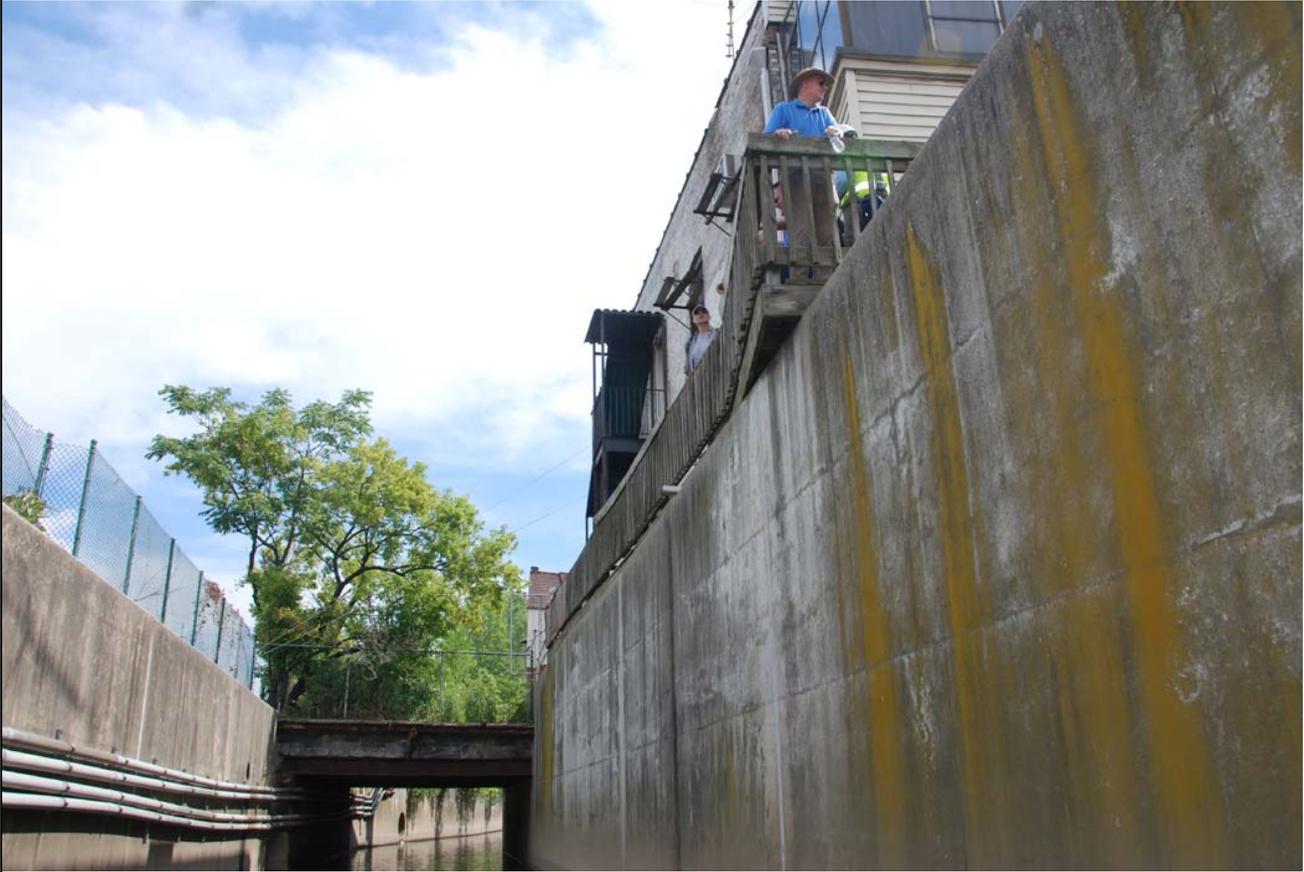
Inspect ID: NAR1_2010_a_0027 **Title:** USACE_CENAN_NAR1_2010_a_0027_1.jpg **Caption:** Deck on top of channel wall (only access way to DS#1).

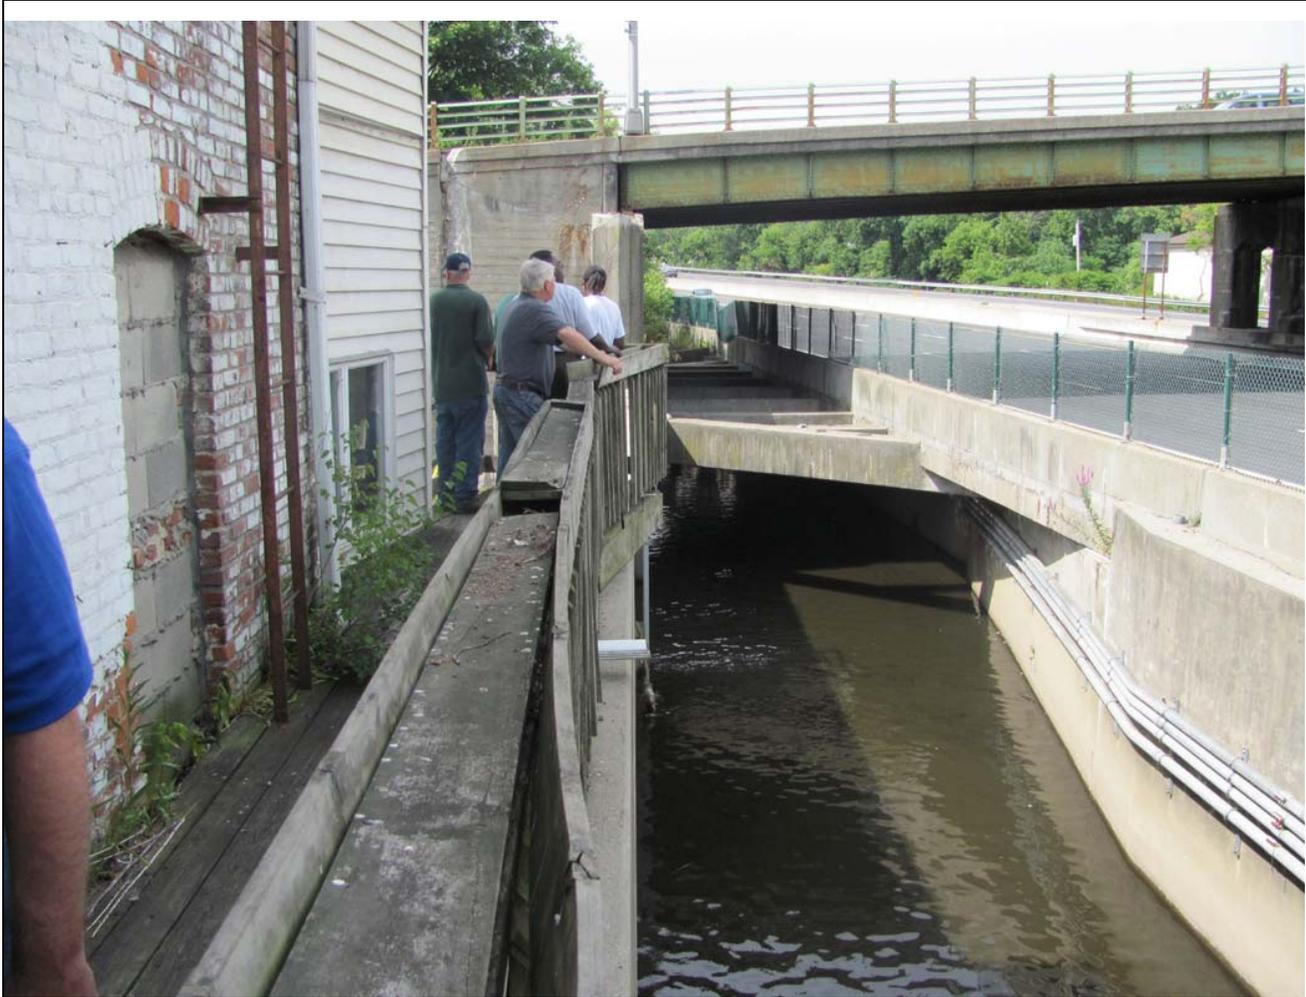
Inspect ID: NAR1_2010_a_0027 **Title:** USACE_CENAN_NAR1_2010_a_0027_2.jpg **Caption:** Deck on top of channel wall (only access way to DS#1).
