Flood Damage Reduction Segment / System Inspection Report

Name of Segment / System: Ardsley Flood Control Project

Date Report Prepared: 7/17/2019

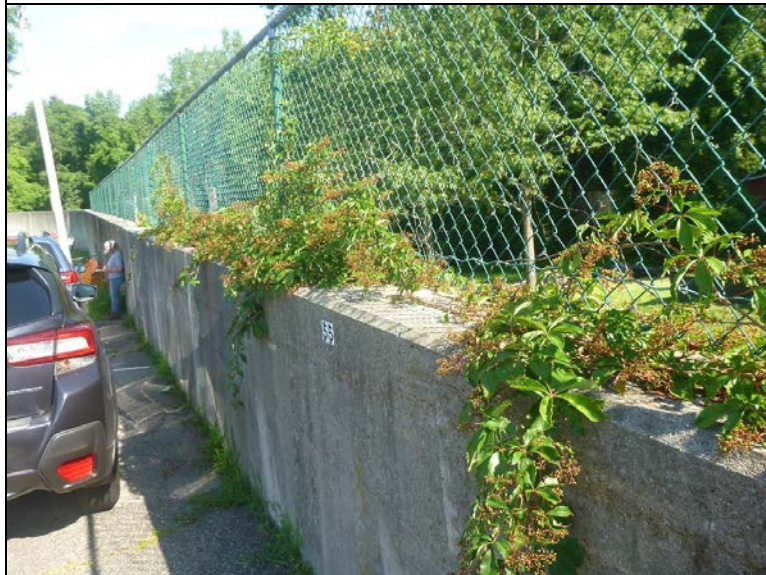
Inspect ID: NAR1_2019_a_0021 **Title:** USACE_CENAN_NAR1_2019_a_0021_1.jpg
Rated Item: 1. Unwanted Vegetation Growth **Caption:** Rating: Minimally Acceptable;
Remarks: Vines in fence along top of wall from monolith 53-55; Action: Maintain vegetation in accordance with USACE guidelines.; Station_1: 3+55B

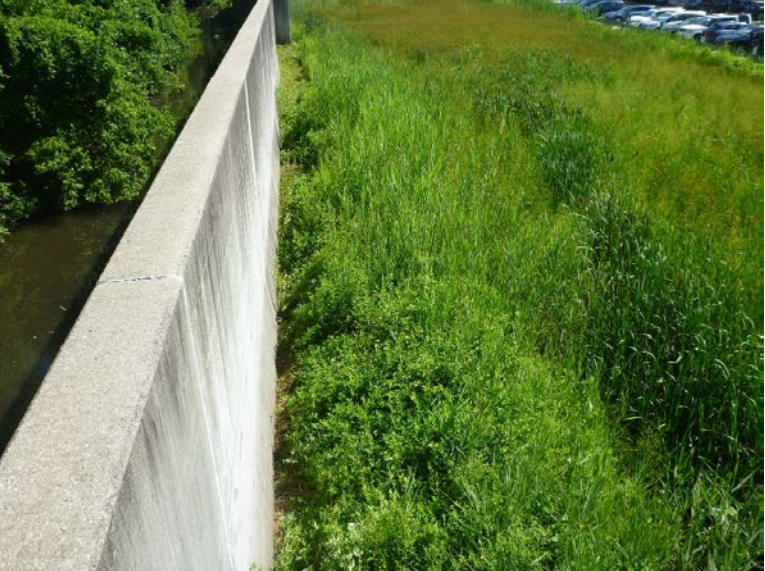
<p>Inspect ID: NAR1_2019_a_0042 Title: USACE_CENAN_NAR1_2019_a_0042_1.jpg Rated Item: 1. Unwanted Vegetation Growth Caption: Rating: Minimally Acceptable; Remarks: Overgrown vegetation along protected side of monoliths 26-30, north of DS#3.; Action: Maintain vegetation in accordance with USACE guidelines.; Station_1: 5+40U</p>

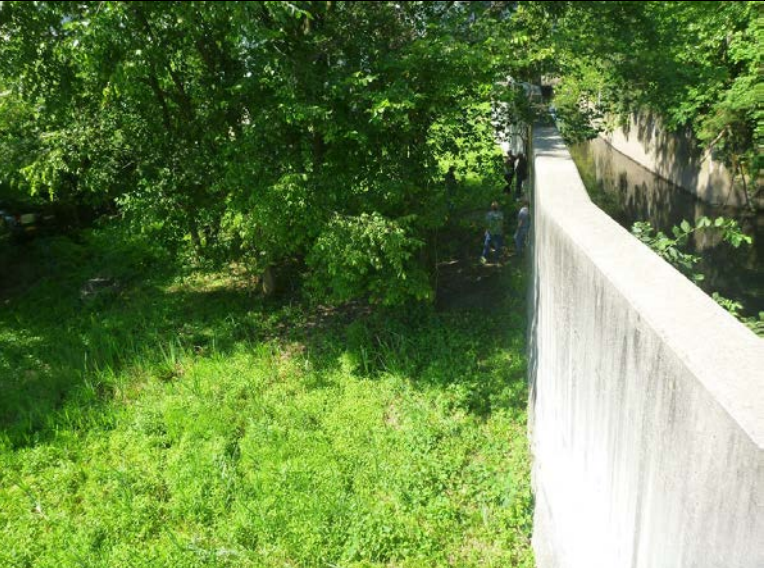
<p>Inspect ID: NAR1_2019_a_0045 Title: USACE_CENAN_NAR1_2019_a_0045_1.jpg Rated Item: 1. Unwanted Vegetation Growth Caption: Rating: Minimally Acceptable; Remarks: Village of Ardsley has successfully removed most of the vegetation behind the floodwall south of DS#3 but a small stand of trees remains.; Action: Remove vegetation in accordance with USACE guidelines.; Station_1: 4+65U</p>

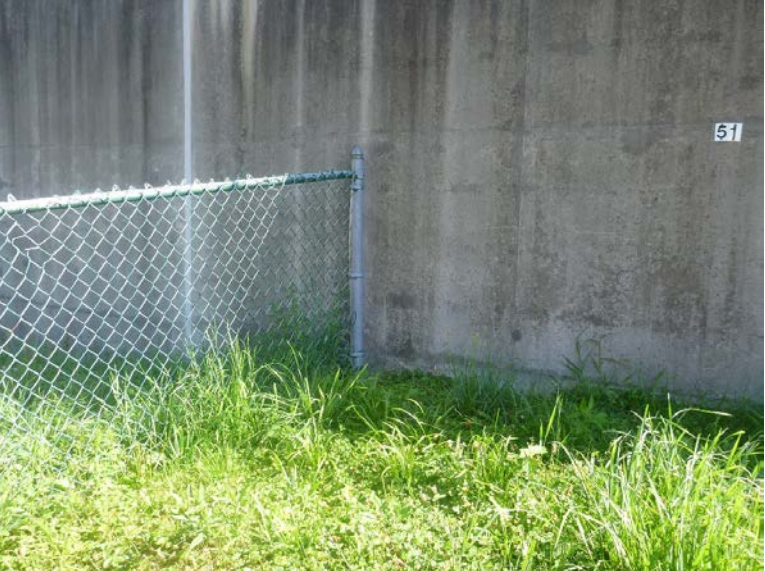
<p>Inspect ID: NAR1_2019_a_0025 Title: USACE_CENAN_NAR1_2019_a_0025_1.jpg Rated Item: 2. Encroachments Caption: Rating: Minimally Acceptable; Remarks: Chain link fence encroaching on protected side of floodwall. Extends 6 ft out from floodwall.; Action: Investigate easement agreement and dispose of encroachment accordingly.; Station_1: 2+70B</p>

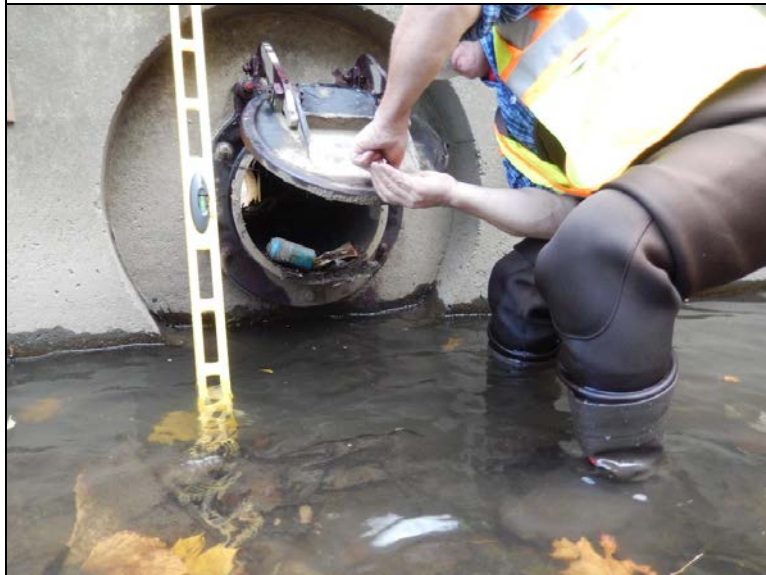
Inspect ID: NAR1_2019_a_0069 **Title:** USACE_CENAN_NAR1_2019_a_0069_2.jpg
Rated Item: 11. Flap Gates/ Flap Valves/ Pinch Valves **Caption:** Rating: Minimally Acceptable; Remarks: DS#1. Flap gate operated in 2016, but stiffly. Sediment in the way. Could not access in 2019.; Action: Clean DS#1 and lubricate flap gate.; Station_1: 0+40U; Photo taken prior to 2019 inspection.

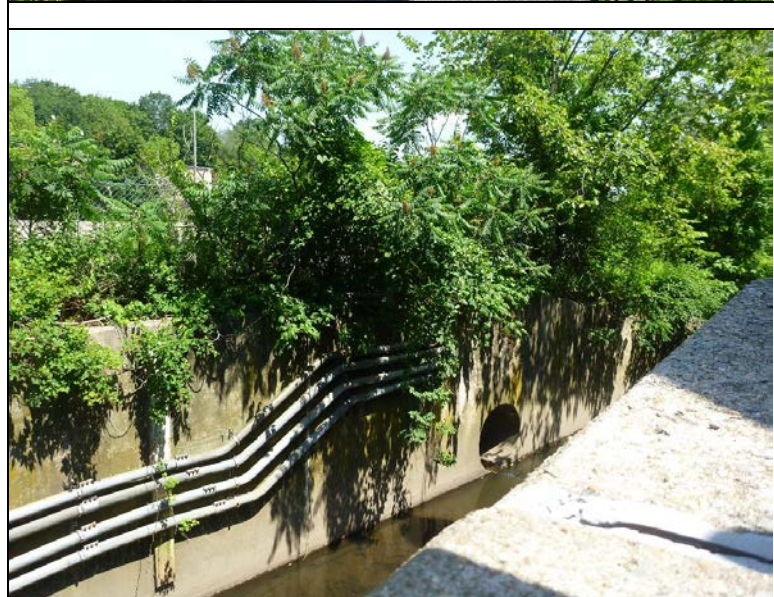
<p>Inspect ID: NAR1_2019_a_0057 Title: USACE_CENAN_NAR1_2019_a_0057_1.jpg Rated Item: 1. Vegetation and Obstructions Caption: Rating: Minimally Acceptable; Remarks: Vegetation encroaching along right bank on top of drainage channel wall.; Action: Coordinate with NYS Thruway Authority to remove vegetation.; Station_1: 2+10U; Station_2: 4+35U</p>

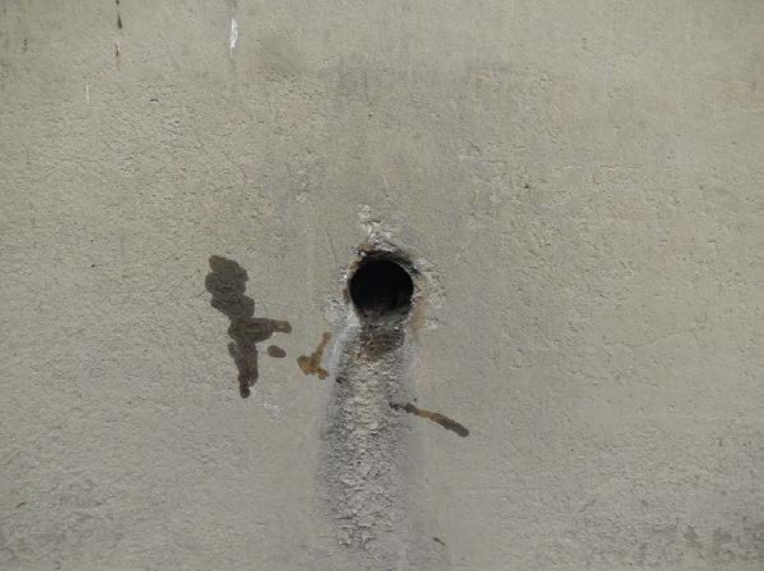
<p>Inspect ID: NAR1_2019_a_0073 Title: USACE_CENAN_NAR1_2019_a_0073_1.jpg Rated Item: 1. Vegetation and Obstructions Caption: Rating: Minimally Acceptable; Remarks: Weep hole blocked with sediment. Could not access in 2019.; Action: Public sponsor should clear vegetation from weep hole.; Station_1: 0+55U; Photo taken prior to the 2019 inspection.</p>

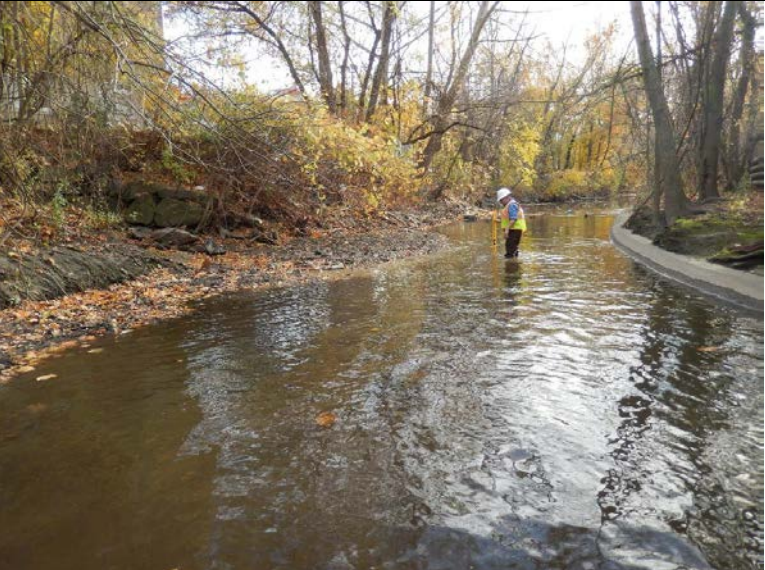
<p>Inspect ID: NAR1_2019_a_0075 Title: USACE_CENAN_NAR1_2019_a_0075_1.jpg Rated Item: 1. Vegetation and Obstructions Caption: Rating: Minimally Acceptable; Remarks: Immediately downstream of the project a large pile of debris (3 ft high) obstructing more then half of the channel, downstream of concrete channel. Could not oserve in 2019.; Action: Remove debris from channel to ensure maximum flow capacity.; Station_1: 0+00U; Photo taken prior to the 2019 inspection.</p>

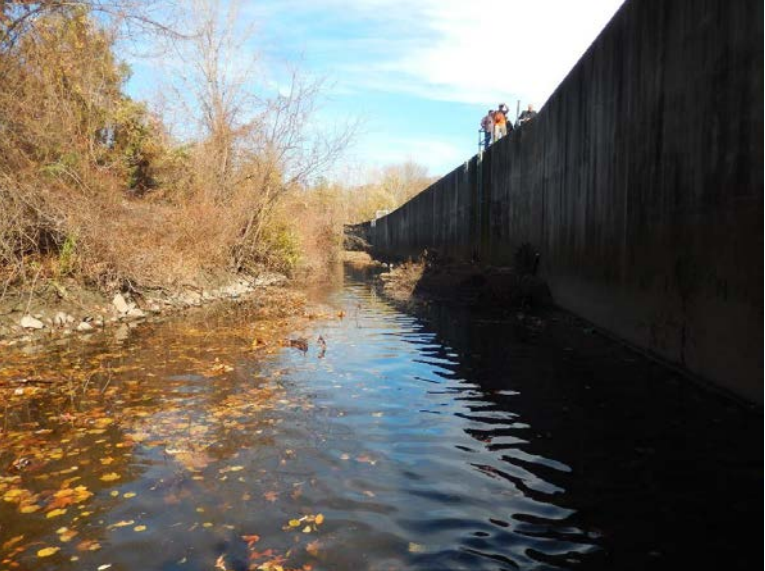
<p>Inspect ID: NAR1_2019_a_0078 Title: USACE_CENAN_NAR1_2019_a_0078_1.jpg Rated Item: 1. Vegetation and Obstructions Caption: Rating: Minimally Acceptable; Remarks: Excessive vegetation and trees on right bank riprap. It is difficult to inspect with shrubs and trees over riprap. Could not access in 2019.; Action: Remove vegetation in accordance with USACE guidelines.; Station_1: 10+40U; Station_2: 3+10U; Photo taken prior to the 2019 inspection.</p>

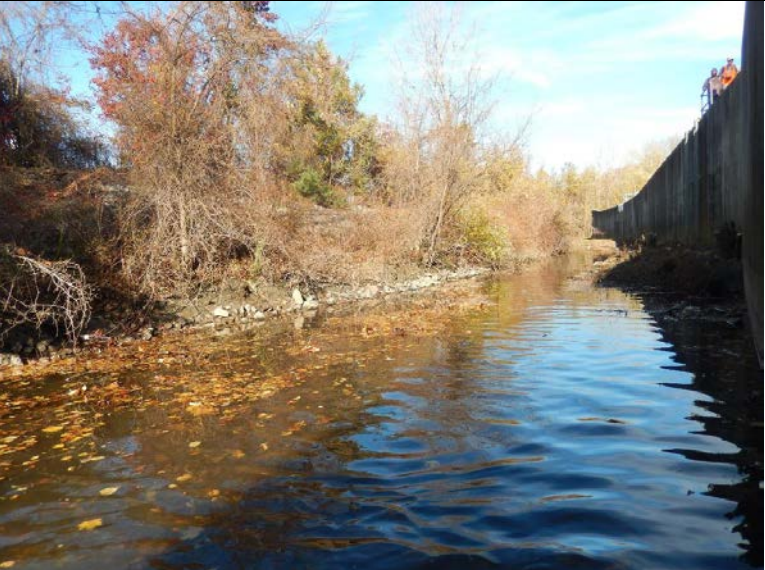
<p>Inspect ID: NAR1_2019_a_0078 Title: USACE_CENAN_NAR1_2019_a_0078_2.jpg Rated Item: 1. Vegetation and Obstructions Caption: Rating: Minimally Acceptable; Remarks: Excessive vegetation and trees on right bank riprap. It is difficult to inspect with shrubs and trees over riprap. Could not access in 2019.; Action: Remove vegetation in accordance with USACE guidelines.; Station_1: 10+40U; Station_2: 3+10U; Photo taken prior to the 2019 inspection.</p>

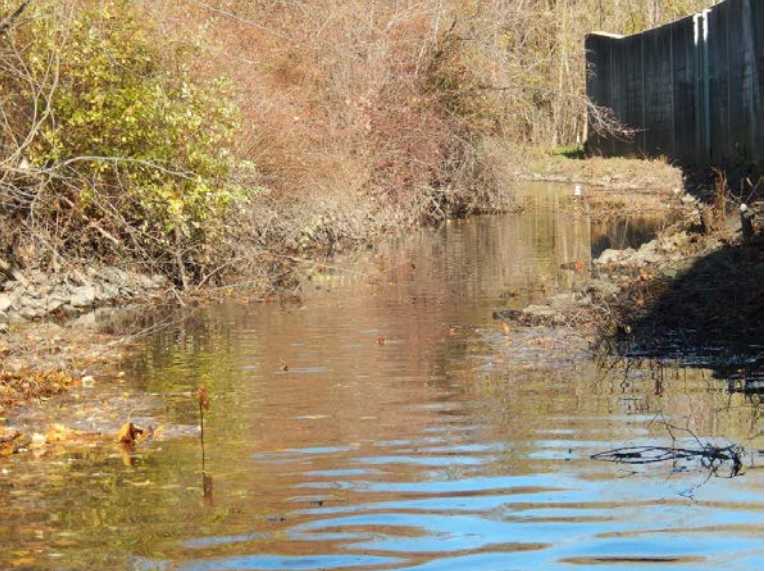
<p>Inspect ID: NAR1_2019_a_0078 Title: USACE_CENAN_NAR1_2019_a_0078_3.jpg Rated Item: 1. Vegetation and Obstructions Caption: Rating: Minimally Acceptable; Remarks: Excessive vegetation and trees on right bank riprap. It is difficult to inspect with shrubs and trees over riprap. Could not access in 2019.; Action: Remove vegetation in accordance with USACE guidelines.; Station_1: 10+40U; Station_2: 3+10U; Photo taken prior to the 2019 inspection.</p>

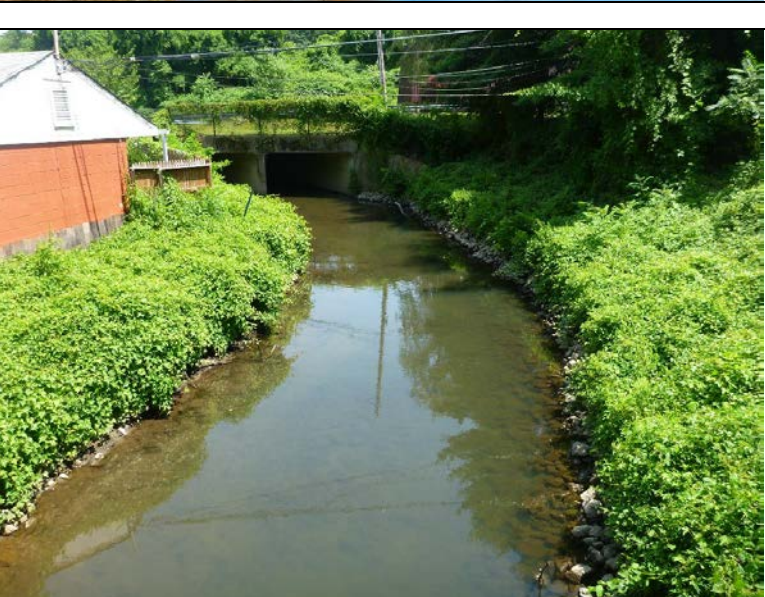
<p>Inspect ID: NAR1_2019_a_0094 Title: USACE_CENAN_NAR1_2019_a_0094_1.jpg Rated Item: 1. Vegetation and Obstructions Caption: Rating: Minimally Acceptable; Remarks: Vegetation on embankment of riprap channel below ; Action: Remove vegetation in accordance with USACE guidelines.; Station_1: 1+00D; ; ;</p>

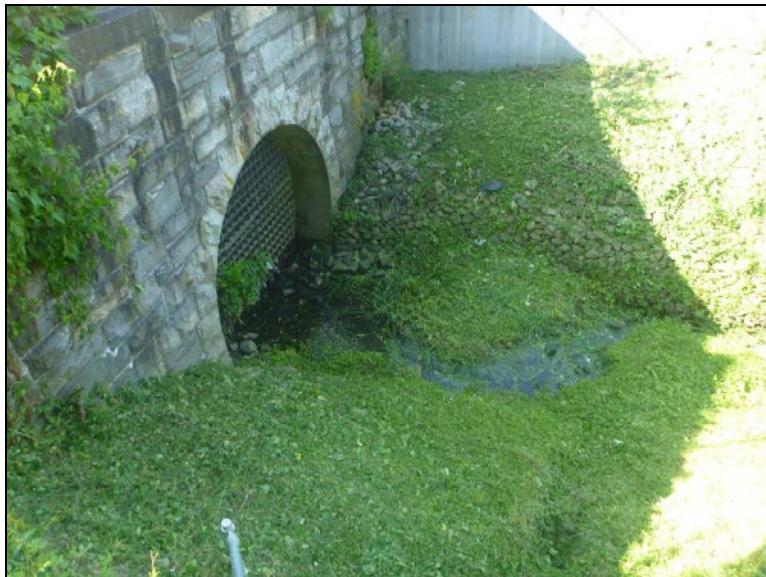
Inspect ID: NAR1_2019_a_0008 **Title:** USACE_CENAN_NAR1_2019_a_0008_1.jpg
Rated Item: 2. Shoaling (sediment deposition) **Caption:** Rating: Minimally Acceptable;
Remarks: Some light sediment at outlet of NYCDEP blow off tunnel.; **Action:** Remove sediment in accordance with USACE guidelines.; **Station_1:** 4+40B

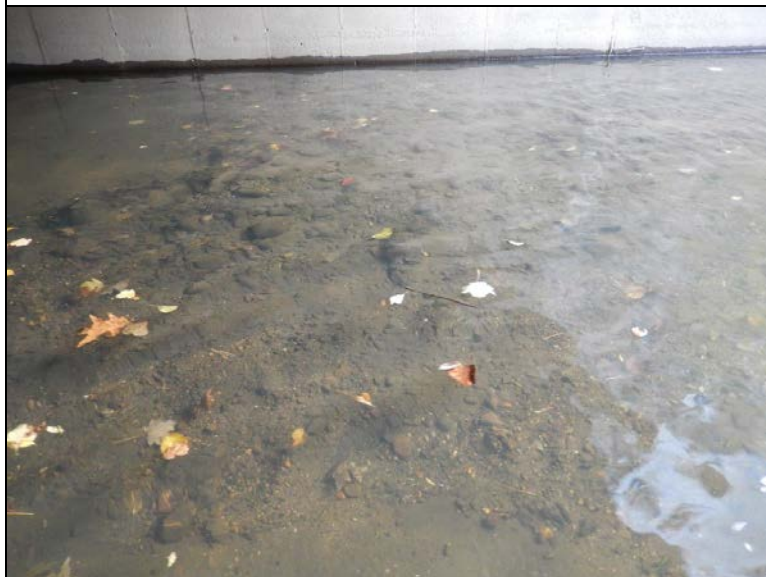
Inspect ID: NAR1_2019_a_0064 **Title:** USACE_CENAN_NAR1_2019_a_0064_1.jpg
Rated Item: 2. Shoaling (sediment deposition) **Caption:** Rating: Minimally Acceptable;
Remarks: Shoaling at bottom of channel at south side of old bridge. Could not observe through high water in 2019.; **Action:** Remove sediment from channel to ensure maximum flow capacity.; **Station_1:** 1+35U; Photo taken prior to the 2019 inspection.

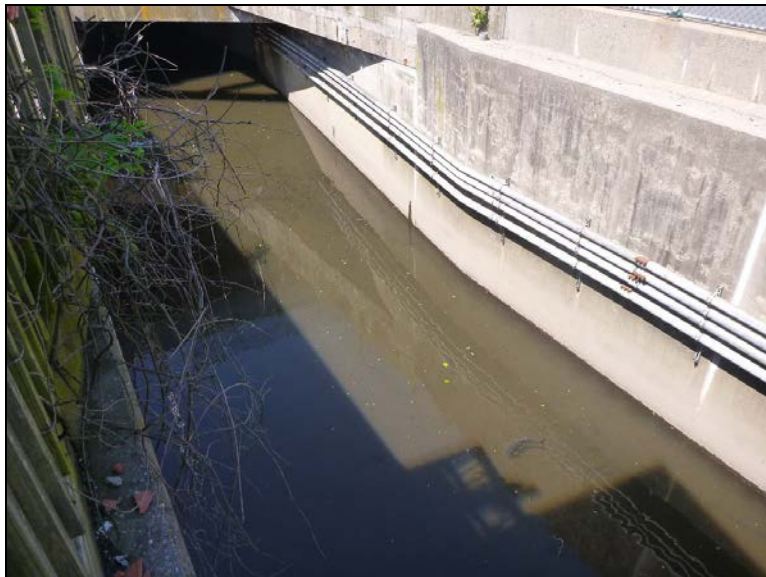
Inspect ID: NAR1_2019_a_0067 **Title:** USACE_CENAN_NAR1_2019_a_0067_1.jpg
Rated Item: 2. Shoaling (sediment deposition) **Caption:** Rating: Minimally Acceptable;
Remarks: Shoaling at DS#1 in flood reduction channel. ; **Action:** Remove sediment from channel to ensure maximum flow capacity.; **Station_1:** 0+55U; ; ;

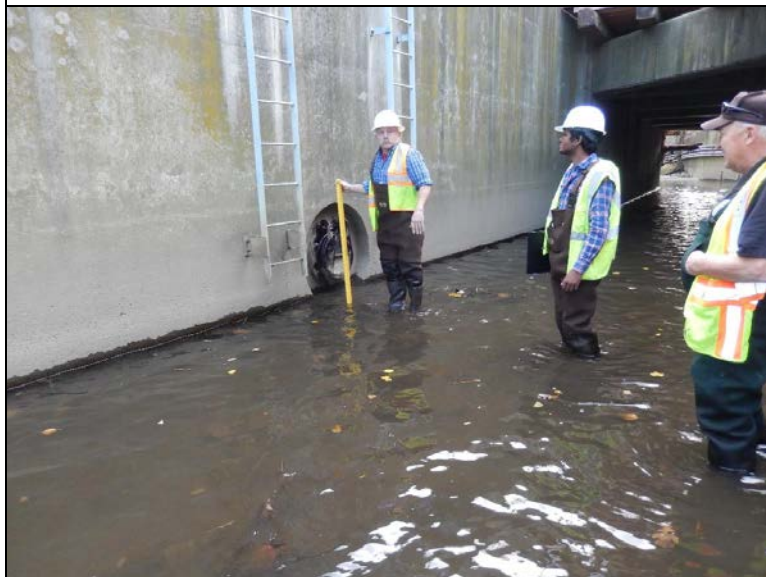
Inspect ID: NAR1_2019_a_0067 **Title:** USACE_CENAN_NAR1_2019_a_0067_2.jpg
Rated Item: 2. Shoaling (sediment deposition) **Caption:** Rating: Minimally Acceptable;
Remarks: Shoaling at DS#1 in flood reduction channel. ; **Action:** Remove sediment from channel to ensure maximum flow capacity.; **Station_1:** 0+55U; ; ; **Photo taken prior to 2019 inspection.**

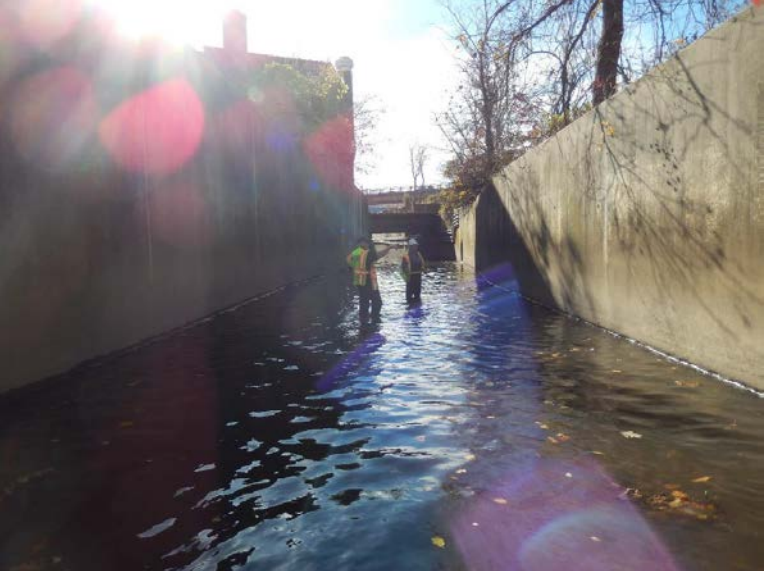
<p>Inspect ID: NAR1_2019_a_0076 Title: USACE_CENAN_NAR1_2019_a_0076_1.jpg Rated Item: 2. Shoaling (sediment deposition) Caption: Rating: Minimally Acceptable; Remarks: Shoaling in channel between monoliths 13 and 14. Could not access in 2019.; Action: Remove sediment in accordance with USACE guidelines.; Station_1: 3+15U; Photo taken prior to the 2019 inspection.</p>
 	<p>Inspect ID: NAR1_2019_a_0058 Title: USACE_CENAN_NAR1_2019_a_0058_1.jpg Rated Item: 3. Encroachments Caption: Rating: Minimally Acceptable; Remarks: Old drainage inlets at Ardsley Square may not have been properly abandoned. 20" pipe from channel wall remains open. Could not access in 2019.; Action: Confirm that pre-project catch basins were abandoned according to the approved plan.; Station_1: 1+80U; Photo taken prior to the 2019 inspection.</p>

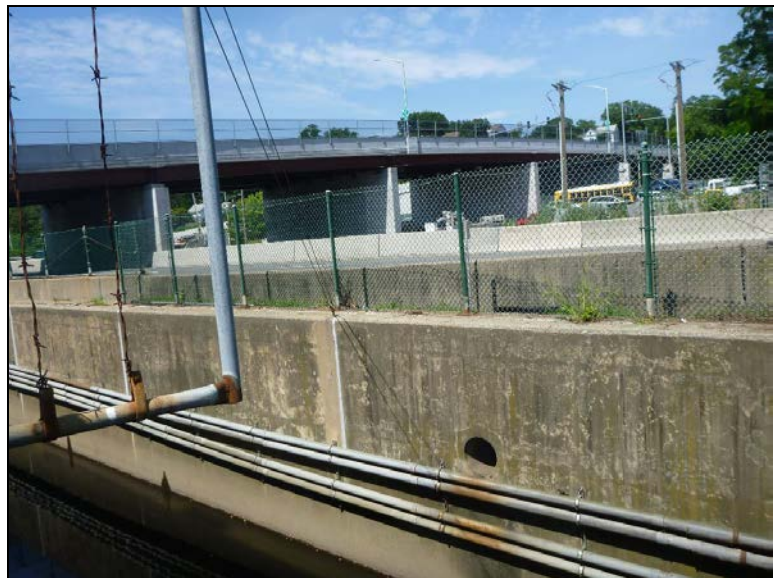
<p>Inspect ID: NAR1_2019_a_0059 Title: USACE_CENAN_NAR1_2019_a_0059_1.jpg Rated Item: 3. Encroachments Caption: Rating: Minimally Acceptable; Remarks: Steel guy wire coming off of building and extending over channel.; Action: Investigate easement agreement and dispose of encroachment accordingly.; Station_1: 1+45U</p>

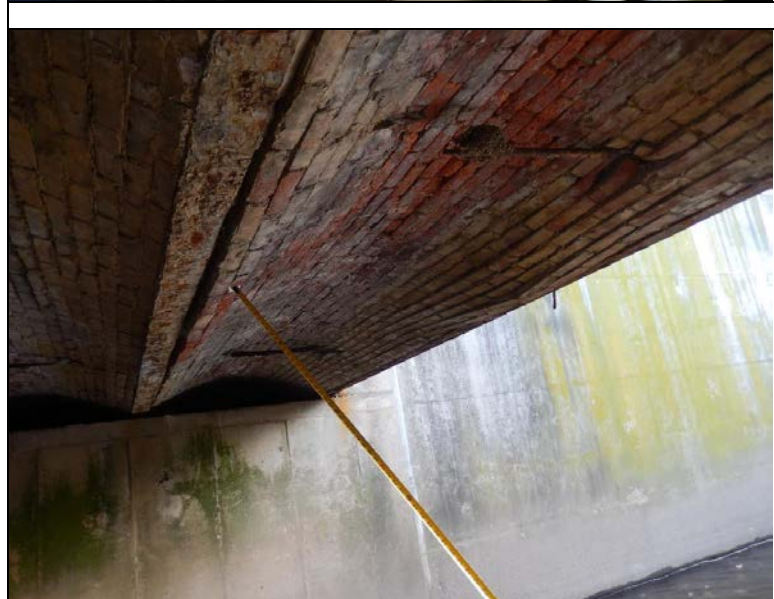
<p>Inspect ID: NAR1_2019_a_0062 Title: USACE_CENAN_NAR1_2019_a_0062_1.jpg Rated Item: 3. Encroachments Caption: Rating: Minimally Acceptable; Remarks: Bricks of the vaulted ceiling, beneath the old bridge, are about to fall due to corroded and broken tie rods. Falling debris could obstruct the channel. Could not observe in 2019.; Action: Shoring is needed to prevent failure of the vaulted ceiling and original bridge structure.; Station_1: 1+35U; Photo taken prior to the 2019 inspection.</p>

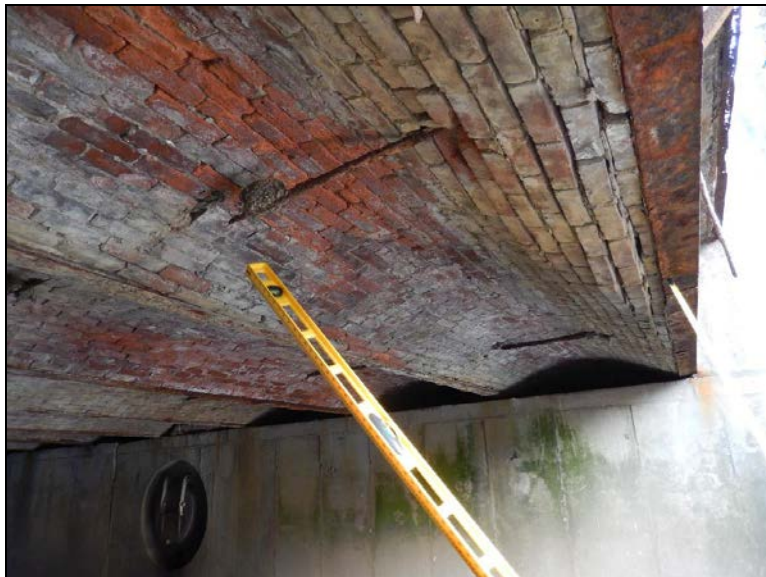
Inspect ID: NAR1_2019_a_0062 **Title:** USACE_CENAN_NAR1_2019_a_0062_2.jpg
Rated Item: 3. Encroachments **Caption:** Rating: Minimally Acceptable; Remarks: Bricks of the vaulted ceiling, beneath the old bridge, are about to fall due to corroded and broken tie rods. Falling debris could obstruct the channel. Could not observe in 2019.; Action: Shoring is needed to prevent failure of the vaulted ceiling and original bridge structure.; Station_1: 1+35U; Photo taken prior to the 2019 inspection.

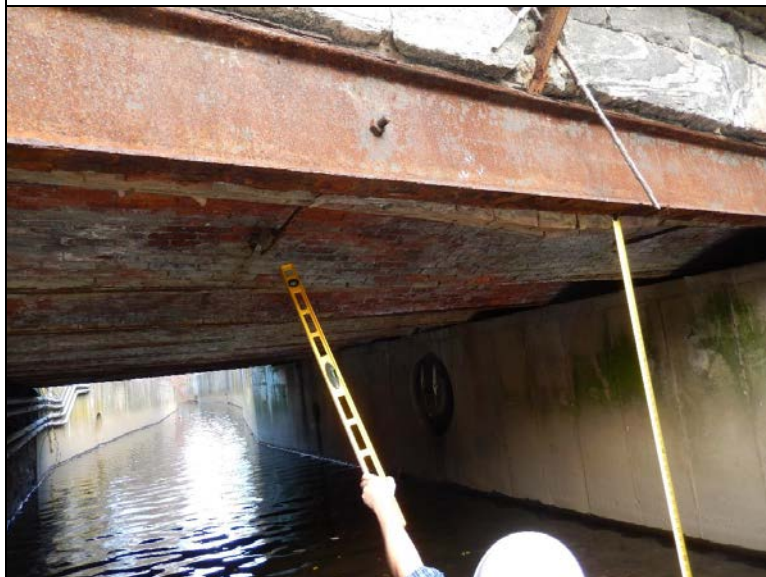
Inspect ID: NAR1_2019_a_0062 **Title:** USACE_CENAN_NAR1_2019_a_0062_3.jpg
Rated Item: 3. Encroachments **Caption:** Rating: Minimally Acceptable; Remarks: Bricks of the vaulted ceiling, beneath the old bridge, are about to fall due to corroded and broken tie rods. Falling debris could obstruct the channel. Could not observe in 2019.; Action: Shoring is needed to prevent failure of the vaulted ceiling and original bridge structure.; Station_1: 1+35U; Photo taken prior to the 2019 inspection.

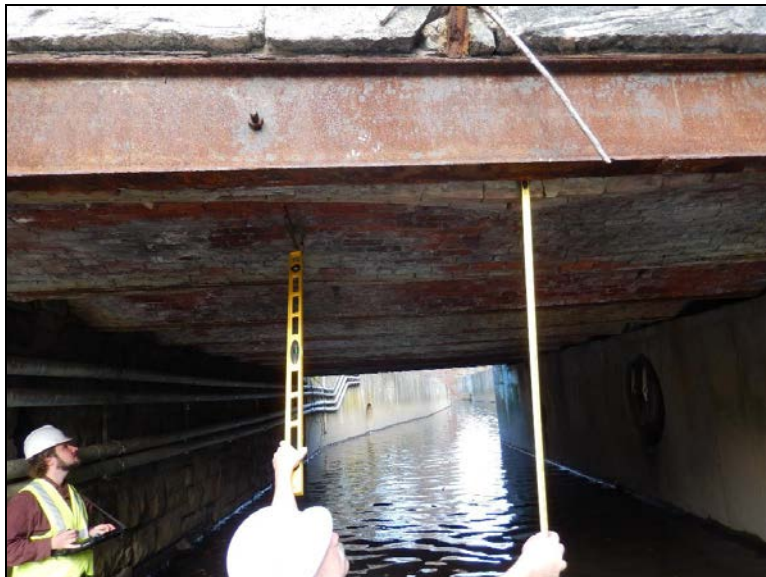
Inspect ID: NAR1_2019_a_0062 **Title:** USACE_CENAN_NAR1_2019_a_0062_4.jpg
Rated Item: 3. Encroachments **Caption:** Rating: Minimally Acceptable; Remarks: Bricks of the vaulted ceiling, beneath the old bridge, are about to fall due to corroded and broken tie rods. Falling debris could obstruct the channel. Could not observe in 2019.; Action: Shoring is needed to prevent failure of the vaulted ceiling and original bridge structure.; Station_1: 1+35U; Photo taken prior to the 2019 inspection.

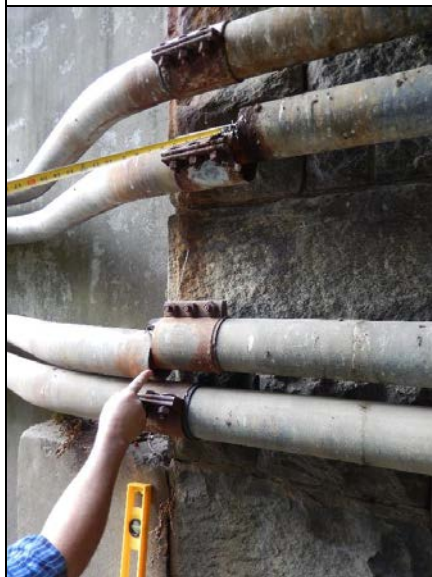
Inspect ID: NAR1_2019_a_0063 **Title:** USACE_CENAN_NAR1_2019_a_0063_1.jpg
Rated Item: 3. Encroachments **Caption:** Rating: Minimally Acceptable; Remarks: Conduits running along right side of channel are broken under bridge. Could not observe in 2019.; Action: Investigate authorization and have utility owner repair or remove.; Station_1: 1+35U; Photo taken prior to the 2019 inspection.

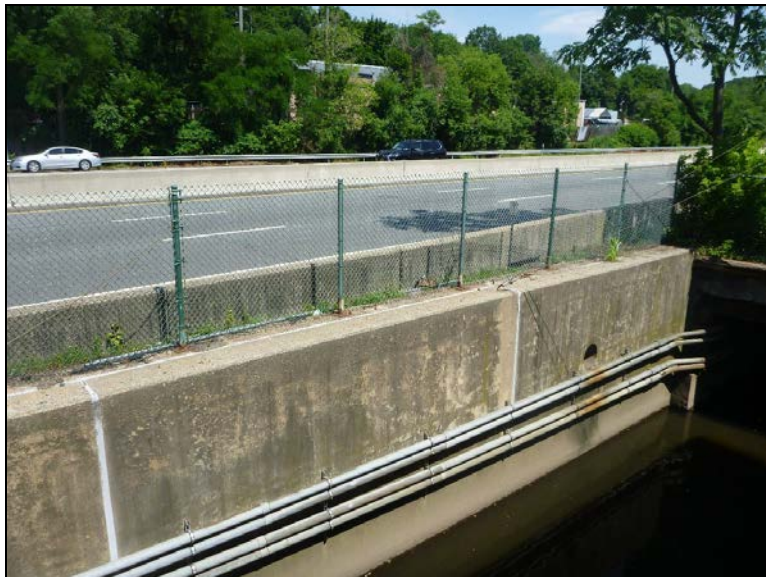
Inspect ID: NAR1_2019_a_0068 **Title:** USACE_CENAN_NAR1_2019_a_0068_1.jpg
Rated Item: 3. Encroachments **Caption:** Rating: Minimally Acceptable; Remarks: A chain metal fence on the wall of the right bank is not on as-built plans.; Action: Investigate easement agreement and dispose of fence encroachment accordingly.; Station_1: 0+55U

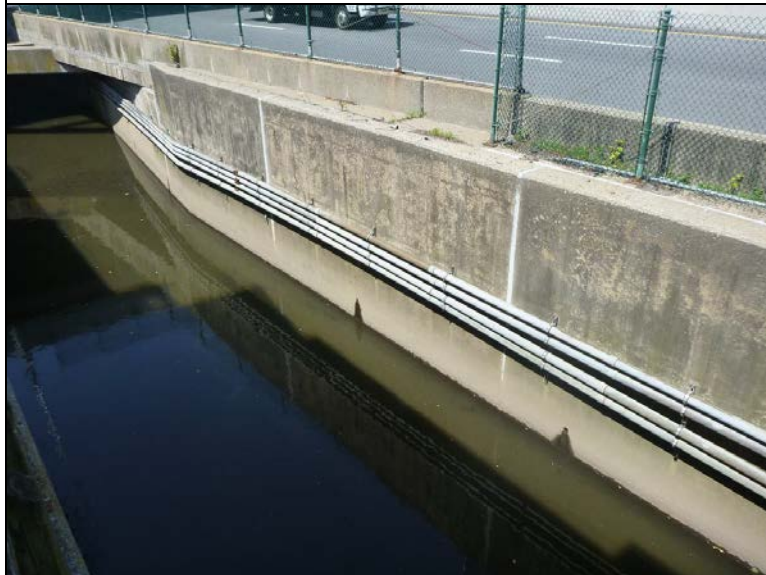
Inspect ID: NAR1_2019_a_0072 **Title:** USACE_CENAN_NAR1_2019_a_0072_1.jpg
Rated Item: 3. Encroachments **Caption:** Rating: Minimally Acceptable; Remarks: Metal conduits (pipes) on right wall of concrete channel.; Action: Investigate easement agreement and dispose of encroachment accordingly.; Station_1: 0+90U

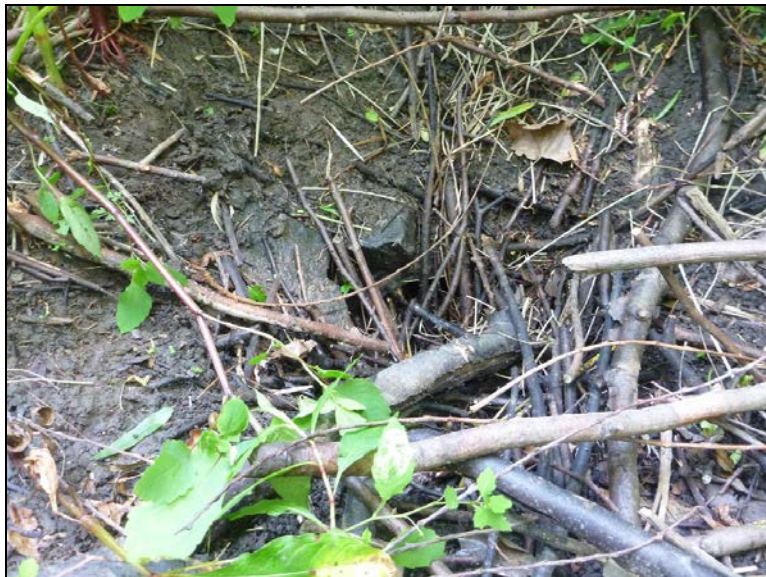
Inspect ID: NAR1_2019_a_0089 **Title:** USACE_CENAN_NAR1_2019_a_0089_1.jpg
Rated Item: 3. Encroachments **Caption:** Rating: Minimally Acceptable; Remarks: 6" PVC outlet pipe found encroaching on interceptor ditch #1.; Action: Local sponsor should investigate the source and authorization for the encroachment.; Station_1: 0+25A

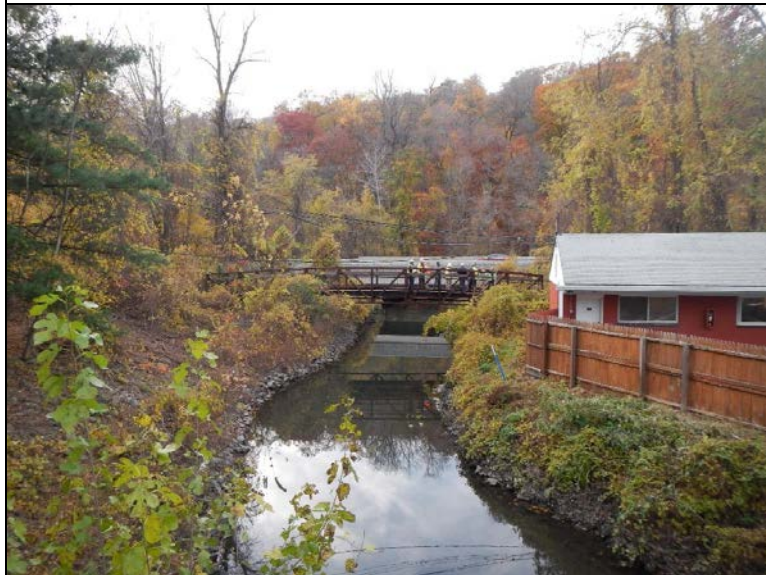
Inspect ID: NAR1_2019_a_0093 **Title:** USACE_CENAN_NAR1_2019_a_0093_1.jpg
Rated Item: 3. Encroachments **Caption:** Rating: Minimally Acceptable; Remarks: Pedestrian bridge over Saw Mill River replaced the railroad bridge that was to be removed. It is not on the project plans.; Action: Document bridge and verify hydraulics of the river are unaffected. ; Station_1: 0+50D; Photo taken prior to the 2019 inspection.

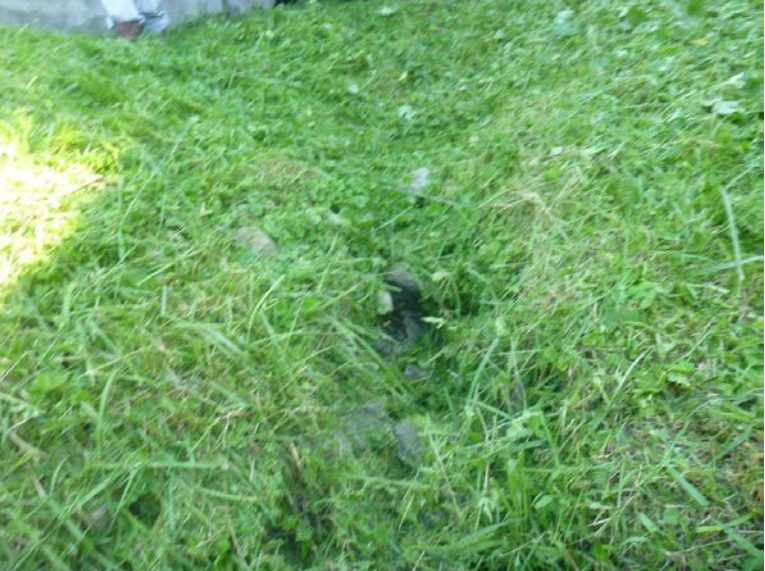
<p>Inspect ID: NAR1_2019_a_0002 Title: USACE_CENAN_NAR1_2019_a_0002_1.jpg Rated Item: 4. Erosion Caption: Rating: Minimally Acceptable; Remarks: Partial erosion of riprap below outlet of Junction Structure #1.; Action: Restore swale to design condition and line unprotected areas with riprap.; Station_1: 4+25B</p>

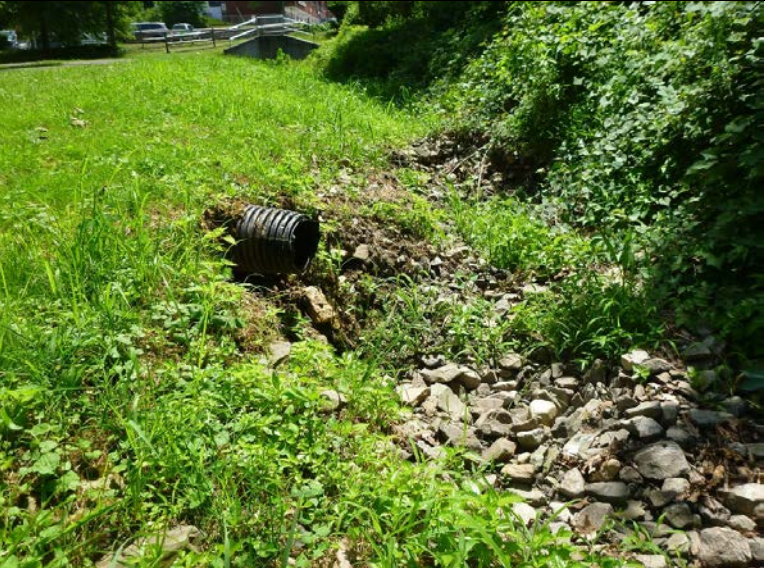
<p>Inspect ID: NAR1_2019_a_0087 Title: USACE_CENAN_NAR1_2019_a_0087_1.jpg Rated Item: 4. Erosion Caption: Rating: Minimally Acceptable; Remarks: Erosion of the embankment of interceptor ditch #1 at 8" pipe.; Action: Repair eroded embankment.; Station_1: 2+55A</p>

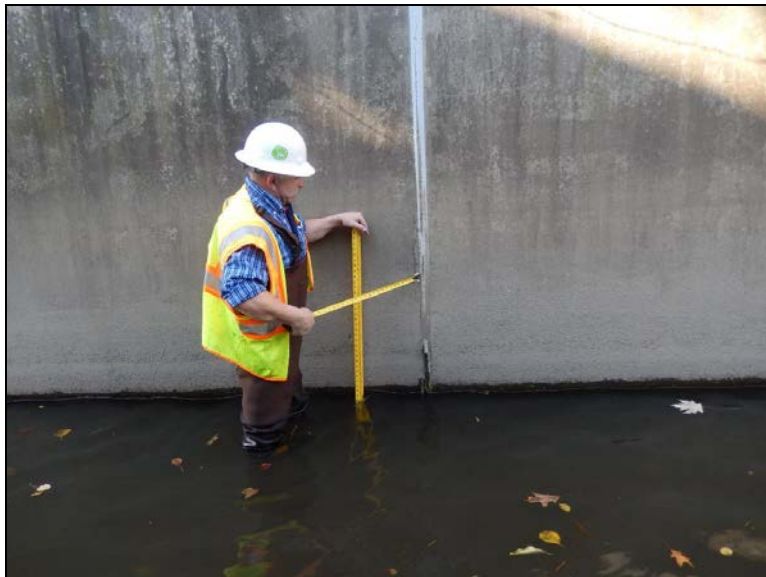
Inspect ID: NAR1_2019_a_0056 **Title:** USACE_CENAN_NAR1_2019_a_0056_1.jpg
Rated Item: 5. Concrete Surfaces **Caption:** Rating: Minimally Acceptable; Remarks: Spalling near joint between monoliths 13 and 14 on the right bank channel wall. Could not access in 2019.; Action: Repair concrete surface in accordance with USACE guidelines.; Station_1: 2+80U; Photo taken prior to the 2019 inspection.

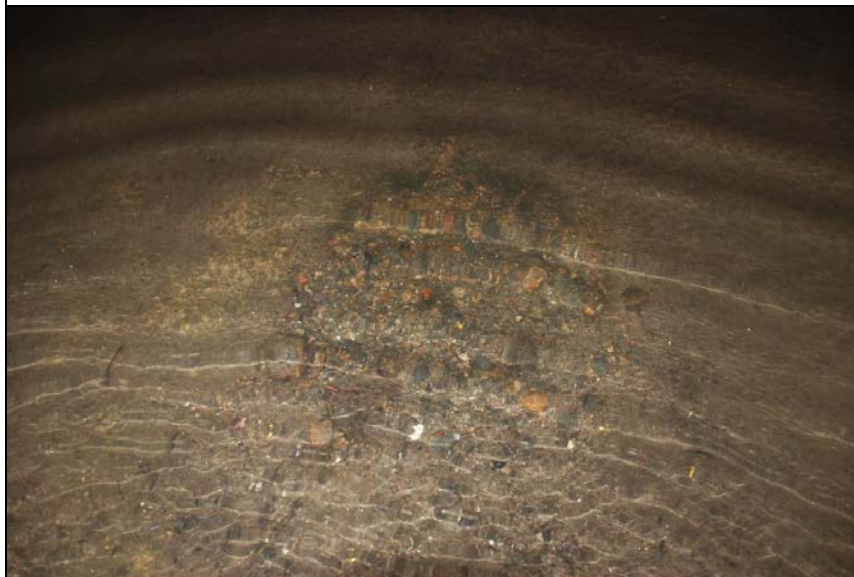
Inspect ID: NAR1_2019_a_0061 **Title:** USACE_CENAN_NAR1_2019_a_0061_1.jpg
Rated Item: 5. Concrete Surfaces **Caption:** Rating: Minimally Acceptable; Remarks: Scour hole at bottom of concrete channel. Could not access in 2019.; Action: Repair concrete surfaces in accordance with USACE guidelines.; Station_1: 1+45U; Photo taken prior to the 2019 inspection.

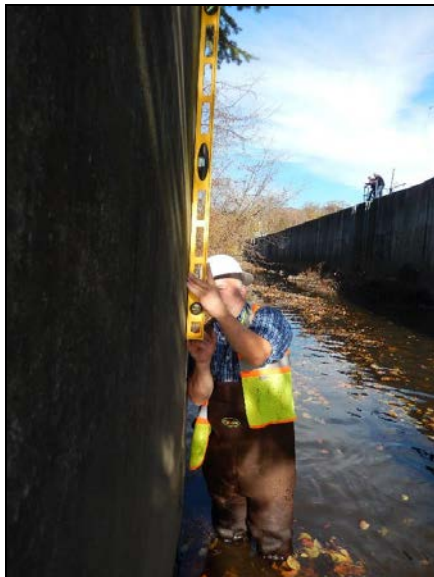
Inspect ID: NAR1_2019_a_0077 **Title:** USACE_CENAN_NAR1_2019_a_0077_2.jpg
Rated Item: 6. Tilting, Sliding or Settlement of Concrete Structures **Caption:** Rating: Minimally Acceptable; Remarks: Right channel wall tilting toward channel 1/4" over 4', between monolith 21 and 22. Could not access in 2019.; Action: Monitor displacement of the concrete monoliths to determine if movement is active.; Station_1: 4+35U; Photo taken prior to the 2019 inspection.

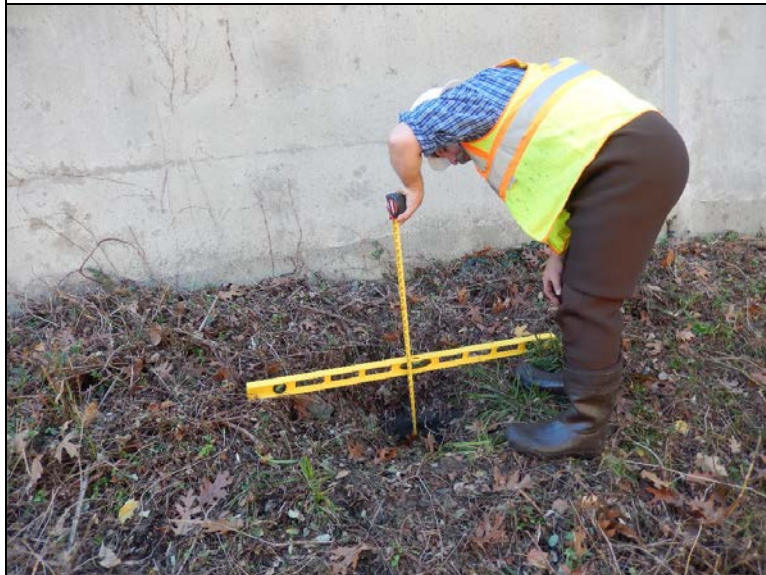
Inspect ID: NAR1_2019_a_0019 **Title:** USACE_CENAN_NAR1_2019_a_0019_1.jpg
Rated Item: 7. Foundation of Concrete Structures **Caption:** Rating: Minimally Acceptable; Remarks: The embankment slope on the exposed side has a depression 5 ft from floodwall, 6 ft wide and 3 ft deep. It may be the result of removing a tree. Could not access in 2019.; Action: Regrade to approved line and grade, reseed and mulch in accordance with USACE guidelines.; Station_1: 3+30B; Photo taken prior to the 2019 inspection.
