Westchester County

Rehabilitation of Ashford Avenue over I-87 and SMRP

BINs 5348380 and 534838A

April 28, 2010

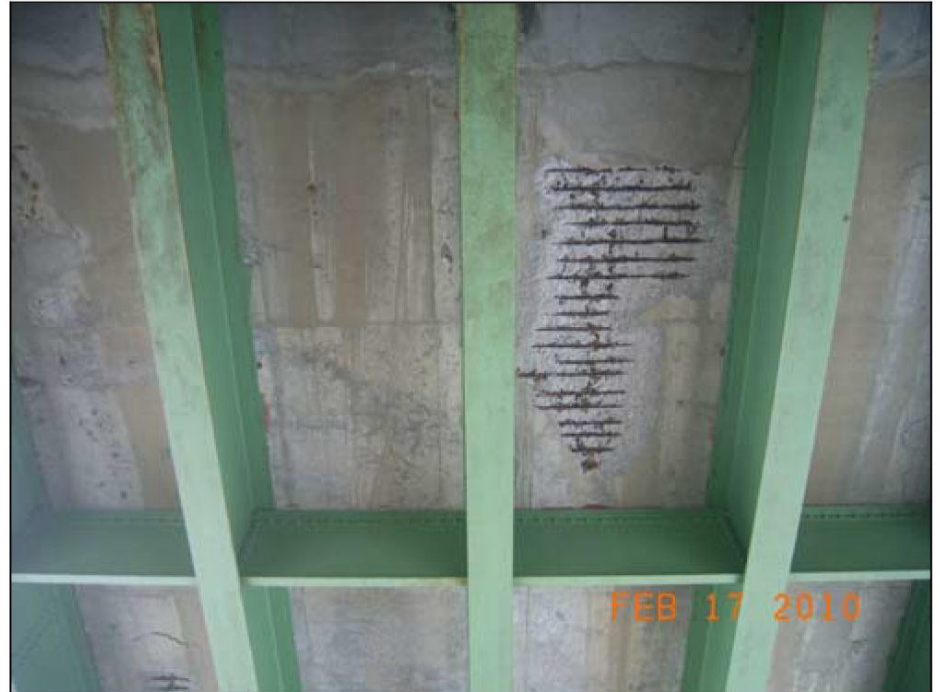
■ In-Depth Inspection Findings (Concrete Deck)

- Joint leakage typical
- Good ride quality, but with localized serious deterioration
- Underside exhibits extensive dampness, efflorescence, cracking, hollowness, and shallow spalls, especially at girder top flanges

Ramp Bridge Photo 21 <Span 2 at Begin. Locally serious deck deterioration.

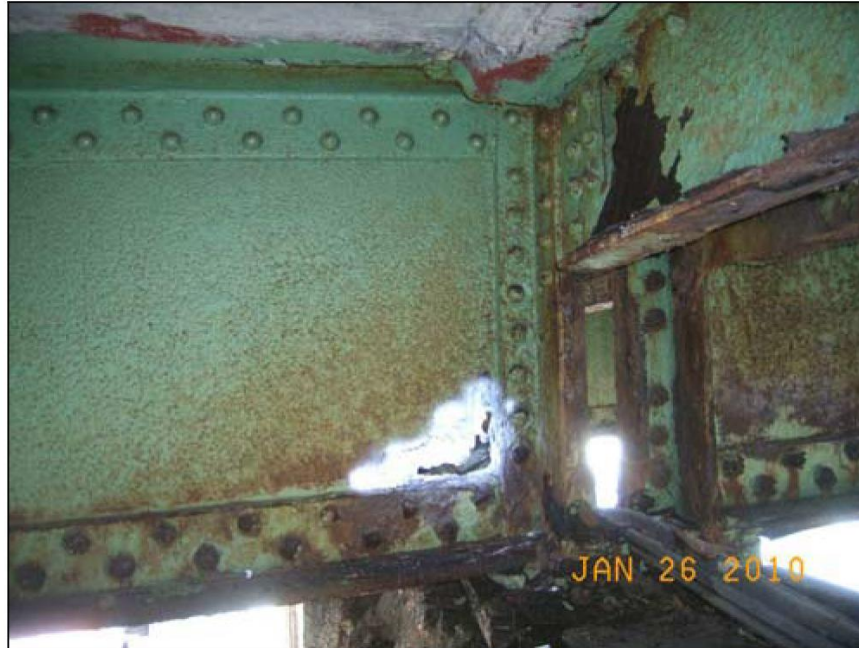
■ In-Depth Inspection Findings (Steel)

- Fascia girders exhibit typical section loss and stiffener deterioration
- Interior girders sections typically show no significant deterioration
- All girders with 10% to 15% section loss at top flange horizontal leg

Main Bridge Photo 60 <09988a>: Span 1 Girder G4, Right side, at Pier 1. Large hole in web plate.

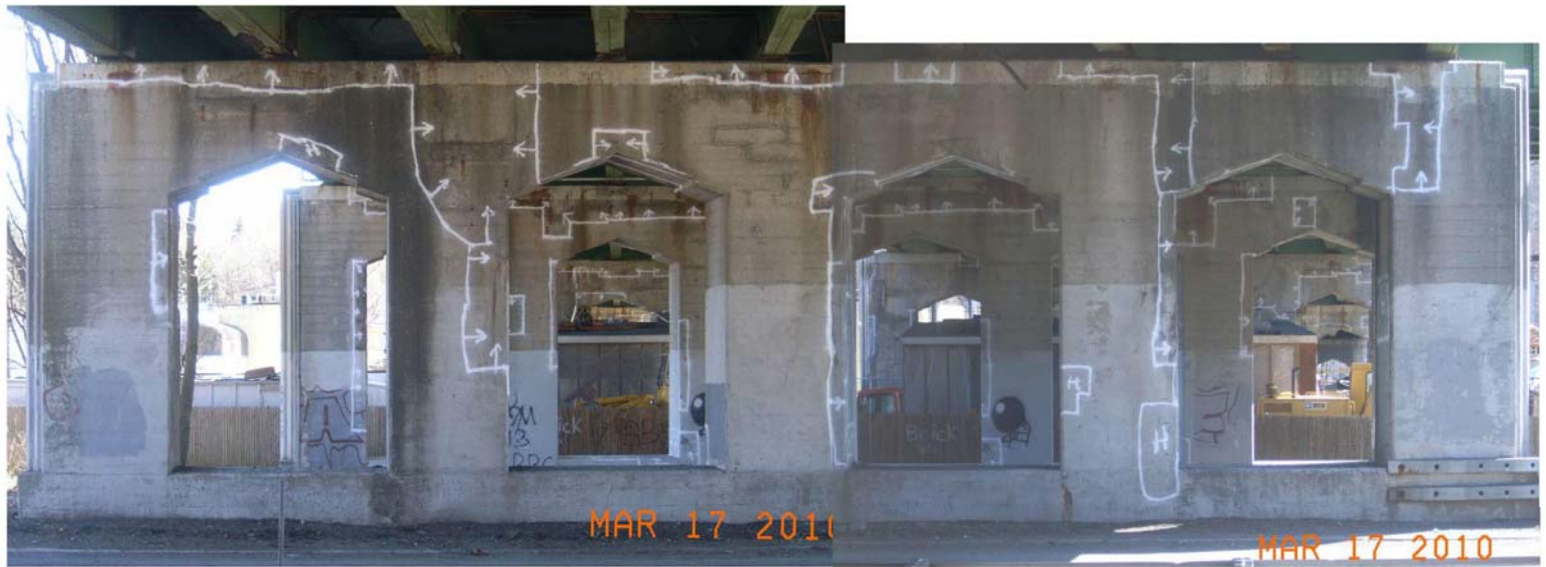
■ In-Depth Inspection Findings (Substructure)

- Bearings, bridge seat, and backwall at fascia show serious deterioration, interior locations in fair condition
- Piers contain cracks, dampness, hollowness, and spalling on 5% to 30% of face area
- Abutments show similar deterioration on 25% of face area at mainline, 75% at ramp
- Wingwalls show similar deterioration on minor to 25% of face area

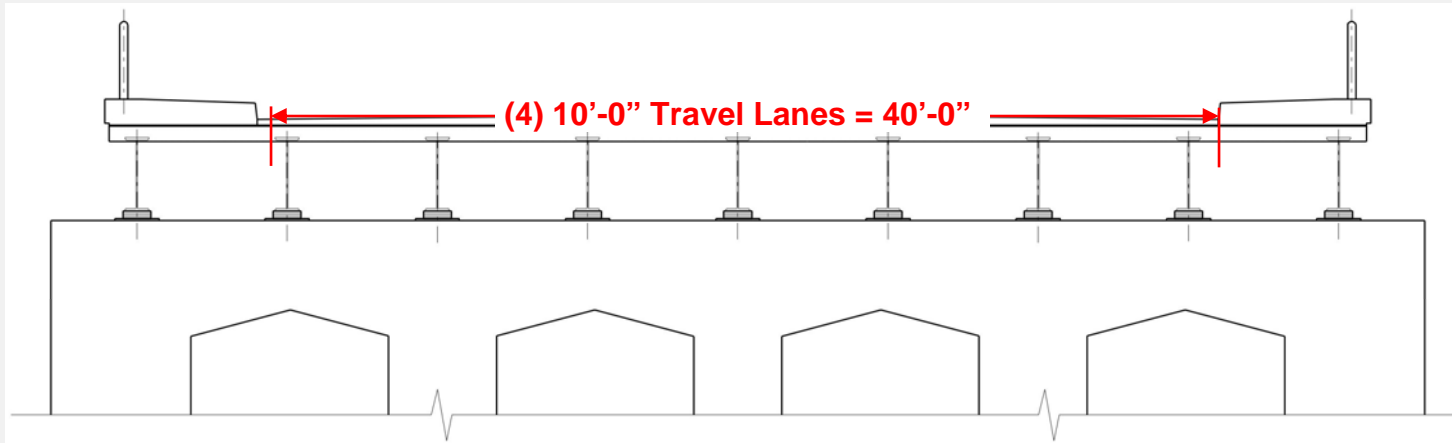
Existing Bridge

<u>BIN 5348380</u>	<u>BIN 534838A</u>
– Total number of spans:	6	3
– Total length of bridge:	405.5 ft	173 ft w/ 100 ft app
– Curb to curb width:	40 ft	24 ft
– Total width of bridge:	52 ft - 8 in	27 ft – 11 in
– Year of construction:	1950	1950
– Last major rehabilitation:	1992	1992
– Computed condition rating:	3.861	4.333
– AADT (1997):	20,342	3,427

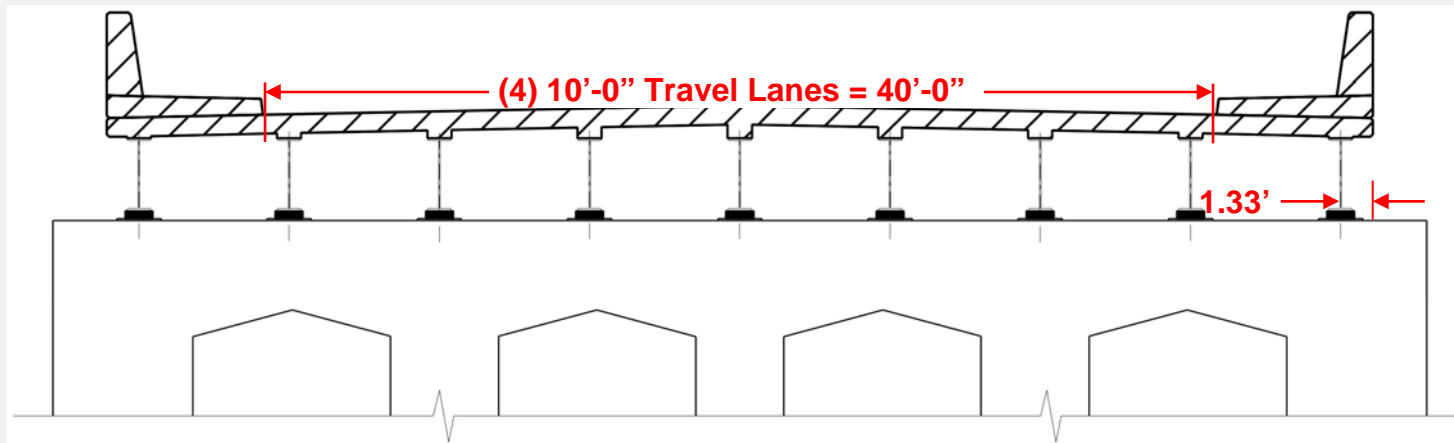
Alternative 1 – Deck Rehabilitation

- Remove existing deck and bearings
- Composite Design (increase capacity)
- New Bearings
- Repair / field paint existing steel superstructure
- Repair concrete substructure
- Replace traffic signals, signage, striping, and lighting
- Effective service life: 20-years
- ESTIMATED COST: \$16.2 million

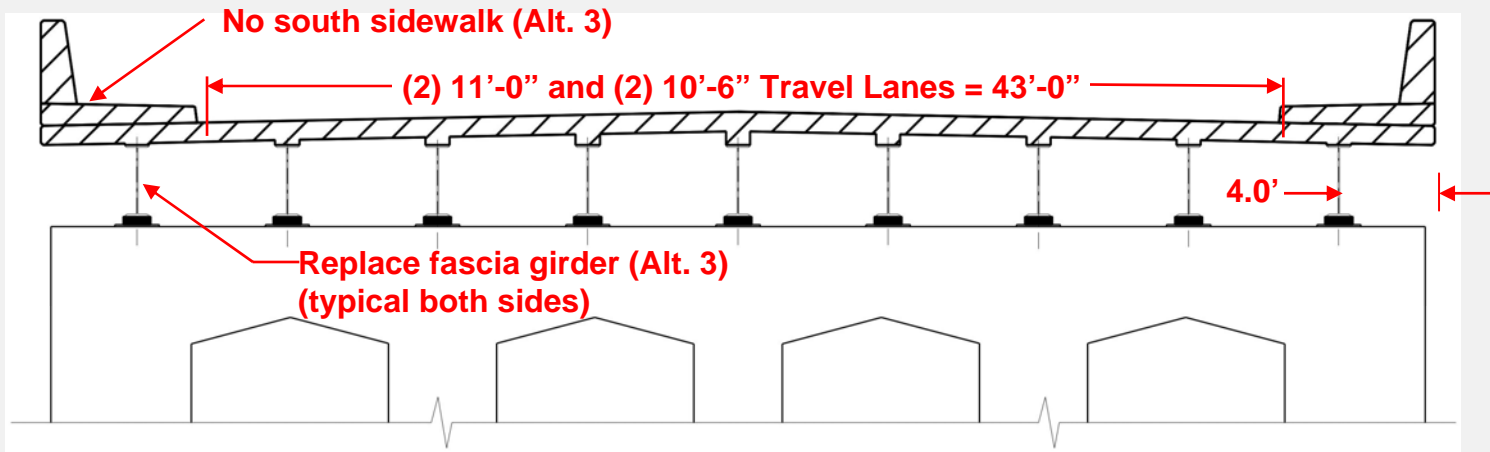
Alternatives 2 & 3 – Rehab. with Widening

- Includes all base rehabilitation work (listed in Alternative 1)
- Widen deck to accommodate 4' fascia overhang
- Effective service life: 20-years
- ESTIMATED COSTS:
 - Alternative 2 - \$16.8 million
 - Alternative 3 - \$18.2 million

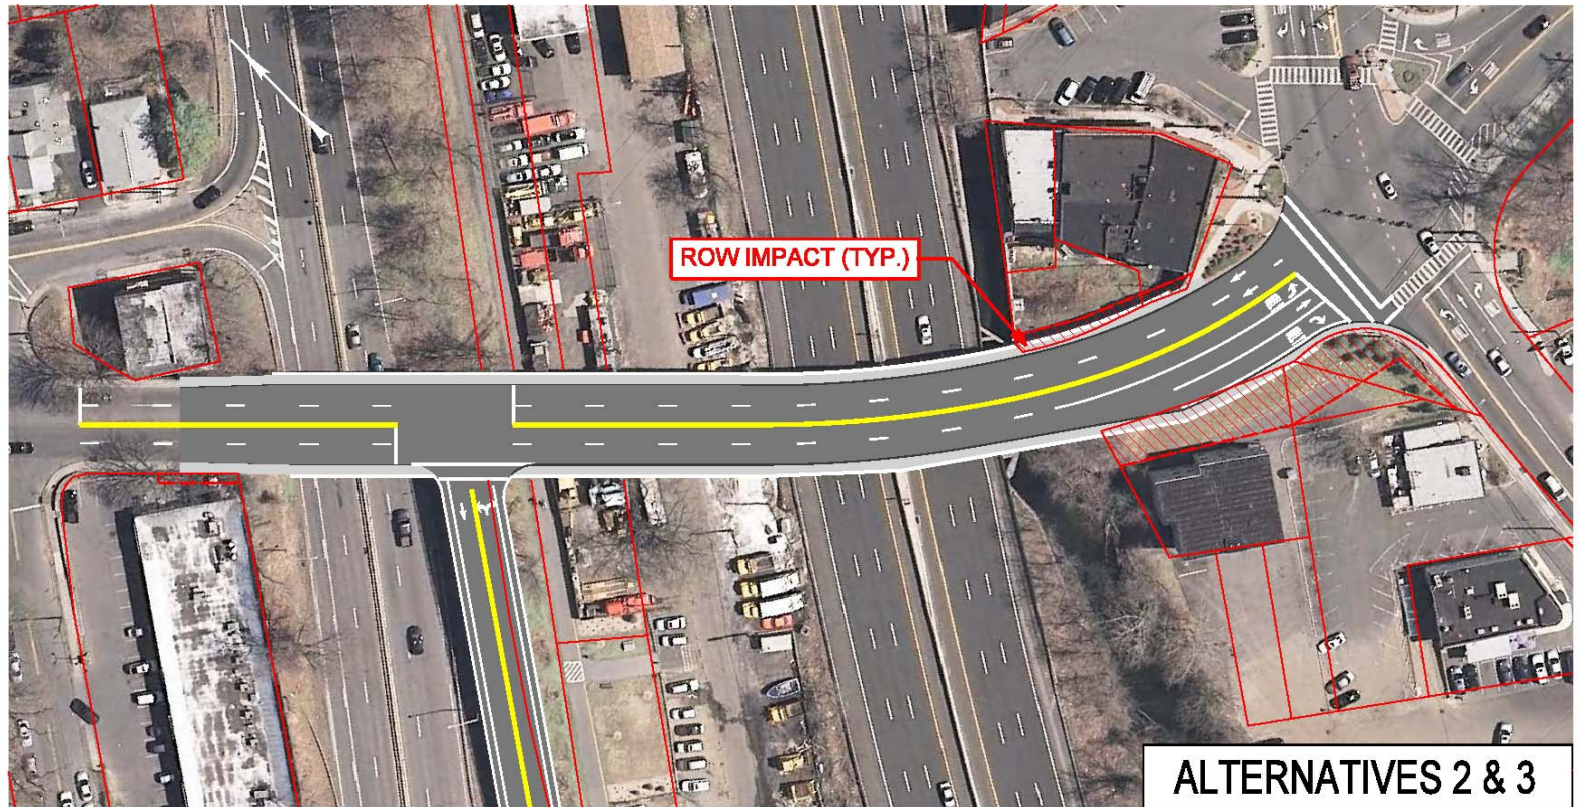
Alternatives 2 & 3 – Rehab. With Widening

Alternative 3, sidewalk removal results in:

- ~10 feet longer right turn bay
- 2 feet curb offset
- Slightly wider travel lanes
- Changes pedestrian movements

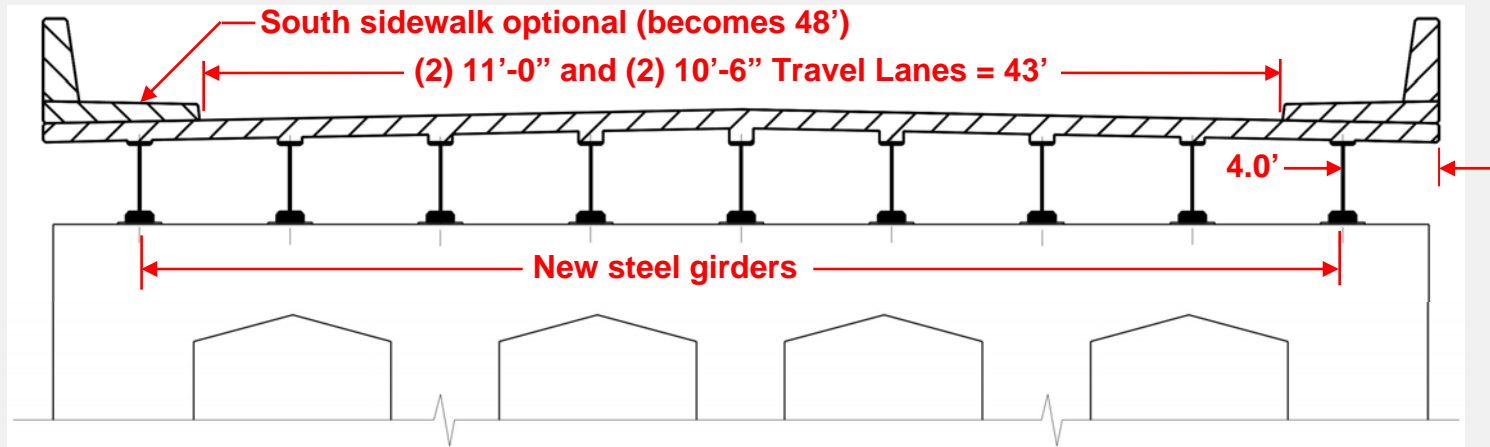
Alternative 4 – Superstructure Replacement

- Complete deck and girder replacement
- Repair concrete substructure
- Accommodate future improvements at Rte. 9a intersection
- Effective service life: 50-years
- ESTIMATED COST: \$19.7 million

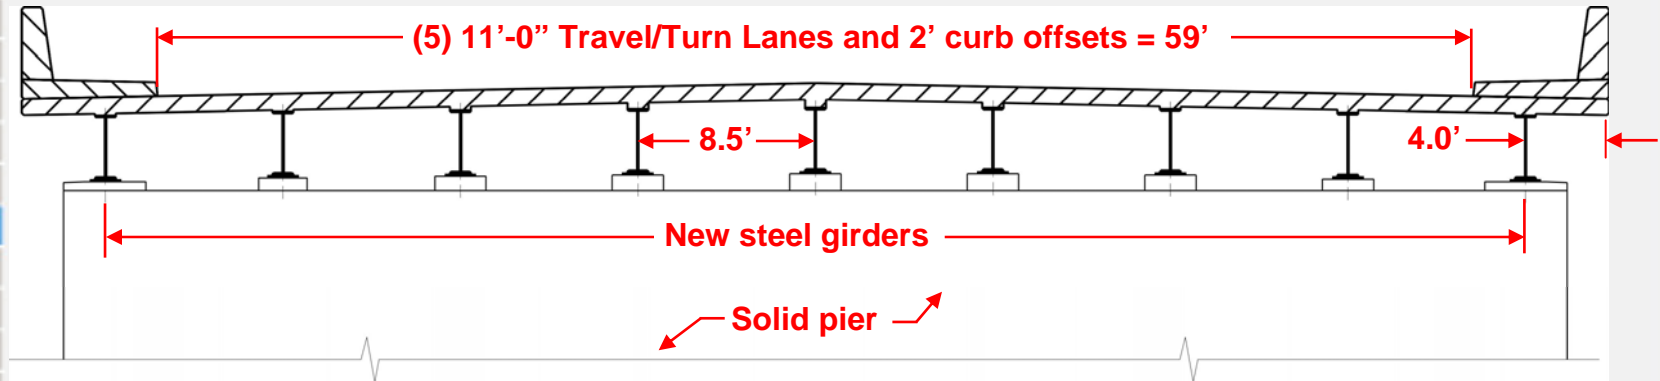
Alternative 5 – Complete Replacement

- Complete superstructure and substructure demolition
- Install 3-span continuous structure
- Install concrete piers, abutment, wingwalls
- Effective service life: 70-years
- ESTIMATED COST: \$28.3 million

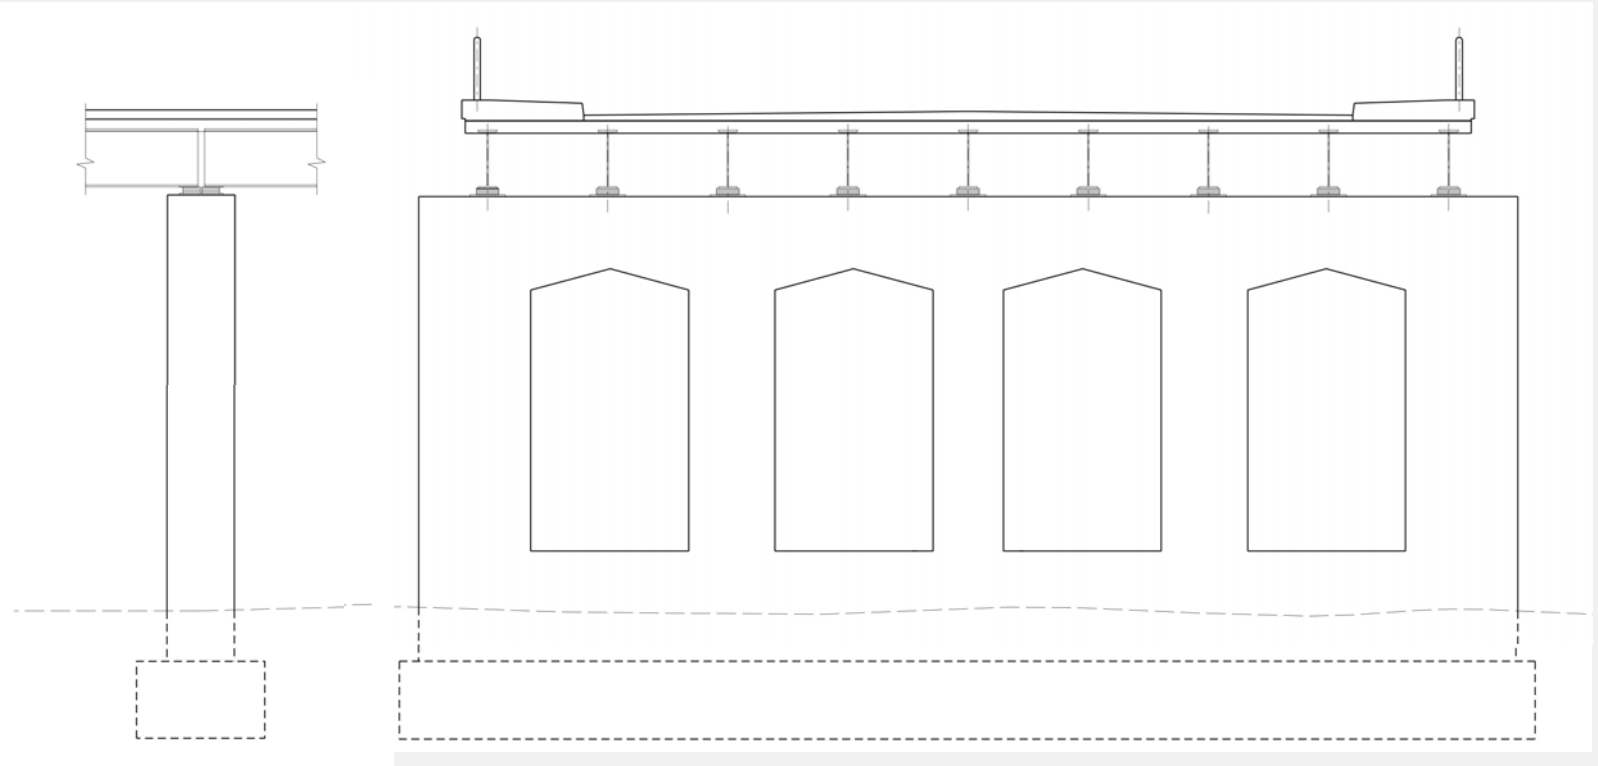
Seismic Retrofit

- Fill in fixed piers (Piers 2 and 4 on mainline, Pier 6 on ramp)
- Increase pier cap with to satisfy minimum seat width requirements
- ESTIMATED COST: \$1.0 million

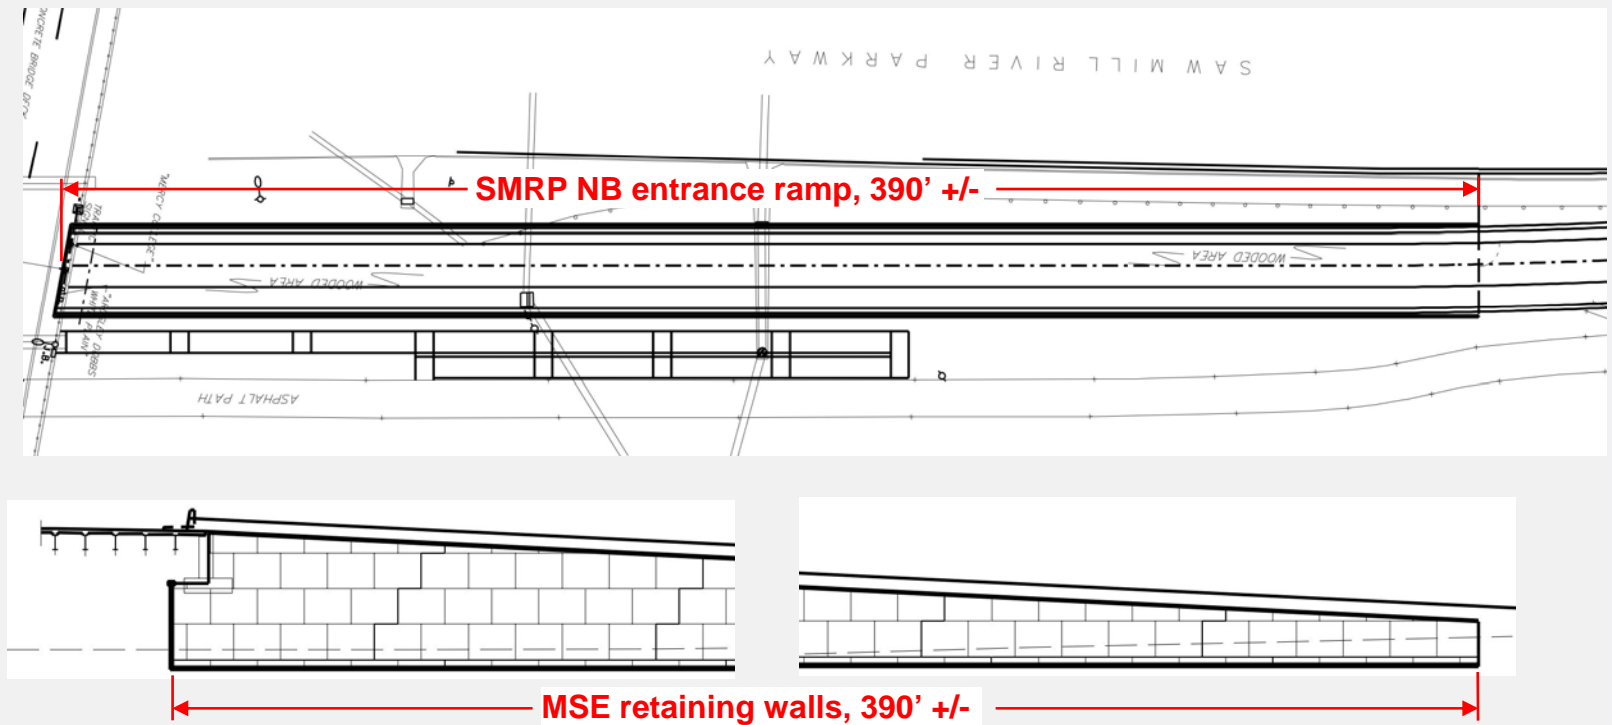
Conceptual Design: Vehicular Ramp

- MSE wall abutment and wingwalls
- 12'-0" travel lane, 6'-0" right shoulder, 3'-0" left shoulder
- ESTIMATED COST: \$3.0 million

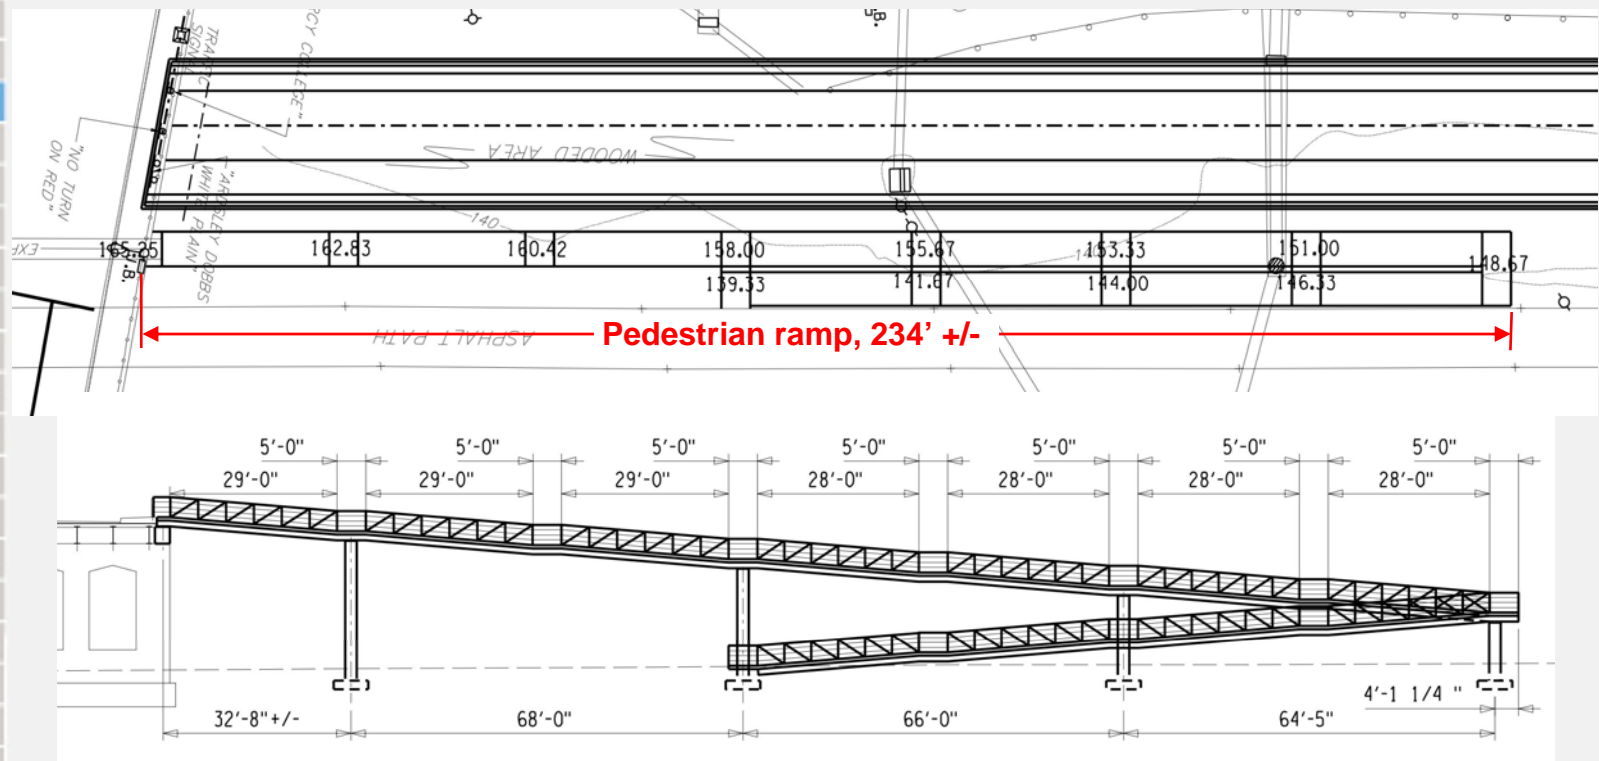
Conceptual Design: Pedestrian Ramp

- Provide access to the South County Trailway from Ashford Avenue
- ADA compliant
- Prefabricated truss pedestrian bridge on concrete piers
- ESTIMATED COST: \$1.5 million

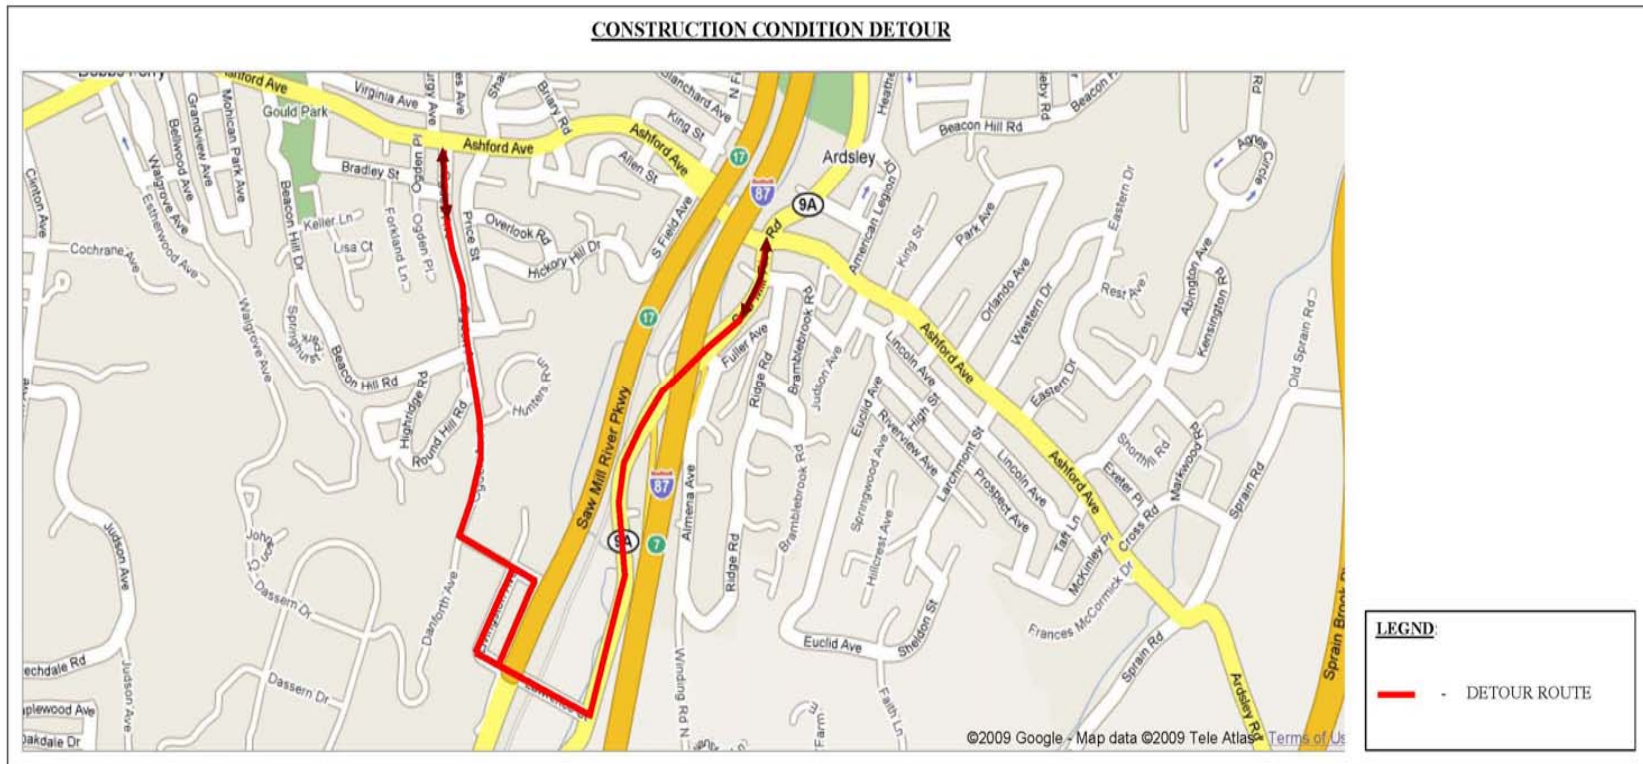
Maintenance and Protection of Traffic

- Staged Construction
- Maintain one lane of traffic in each direction at all times
- Major operations over Thruway and SMRP during off-peak periods
- Temporary detour during ramp work
